FINAL PRELIMINARY ENGINEERING REPORT

WITHLACOCHEE RIVER BRIDGE REPLACEMENT

ON S.R. 700 IN PASCO COUNTY, FLORIDA

WPI No.: 7115954
State Project No.: 14080-3506
Bridge No.: 140026

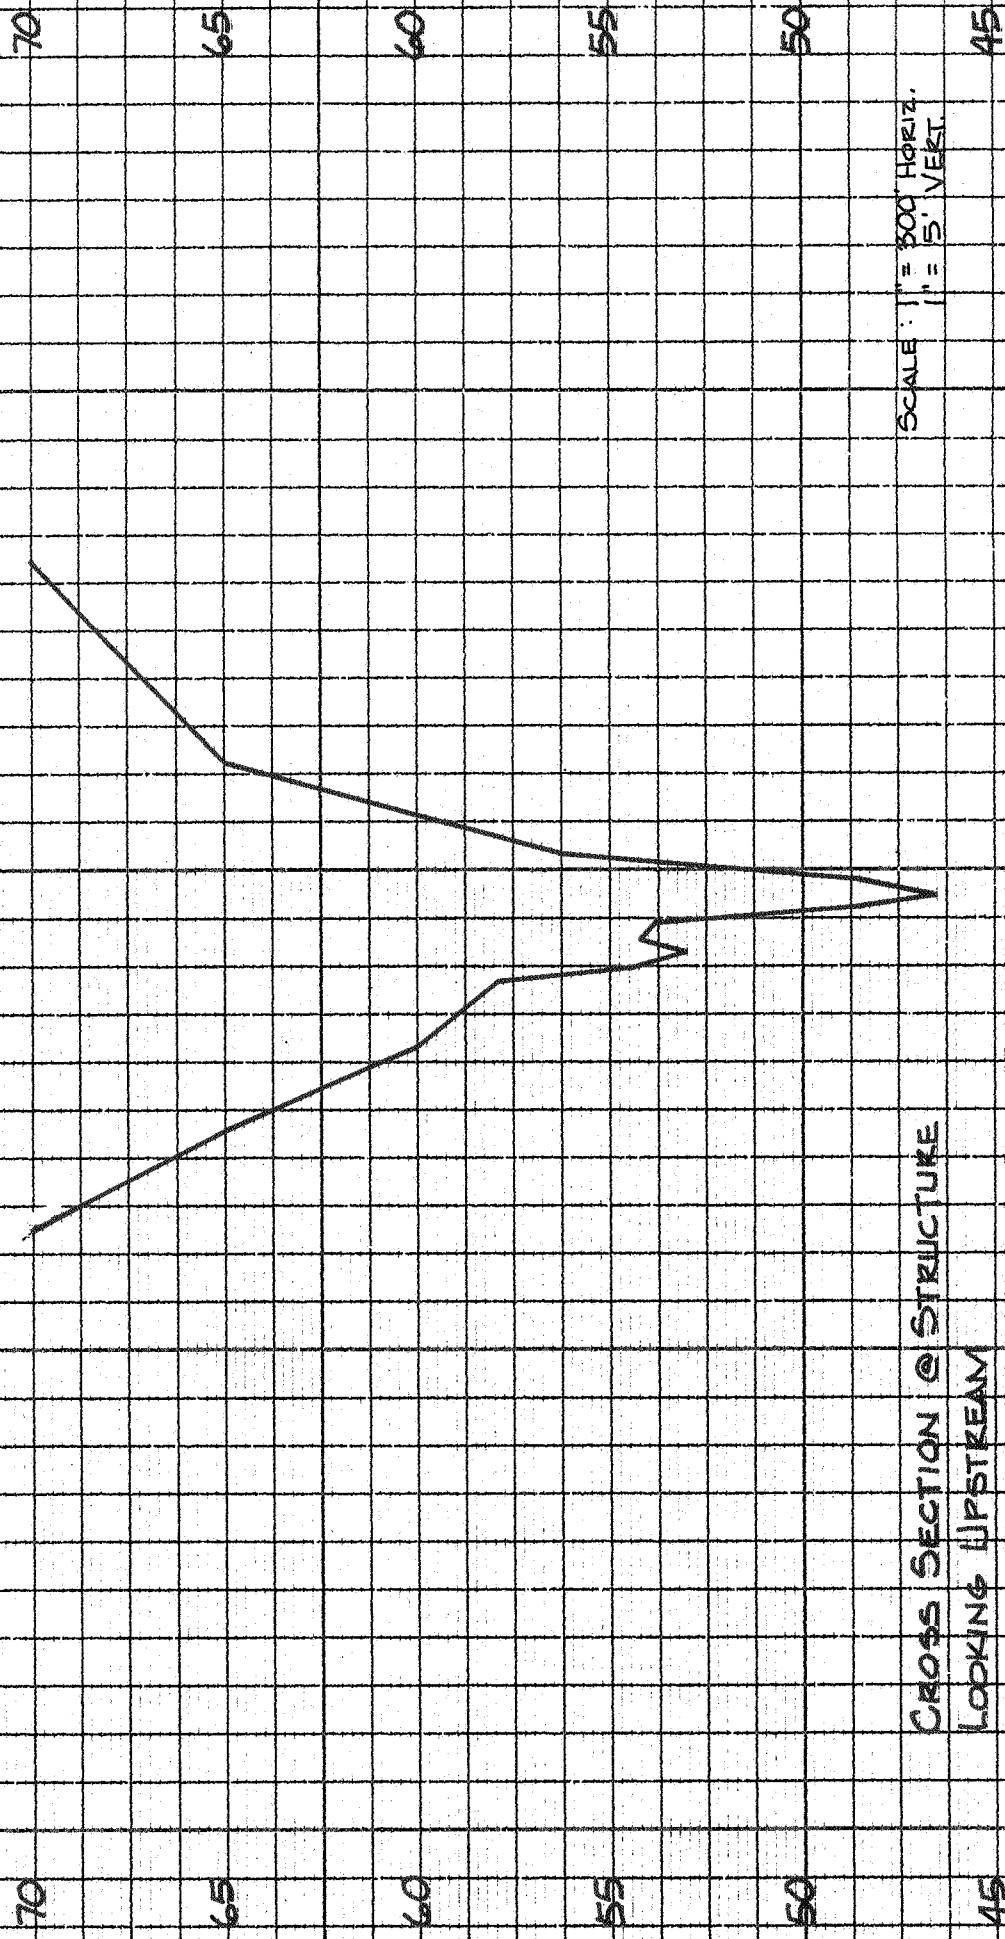
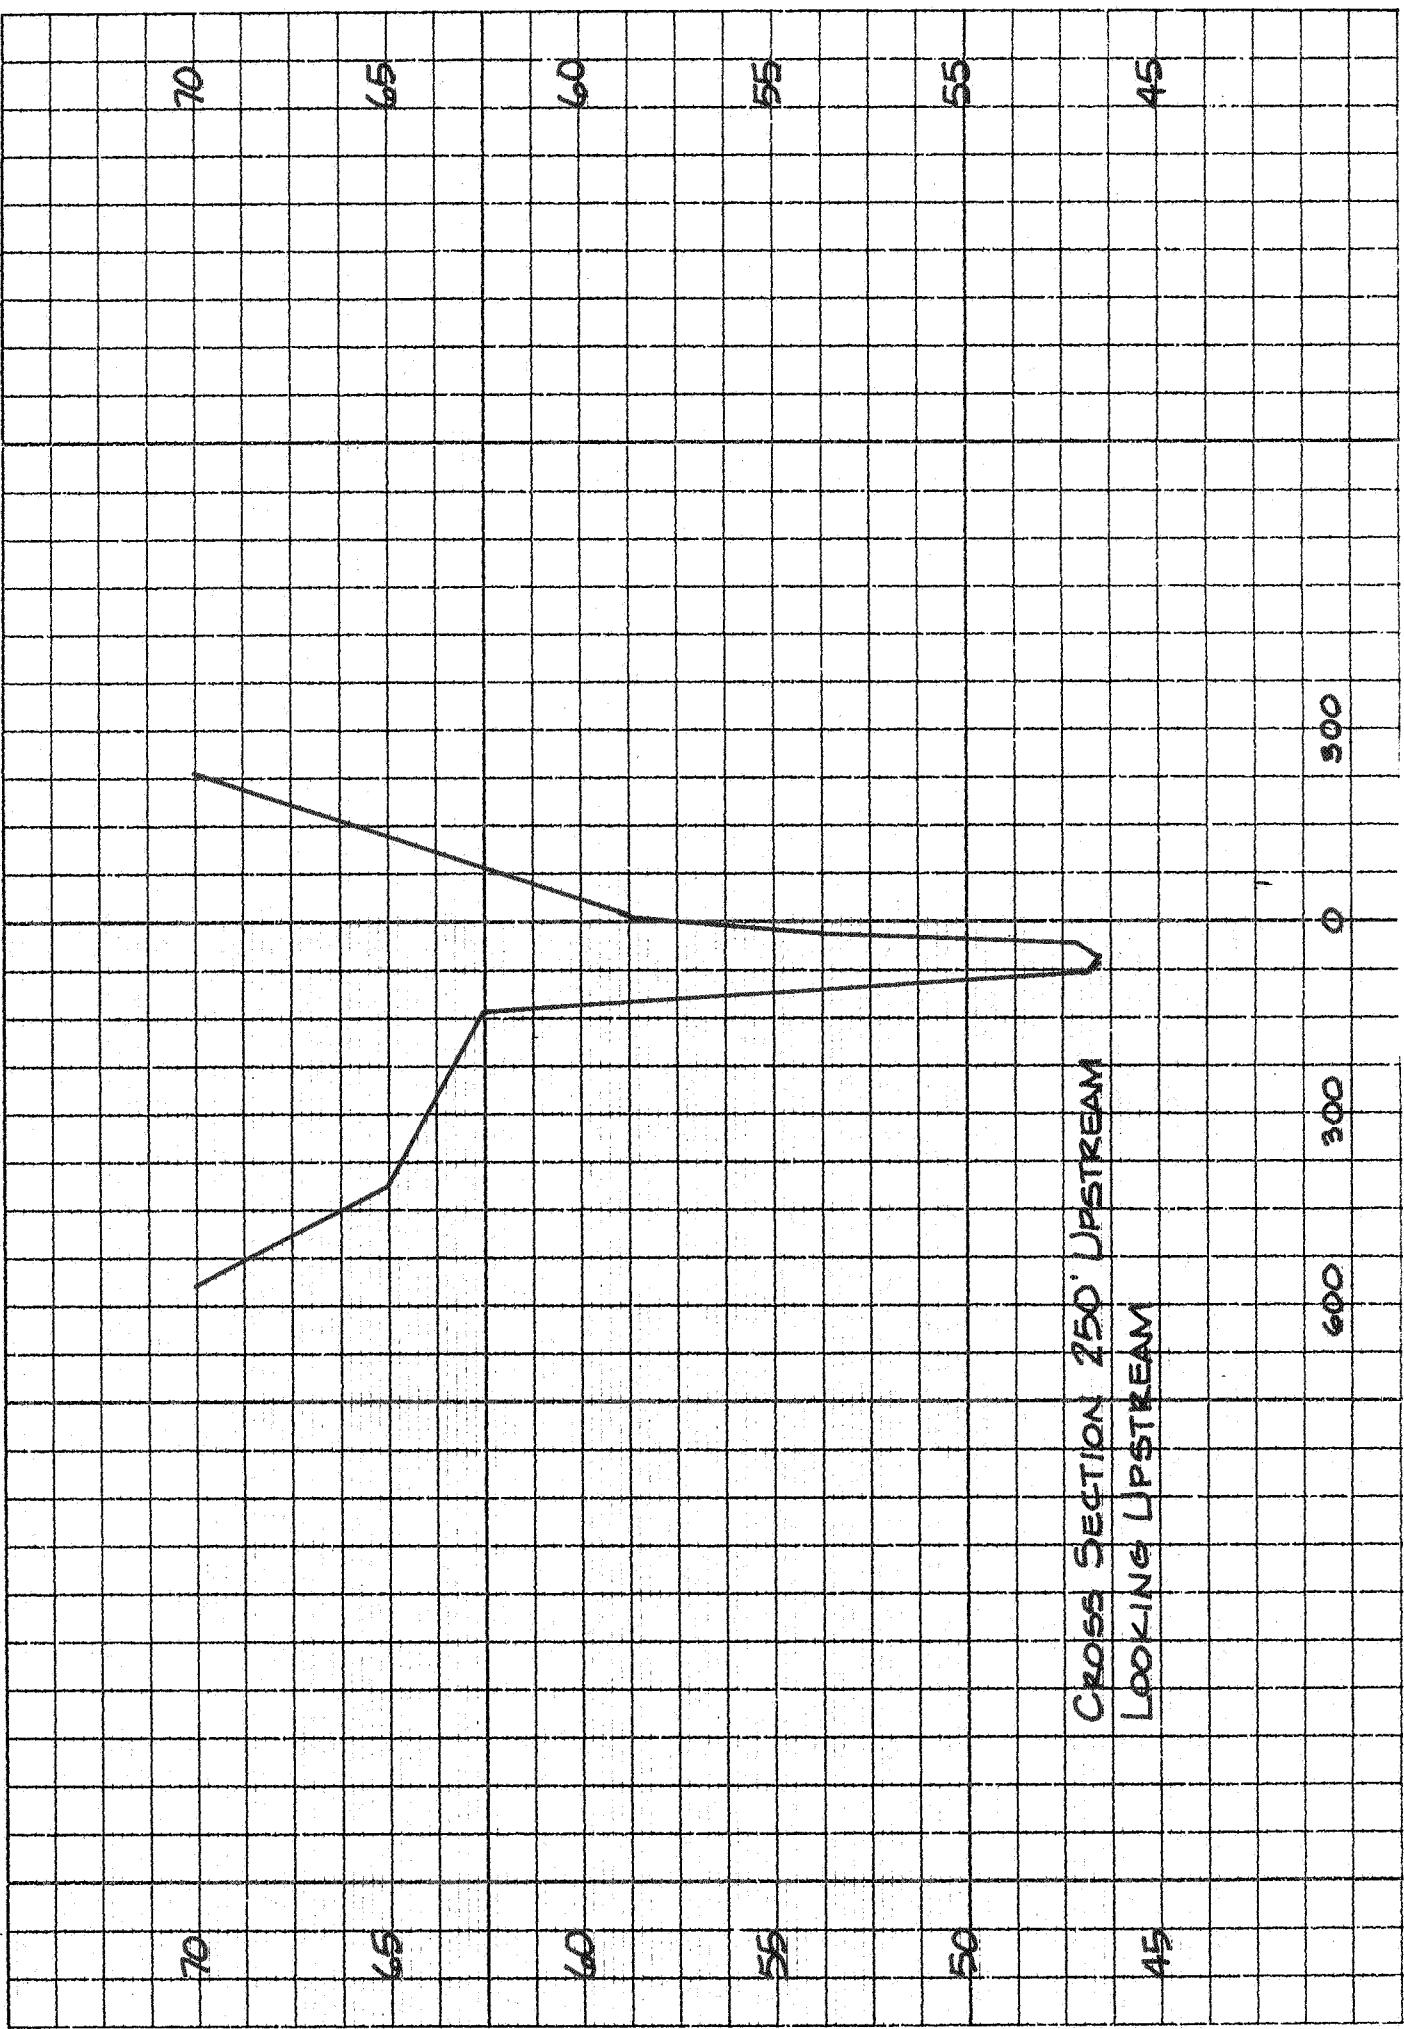
WSPRO INPUT/OUTPUT

WSPRO INPUT
EXISTING & PROPOSED 245' BRIDGE

The FHWA's WSPRO computer program was used to determine potential water stages and flow velocities for the 25-year, 50-year and 100-year floods for the alternative replacement structures. Discharge rates for the Trilby stream gage, which is located 1.53 miles upstream of the SR 700 (US 98) crossing, were used in conjunction with USGS regression equations in order to determine design discharge rates at the project site. Starting water surface elevations were taken from the SWFWMD report Flood-Plain Information on the Withlacoochee River. A summary of discharge, average flow velocity through the structure, and water surface elevation 250 feet upstream of the structure, for the no structure condition, the existing structure, and the replacement alternative structures is shown in Table 4.2.
