Draft Cultural Resource Assessment Report

**US 98 / State Road (SR) 35 / SR 700
From County Road (CR) 54 to US 301 (SR 39)
Project Development & Environment (PD&E) Study**

Florida Department of Transportation

Work Program Item Segment No. 443368-2

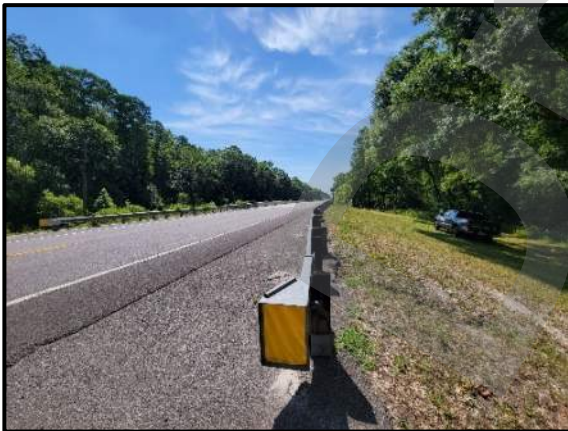
Photo 2-1 Southeast view of built-up US 98 ROW.

Currently, the APE is primarily a rural setting with mixed agricultural, residential, and commercial development. Disturbances noted within the APE include the elevated road berm, utilities, and ditches (**Photos 2-1 - 2-8**).

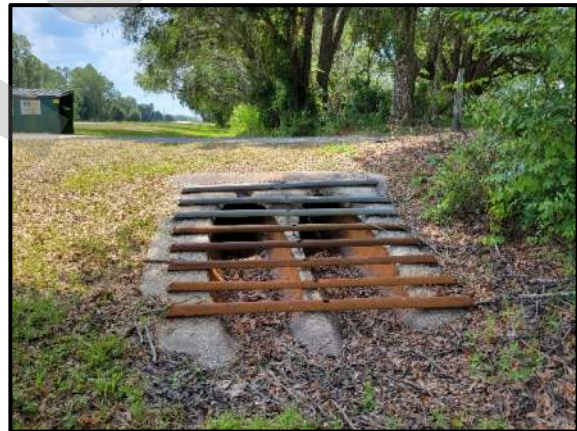
Photo 2-2 Drainage culvert within the APE.

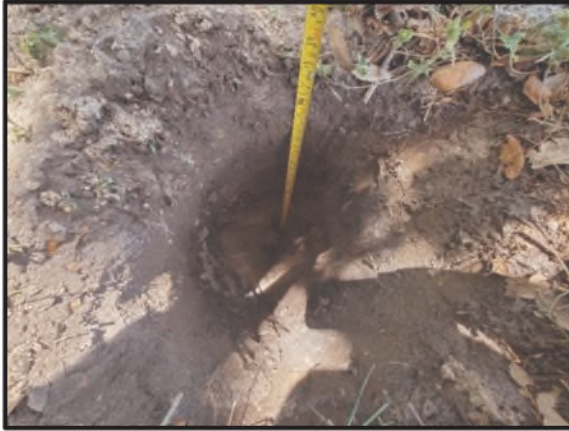
Photo 5-1 Stratigraphy in the western part of the APE.

- Southern portion of the APE: 0 to 30 cm below surface (cmbs) of dark brown, gray sand followed by 30 to 100 cmbs of reddish, brown sand with concretions.
- Western portion of APE, south of US 98: 0-60 cmbs of gray, brown sand followed by 60-100 cmbs of light brown sand (**Photo 5-1**)
- Approximate center portion of APE: 0-40 cmbs of light-gray, brown sand; 40-60 cmbs of light gray sand; and 60-100 cmbs of dark brown sand (**Photo 5-2**)
- Water was encountered in several test pits at the extreme outer limits of the APE (**Photo 5-3**)
- Northern portion of the APE: 0-30 cmbs of dark brown sand followed by 30-100 cmbs of orange, brown sand (**Photo 5-4**)

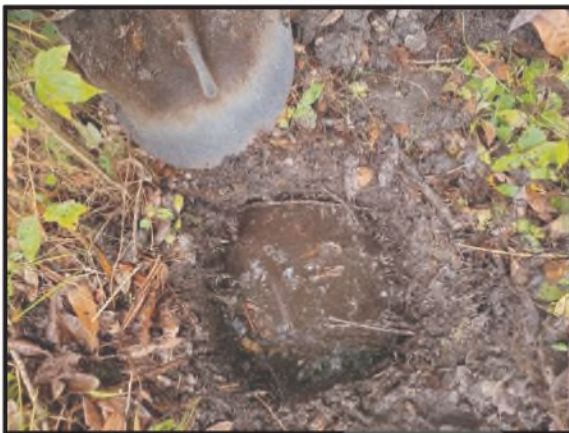
Photo 5-3 Water encountered in several of the shovel tests.

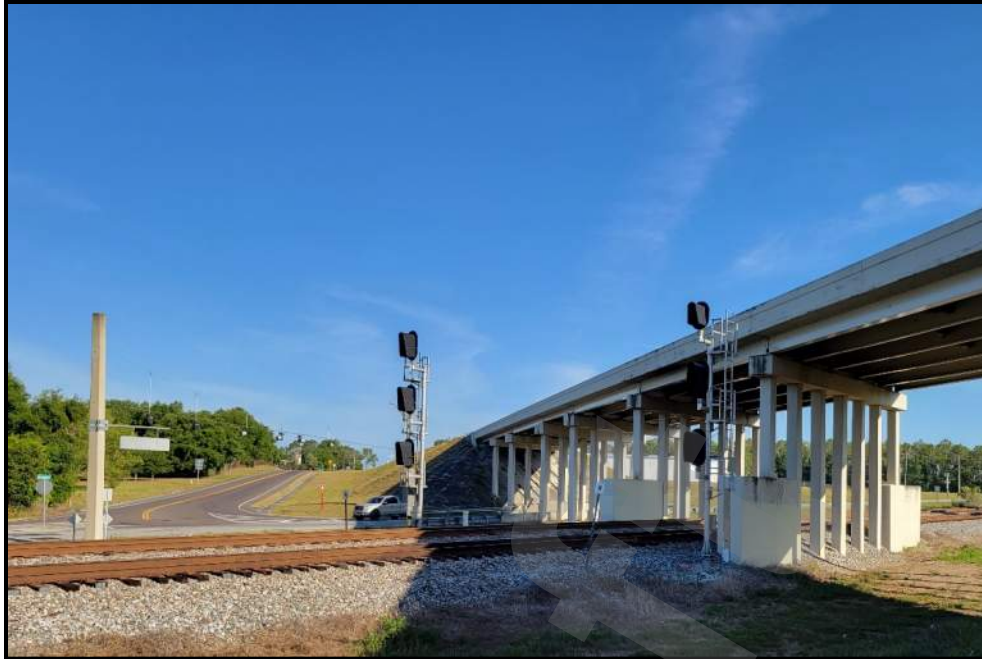
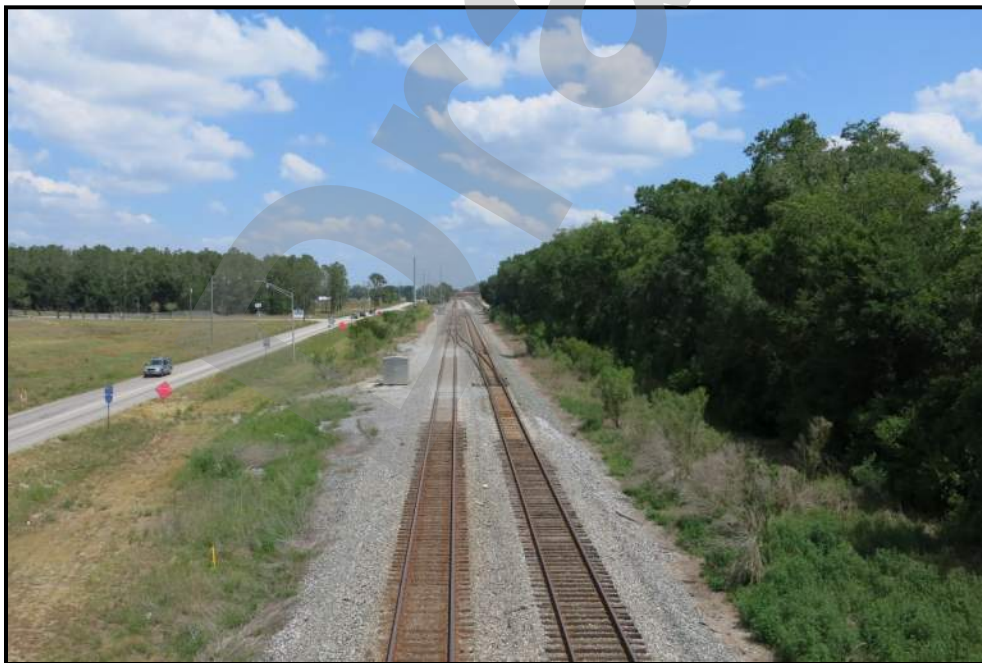
Photo 5-13 South Florida Railroad – Pemberton Ferry Branch/Richloam Railroad (8PA02802), looking northwest.

Photo 5-14 South Florida Railroad – Pemberton Ferry Branch/Richloam Railroad (8PA02802), looking northwest.

8PA02802: The segment of the South Florida Railroad – Pemberton Ferry Branch/Richloam Railroad within the APE was constructed in ca. 1885 and is located in Sections 18 and 19 of Township 25 South, Range 22 East (USGS Dade City 1960). This segment is approximately 0.45 miles long and runs parallel to Old Lakeland Highway (**Photos 5-13 and 5-14**). The rail line consists of two sets of standard gauge

The railroad is a typical example found throughout Florida and does not possess distinctive historic characteristics or materials. The railroad, however, does possess historical significance for its association with the development of Florida's railroads. Therefore, the segment of the South Florida Railroad – Pemberton Ferry Branch/Richloam Railroad (8PA02802) within the APE appears eligible for listing in the NRHP at the local level under Criterion A in the areas of Community Planning & Development and Transportation.

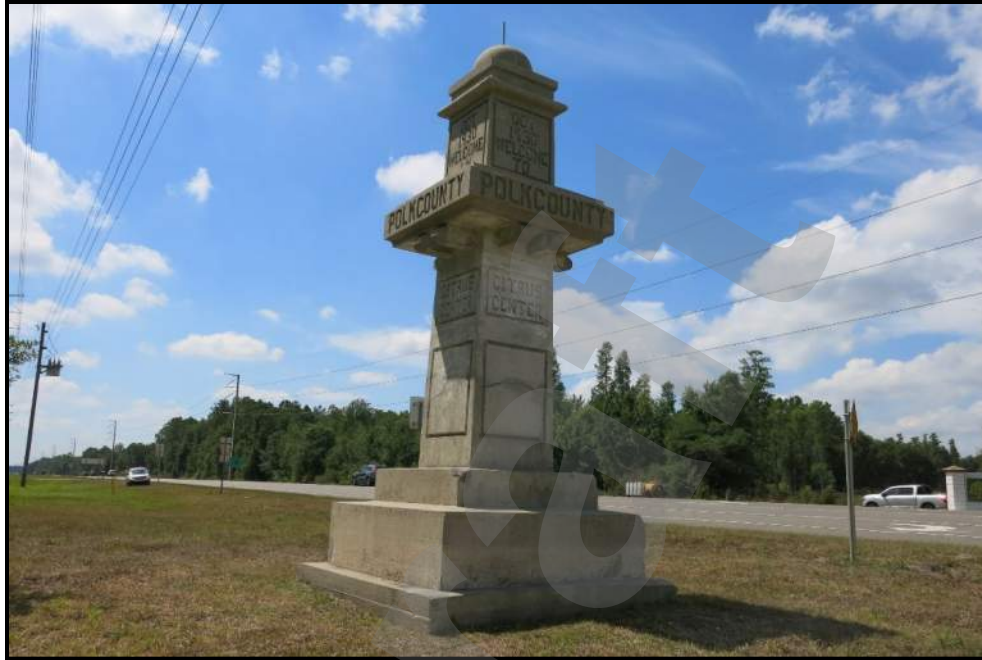
Photo 5-15 Polk-Pasco County Line Obelisk (8PA03346), looking southeast.

8PA03346: The Polk-Pasco County Line Obelisk in Kathleen, Florida is a ca. 1930 Neo-Classical Revival style monument located on the northeastern side of US 98 at the intersection of CR 54 (**Photo 5-15**). This cast concrete obelisk has an overall height of roughly 15 feet and is topped by a sphere. It features a square base, tapered column, and a collar supported by scrolled brackets. The obelisk serves as the northern boundary marker between Polk County to the south and Pasco County to the north. The northwest and southwest sides of the US 98 Polk-Pasco County marker are engraved with the following, "Oct 1930 Welcome to Polk County Citrus Center" while the northeast side of the marker is engraved with the same phrase; however, it reads "welcome in" rather than "welcome to." The southeast side of the marker heading into Pasco County is not engraved.

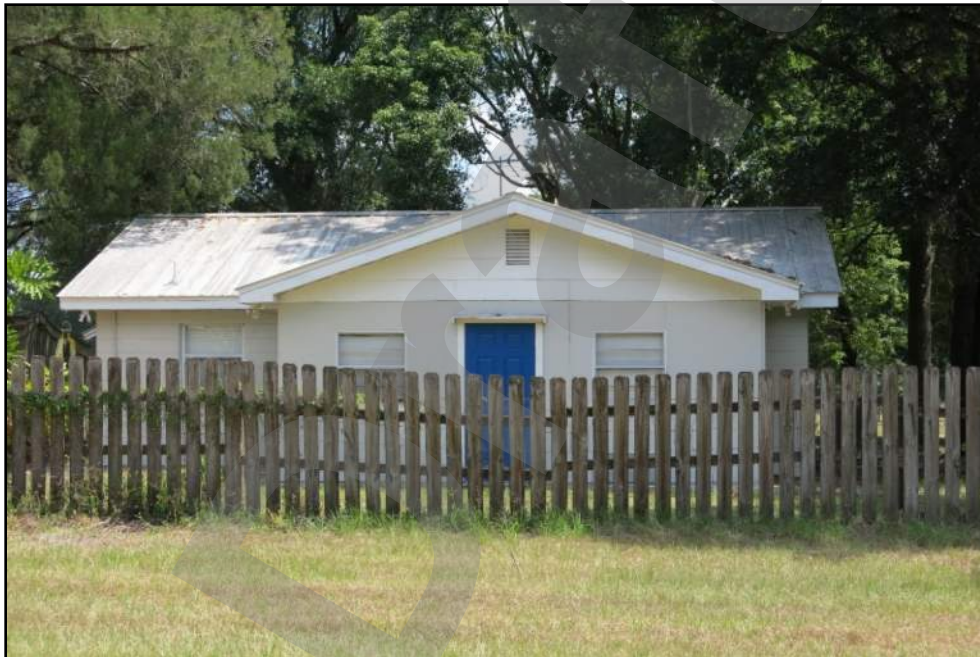
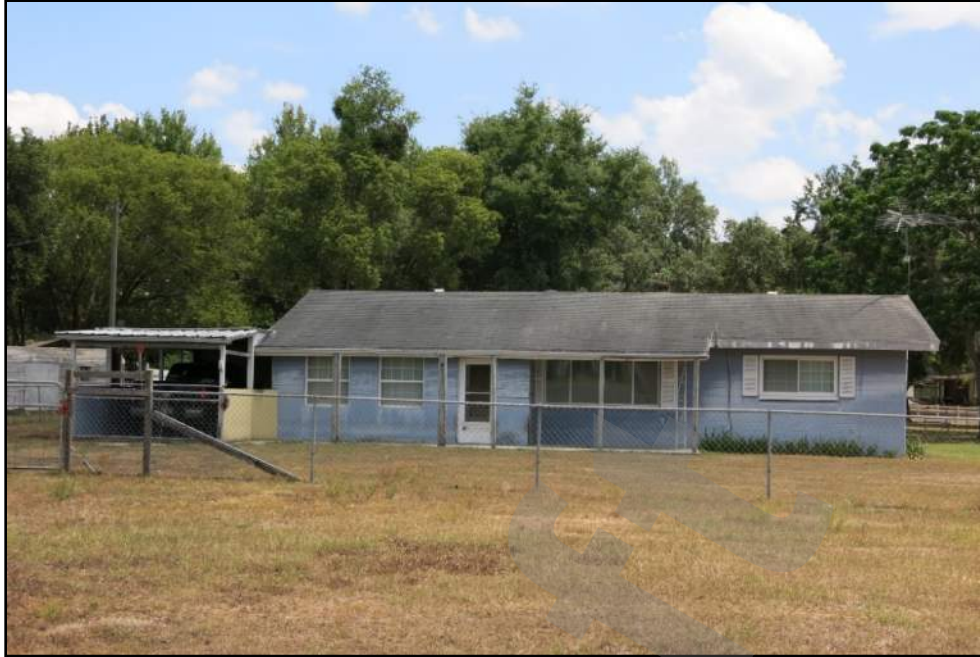
Photo 5-16 Masonry Vernacular style building (8PA03350) located at 9242 US Highway 98, looking northeast.

Photo 5-17 Masonry Vernacular style building (8PA03362) located at 10150 US Highway 98, looking northeast.

Masonry Vernacular: A total of 13 historic resources (8PA03350, 8PA03353, 8PA03355, 8PA03357, 8PA03362, 8PA03365, 8PA03366, 8PA03367, 8PA03374, 8PA03375, 8PA03376, 8PA03379, 8PA03381) within the APE are of the Masonry Vernacular style (**Photos 5-16 & 5-17**). The majority of these resources are single-family residences; however, one resource serves a commercial purpose (8PA03367). These resources have construction dates that range from ca. 1950 to ca. 1975. Masonry Vernacular style buildings reflect the local customs, environment, and building materials, and do not rely on academic architectural vocabulary for their design and ornament. Within the APE, the commercial building has fixed pane windows with wood frames, a shed roof covered with ribbed sheet metal, and exterior ornamentation is minimal. The buildings used as single-family residences generally have a concrete slab or continuous concrete block foundations and concrete block walls and the windows typically are awning or single-hung sash. Roof types commonly consist of gable, most of which are clad with composition shingles. The exterior cladding often consists of painted concrete block, stucco, and artificial masonry or brick veneer. Most display replacement windows and roofs, fenestration changes, and additions.

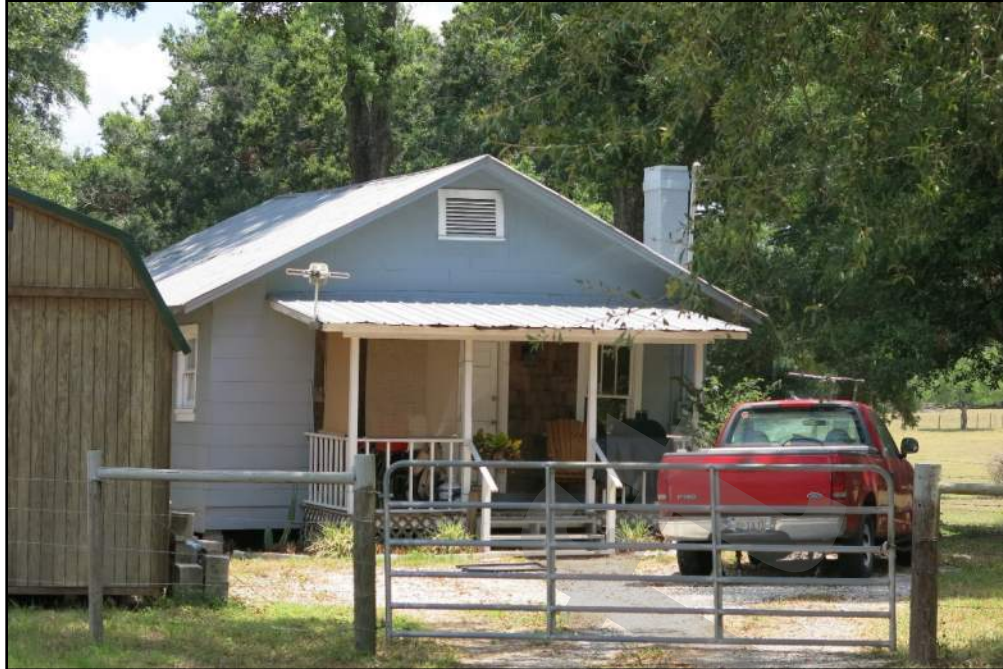
Photo 5-18 Frame Vernacular style building (8PA02224) located at 1061 Beckum Road, looking northeast.

Frame Vernacular: A total of five (5) historic resources (8PA02224, 8PA03351, 8PA03361, 8PA03364, 8PA03377) within the APE are of the Frame Vernacular style (**Photo 5-18**) and have construction dates that range from ca. 1925 to ca. 1973. All of the resources represented in this style are single-family residences. Frame Vernacular style buildings are simple structures built with available local materials and boasting little ornamentation (McAlester 2013). They are often built by developers, contractors, master carpenters, or the building's occupants. These buildings are decidedly practical structures. Within the APE, this building type has pier, continuous, or slab foundations. Gable roofs are most common, and the majority of the roofs are clad with composition shingles or sheet metal. The majority of these buildings are clad in wood siding, vinyl, or asbestos. Fenestration typically includes single-hung sash windows, but awning and fixed windows are also present. Exterior ornamentation is minimal, and typically consists of wood window and door surrounds, corner boards, gable vents, and exposed rafter tails. The majority display alterations or additions, such as replacement siding and windows and living-space additions.

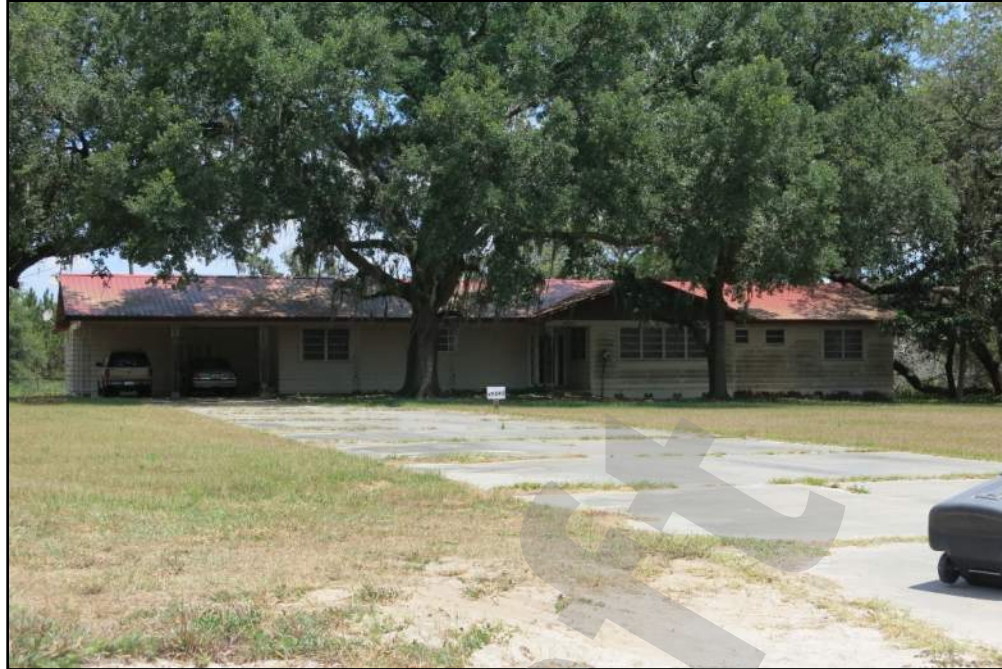
Photo 5-19 Ranch style building (8PA03368) located at 39345 Townsend Road, looking north.

Ranch: Two (2) historic resources (8PA03363 and 8PA03368) within the project APE are of the Ranch style (**Photo 5-19**). These are residential buildings that have construction dates in ca. 1965 and ca. 1967. The style, which gained popularity after World War II, features low-slung buildings and a low-pitched roof with large windows (McAlester 2013). Within the APE, this building type has continuous concrete block foundations. Gable roofs are clad with composition shingles and ribbed sheet metal. The buildings are clad in asbestos, as well as stucco and brick veneer. Fenestrations include awning and single-hung sash windows. Exterior ornamentation is minimal, and typically consists of gable vents and wide roof overhangs. The resources display alterations or additions, such as replacement roofs and windows and living-space additions.

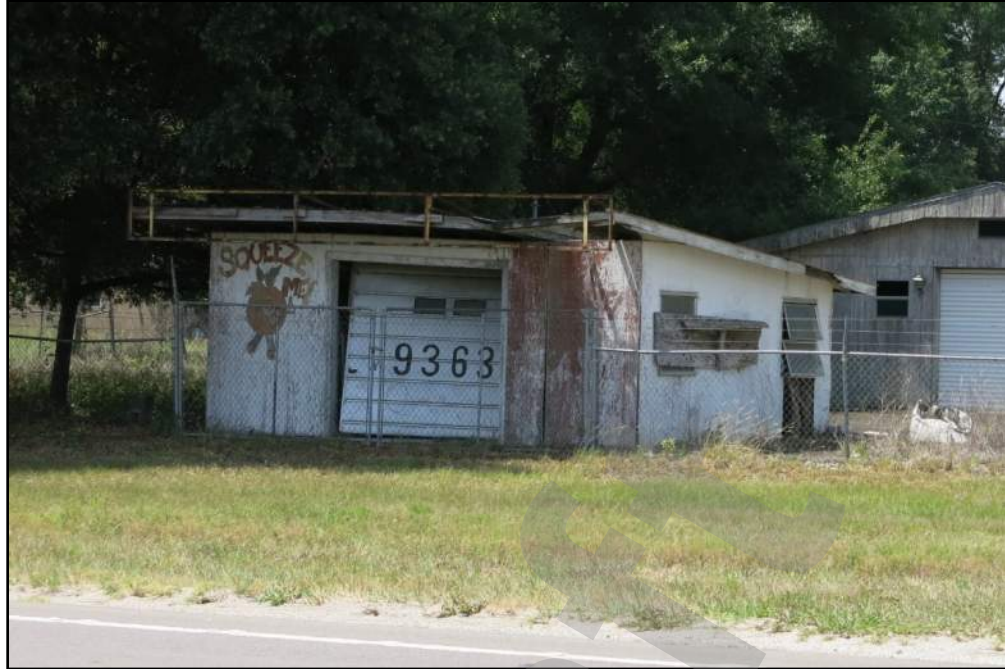
Photo 5-20 Building with no style (8PA03354) located at 9363 US Highway 98, looking south.

No Style: Twelve (12) historic resources within the project APE are buildings with no style (8PA03352, 8PA03354, 8PA03358, 8PA03359, 8PA03360, 8PA03369 – 8PA03373, 8PA03378, 8PA03380). These buildings have construction dates that range from ca. 1957 to ca. 1975 (**Photos 5-20 and 5-21**). Of

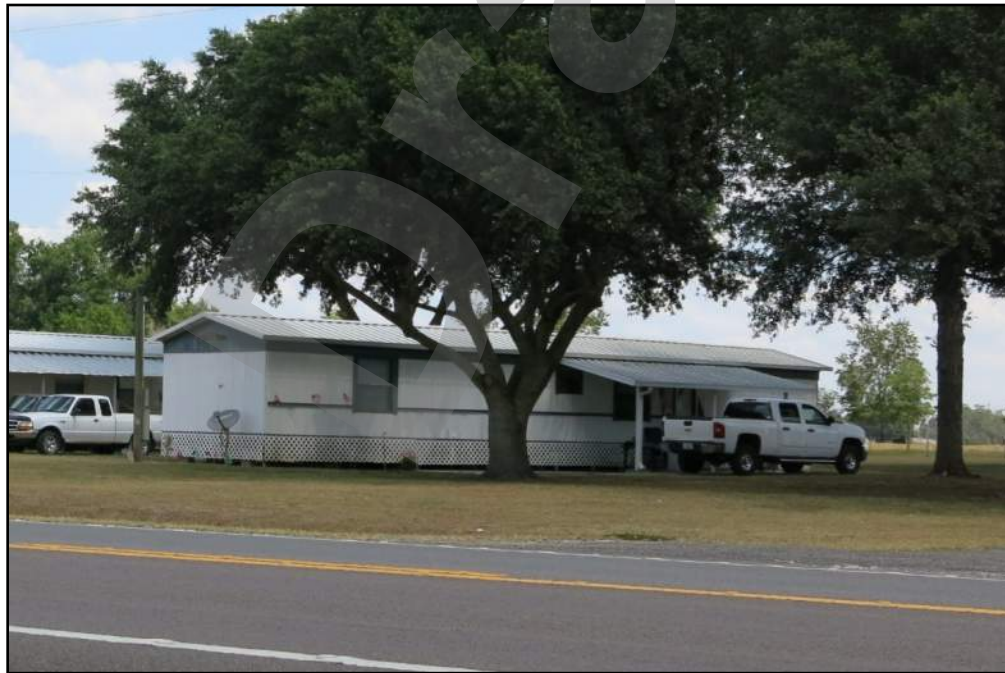
Photo 5-21 Mobile home with no style (8PA03358) located at 9960 US Highway 98, looking north.

Within the APE, the mobile home varies between single-wide and double-wide, and all display alterations or additions. This building type usually rests on a pier foundation that is covered by metal skirt panels. Metal awning or single-hung sash windows with clamshell hurricane awnings are most common, and exterior ornamentation is minimal. These manufactured buildings have no style and are simply built in a factory with a steel chassis to allow for the ability to be moved. The outbuildings are commonly constructed wood or metal frame buildings, clad in plywood or sheet metal, with shed or gable roofs.

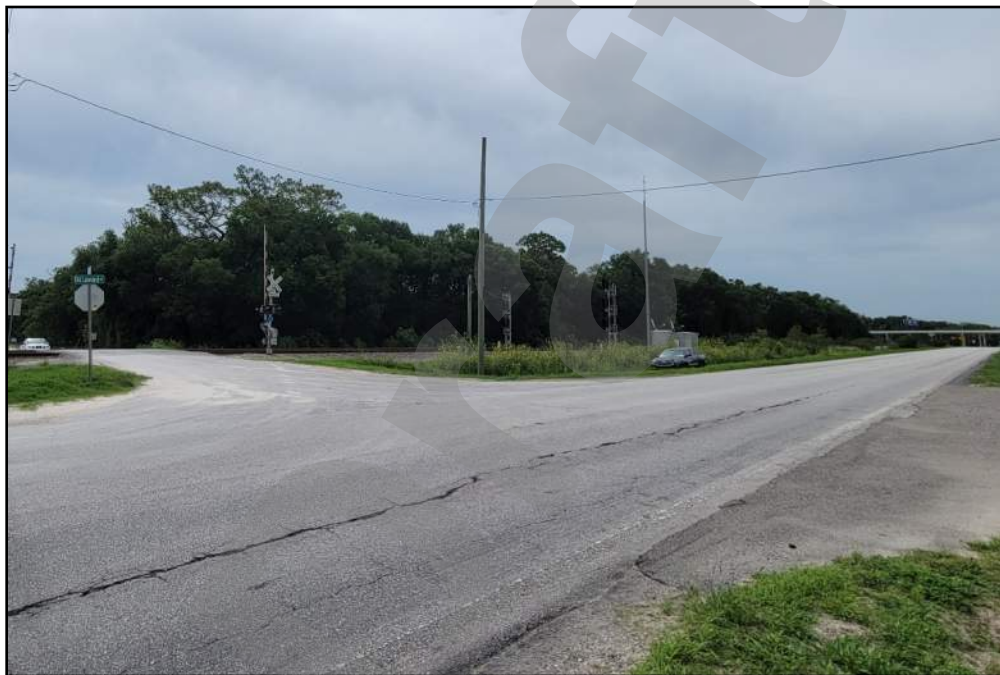
Photo 5-22 Old Lakeland Highway (8PA03343), looking southeast from the northwest corner of Old Lakeland Highway and Messick Road looking southeast

The overwhelming majority of the Old Lakeland Highway is located outside the project APE. Surveying and recording the entire highway are beyond the scope of this report, as such only the segment within the project APE was surveyed and recorded. The surveyed segment is a common two-lane roadway found throughout Pasco County, without historic paving or markers. It lacks specific design features or characteristics that would differentiate it from other similar roads and several similar roads were constructed through the region during the early twentieth century. Its setting within the APE has been greatly altered with the construction of US 98 and the associated overpass and the introduction of modern traffic signage along the road.

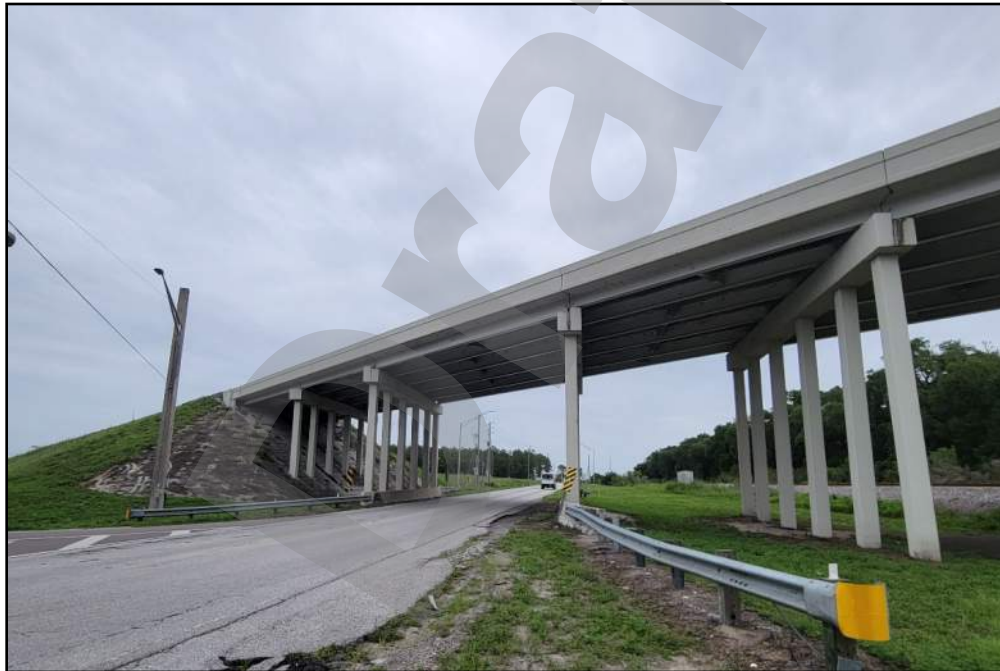
Photo 5-23 Typical example of a stringer (multi-beam) bridge within the APE. US 98 over CSX Railroad/CR-35A (Bridge No. 140025) (8PA03356), looking north from Old Lakeland Hwy/CR 35 Alt.

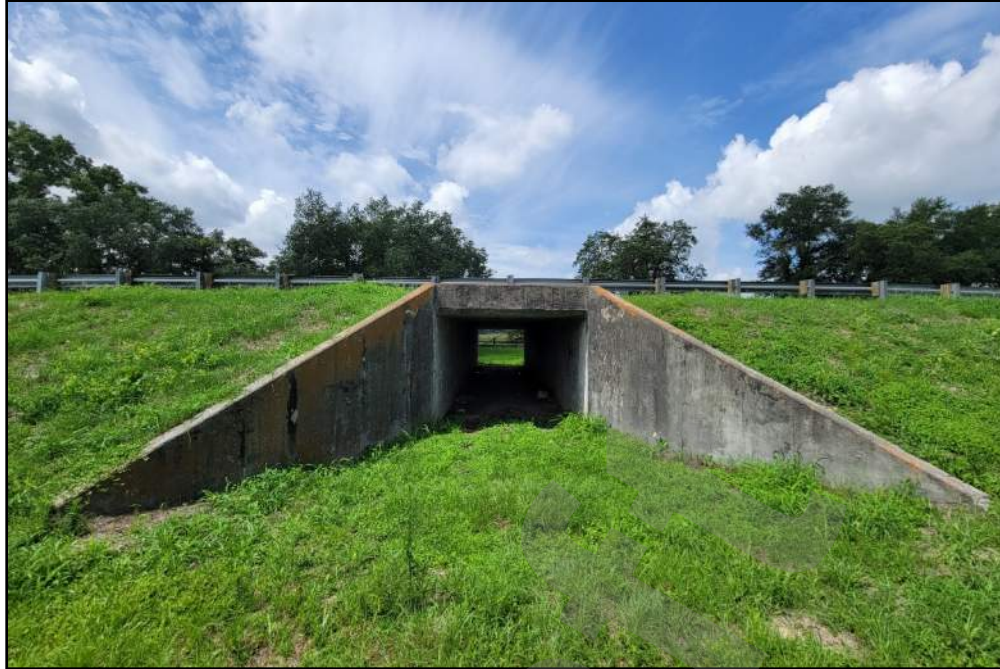
Photo 5-24 Typical example of a cattle pass box culvert within the APE. US 98 Cattle Pass #2 (8PA03349), looking southeast.

Bridges & Culverts: Two bridges, Bridge No. 140024 (8PA03348) and Bridge No. 140025 (8PA03356), and two box culverts (8PA03347 and 8PA03349) are located within the APE (**Photos 5-23 and 5-24**). The bridges include the US 98 over Hillsborough River, Bridge No. 140024 (8PA03348) and the US 98 over CSX Railroad/CR-35A, Bridge No. 140025 (8PA03356). Both are Stringer (Multi-Beam) bridges that were built in 1951 during the construction of US 98. The bridges range from 200-ft to 363-ft in length and are 43-ft in width with paneled concrete walls along the span of the bridges and metal guardrails on timber posts along the bridge approaches. Both bridges are inscribed with the date “1951” on the concrete parapet walls and the superstructures are supported by concrete pile bents and sloped, solid concrete abutments. The bridges were reconstructed in 1995 and do not possess any notable engineering features or design elements that would differentiate it from dozens of similar examples built throughout Florida during the same time period.

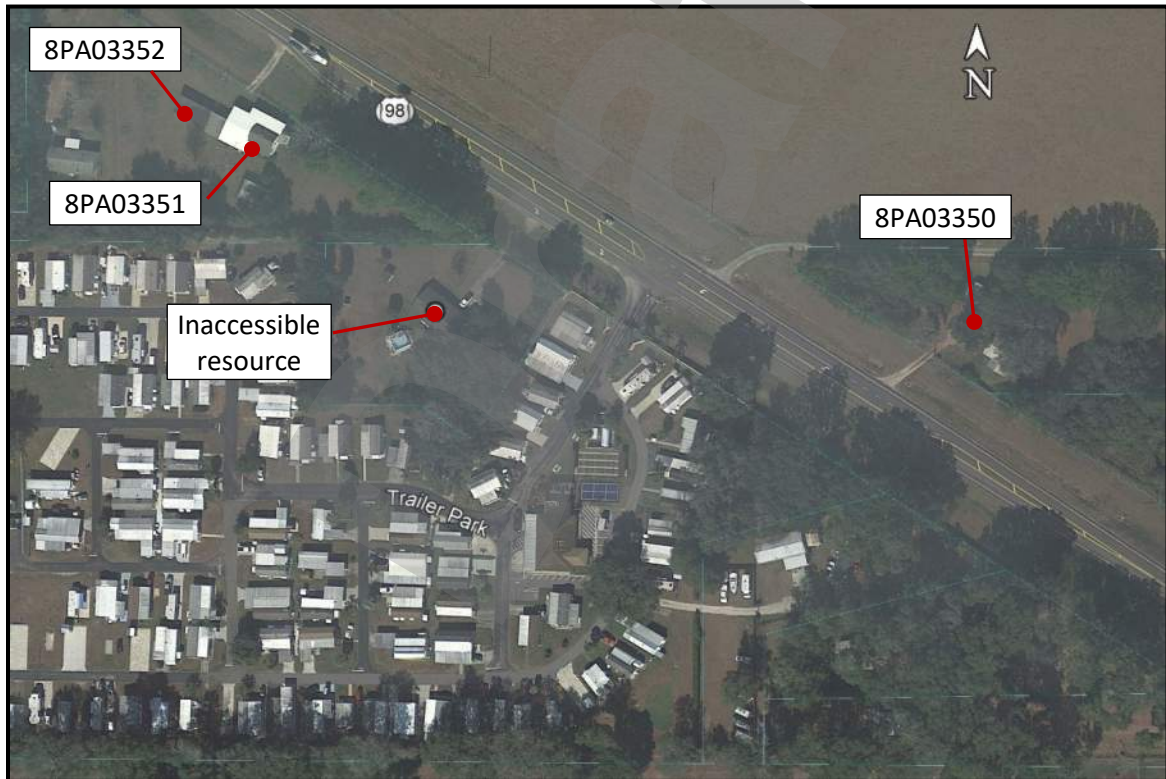
Figure 5-17 Location of inaccessible historic resource.

In addition to the 40 historic resources identified within the APE, the Pasco County property appraiser identified one historic resource constructed in ca. 1961 that could not be evaluated or recorded during the field survey due to lack of accessibility and/or obstructed views from the US 98 ROW (**Figure 5-17**). The resource is located at 9287 US Highway 98. Based on available information from the Pasco County property appraiser's website and observations of the surrounding area, the resource can be described as typical example of a vernacular style building. Google Earth and the Pasco County property appraiser site cannot act as reliable sources in providing visual aid to what a property currently looks like. The property was not recorded or evaluated due to obstructed views from the ROW and the location down a private drive; therefore, the status and condition of this resource is unknown (**Photo 5-25**). Per the Concept Plans dated October 2021, there is no proposed ROW acquisition from this parcel. Since the building is hidden by existing vegetation on the parcel and there is no proposed ROW acquisition, the proposed project should have no effect on the building.

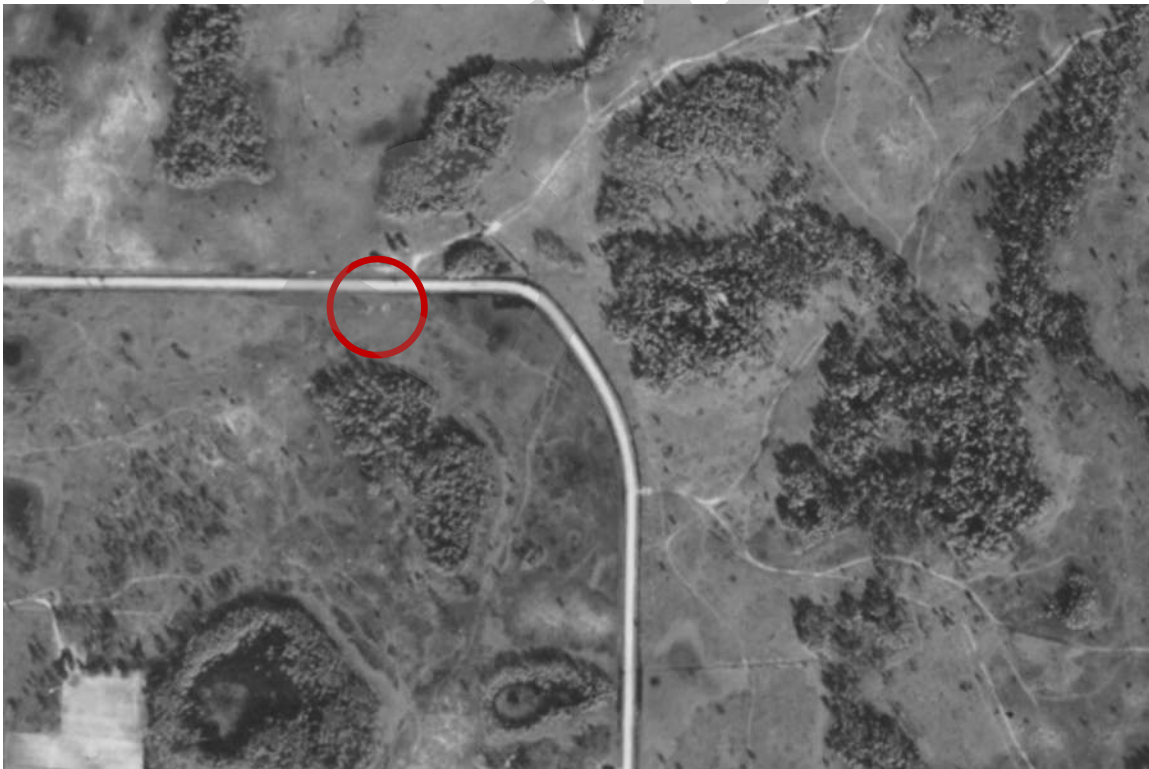
Photo 1. 1941 aerial photograph depicting CR 54 and the Polk-Pasco County Line Obelisk prior to the construction of US 98 (USDA 1941).

The markers were ready for the October 23rd visit by the delegation, which consisted of 87 engineers from 35 different countries. The group “drove into Polk County at Loughman and toured Haines City, Waverly, Bok Tower, Lake Wales and Winter Haven before driving to Lakeland,” from which they headed west toward Plant City. Following the tour, the markers were left in place to welcome tourists, and no additional ones were constructed (Bair 1999). The Polk-Pasco County Line Obelisk was originally located on the south side of CR 54 (**Photo 1**); however, the location was slightly altered to accommodate the construction of US 98 during the 1950s (USDA 1941). The obelisk appears to have been shifted slightly north of the original location to be located northeast of US 98 (USDA 1957) (**Photo 2**). The eastern segment of CR 54 was abandoned and gradually became overgrown.

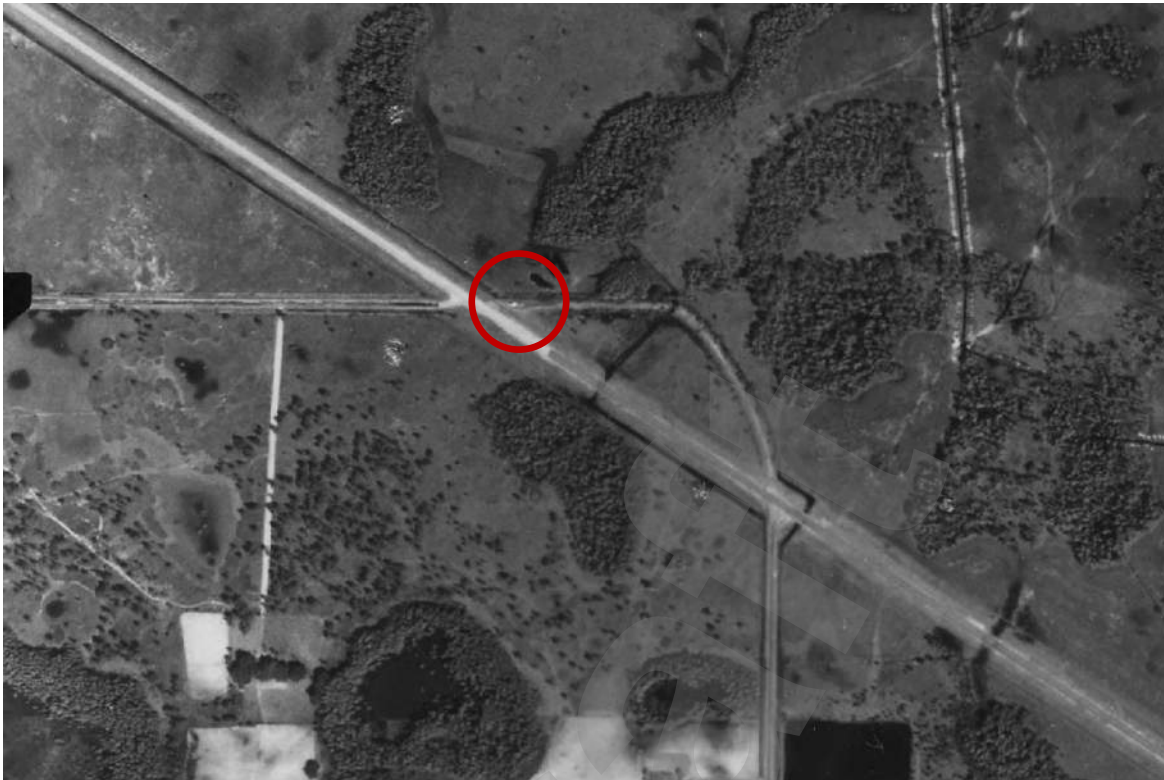
Photo 2. 1957 aerial photograph depicting CR 54 and the Polk-Pasco County Line Obelisk during the construction of US 98 (USDA 1957).

Explanation of Evaluation: Despite the fact that the location of the US 98 obelisk was slightly altered, the marker has stood at the same route where it was originally erected, thus it continues to maintain some integrity of location. The alteration was a necessary adjustment to allow for continued road improvements through the region – improvements similar to those that lend the resource its significance. Similar to the aforementioned NRHP-eligible obelisk located along US 92 at the Hillsborough County line (8HI05328), the marker maintains its integrity of design, setting, materials, workmanship, feeling, and association. Overall, the Polk-Pasco County Line Obelisk appears eligible for listing in the NRHP at the local level under Criterion A in the areas of Transportation and Local History as a reminder of Polk County's contributions to the state roadway system.

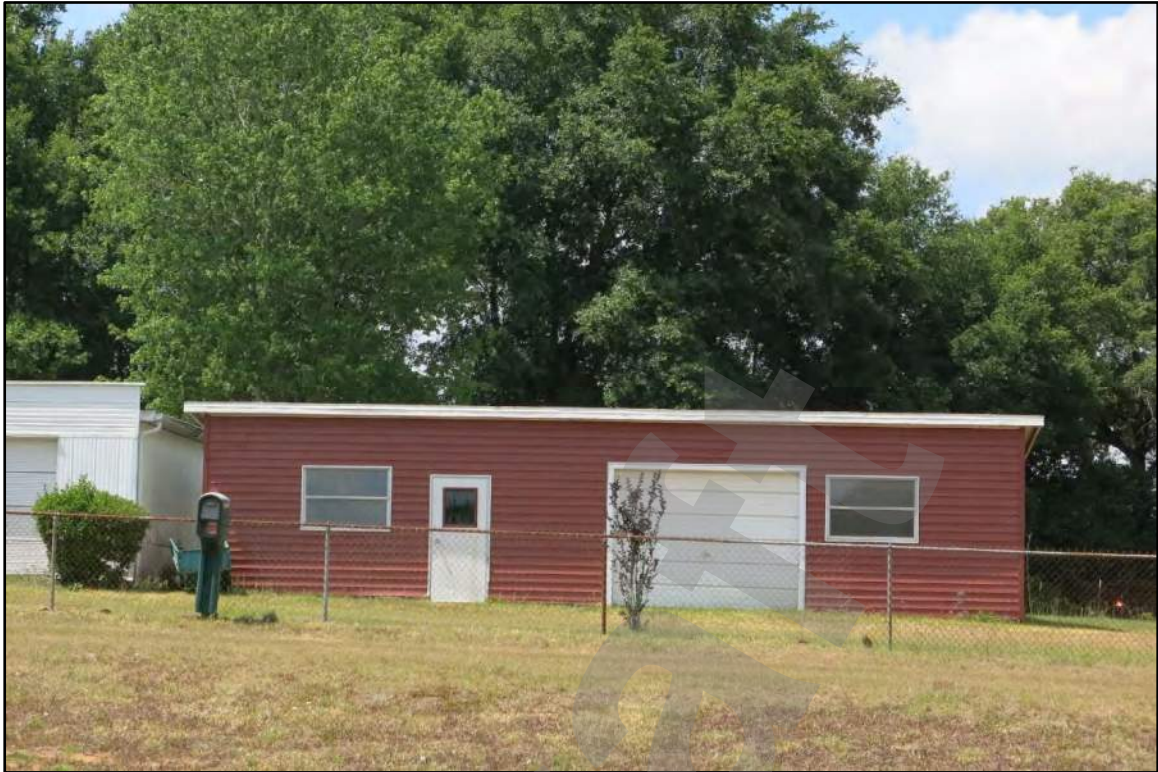
PHOTOGRAPHS

Condition (overall resource condition): excellent good fair deteriorated ruinous

Narrative Description of Resource
 A one-story Masonry Vernacular style building w/ several material alterations, including replacement roofing, siding, and windows.

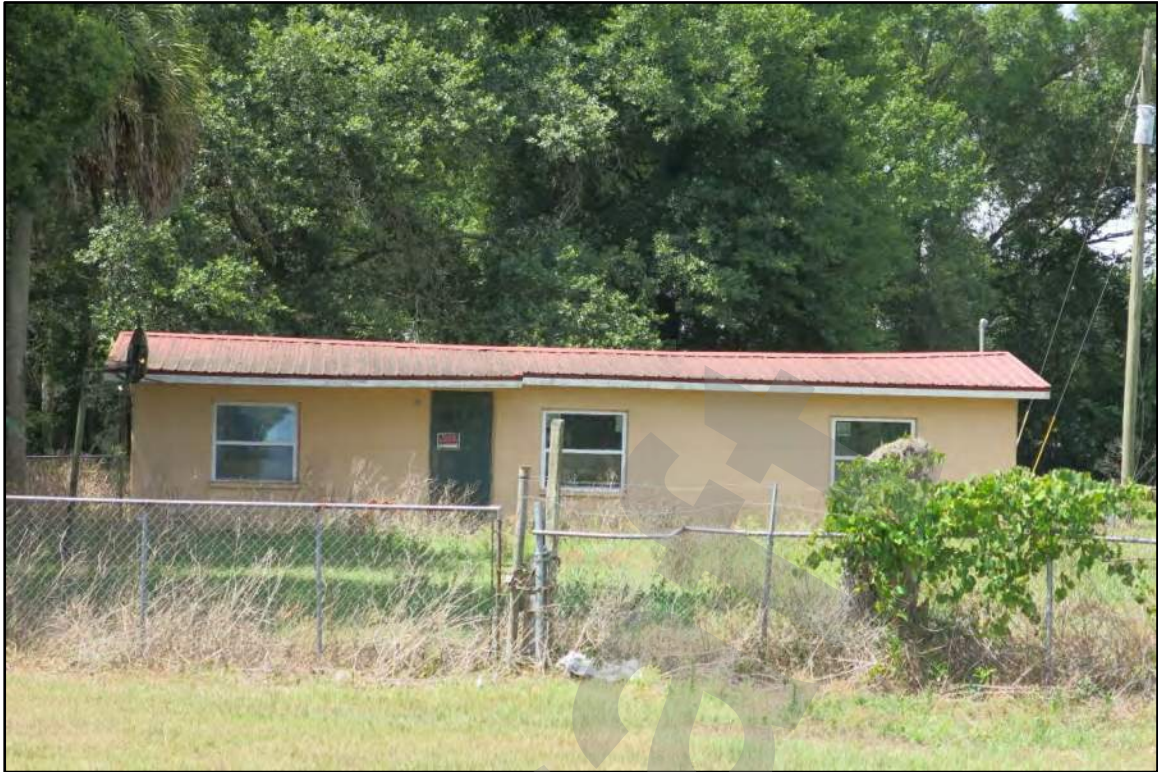
PHOTOGRAPHS

Condition (overall resource condition): [] excellent [] good [] fair [x] deteriorated [] ruinous

A one-story garage w/ no style with an individual tilt up canopy garage door. The building is significantly deteriorated w/ removed siding, a collapsing roof, removed signage, and damaged garage door.

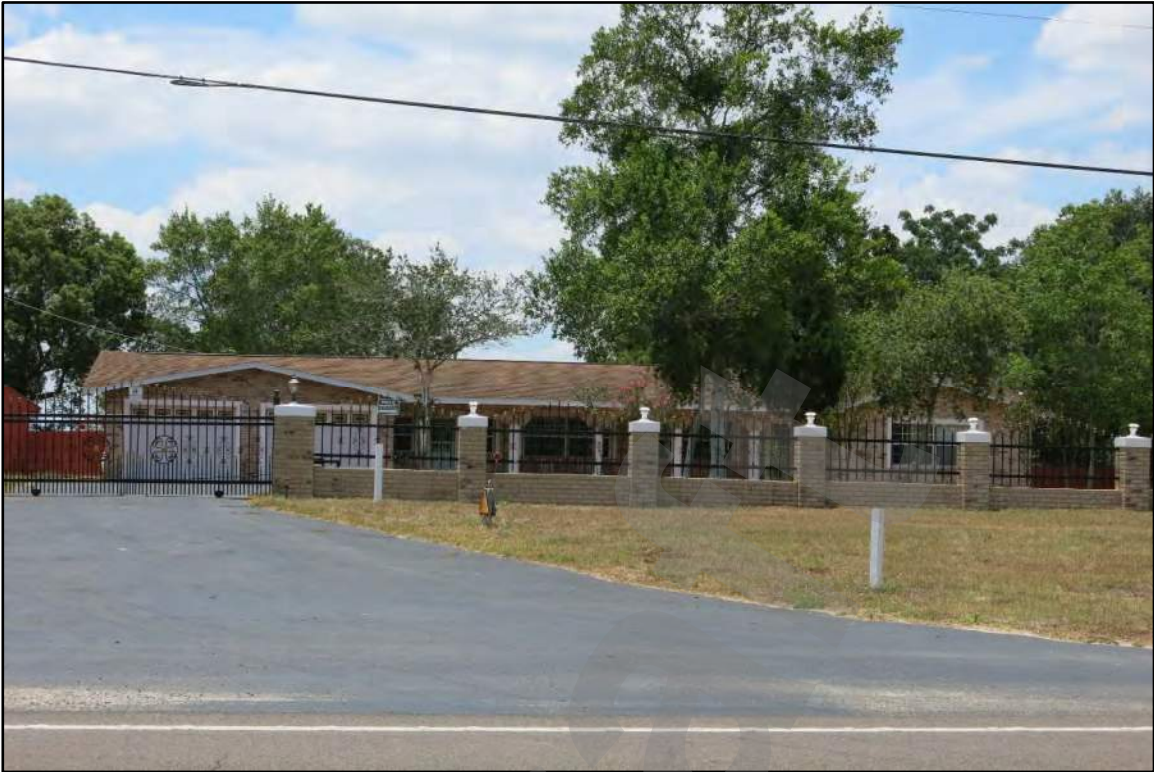
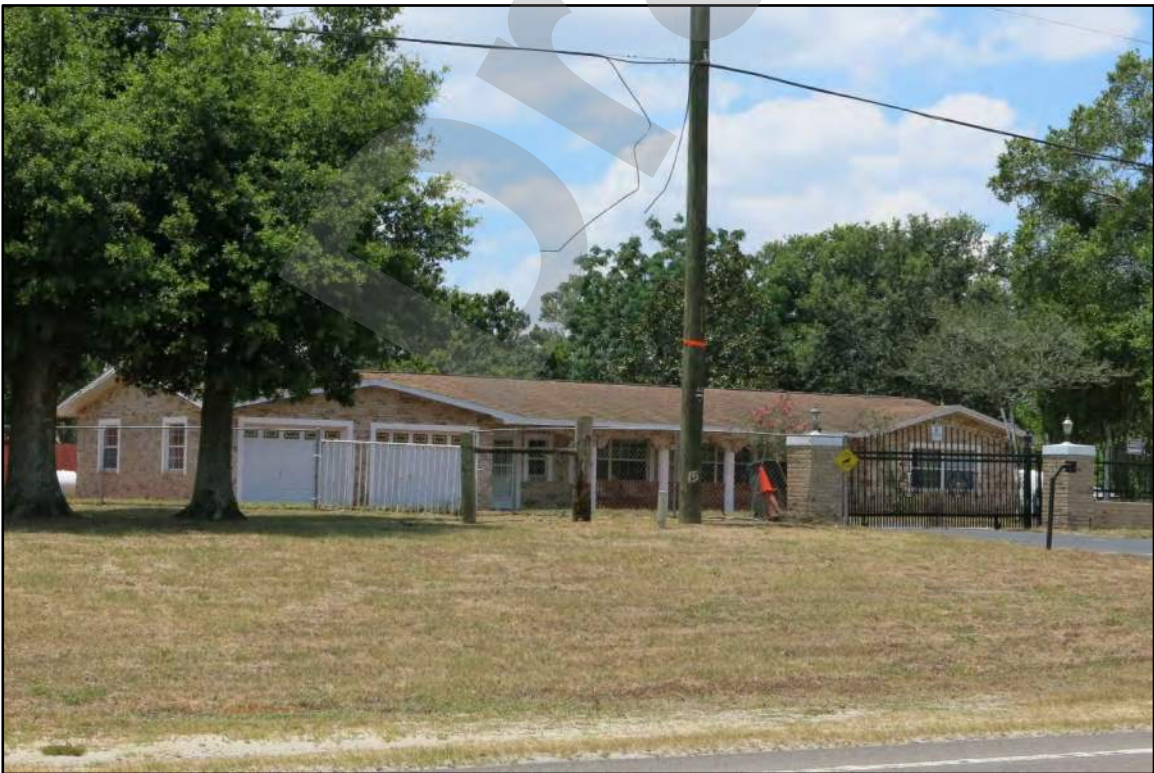
PHOTOGRAPHS

A one-story Ranch style building w/ a gable roof extension addition and an addition w/ two two-car garages on the E ELEV. The sectional garage doors have inset stained glass lights.

Condition (overall resource condition): [] excellent [x] good [] fair [] deteriorated [] ruinous

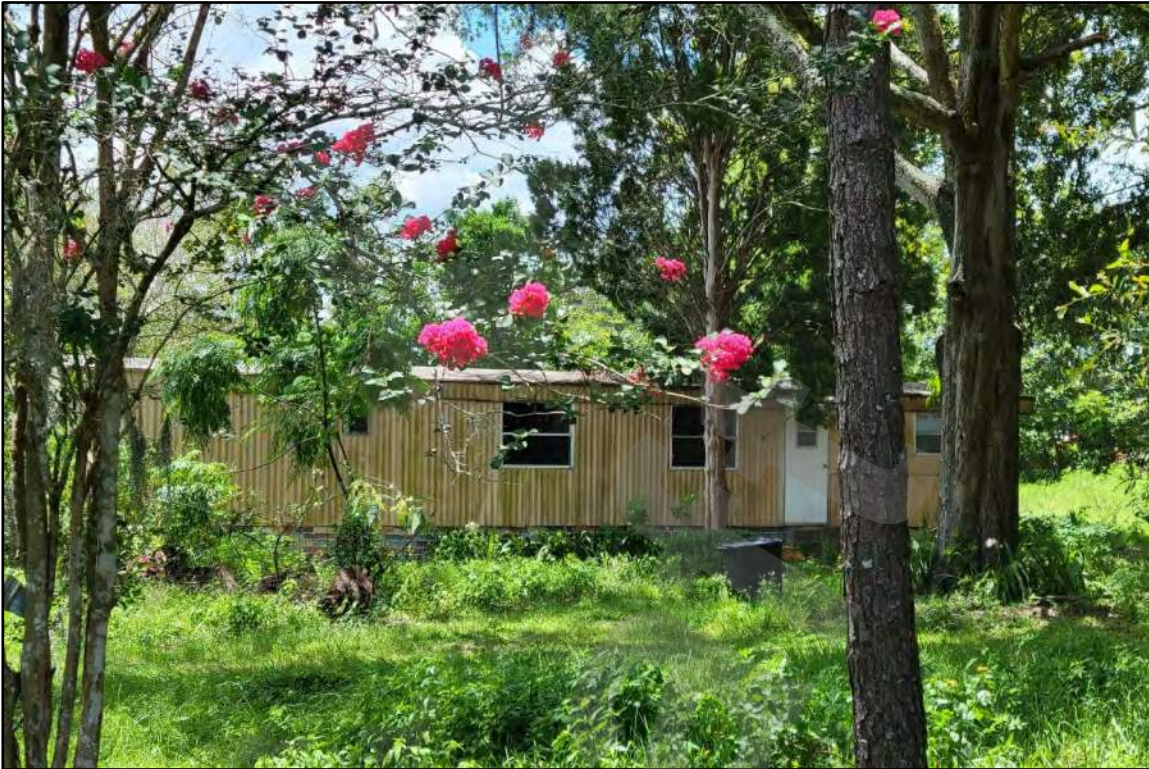
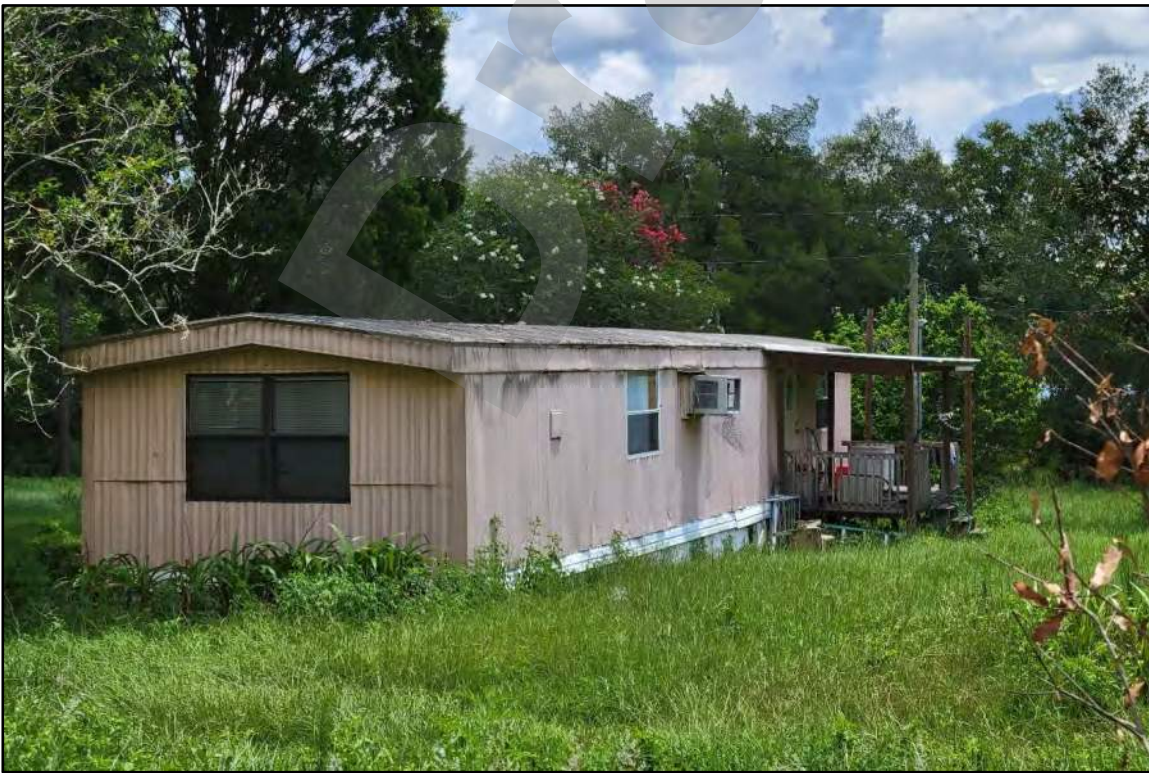
PHOTOGRAPHS

Chimney: No. 0 Chimney Material(s): 1. 2.
Structural System(s): 1. Wood frame 2. 3.
Foundation Type(s): 1. Piers 2.
Foundation Material(s): 1. Obscured 2.

Condition (overall resource condition): [] excellent [x] good [] fair [] deteriorated [] ruinous

Narrative Description of Resource
A one-story mobile home with no style that has a wall-mounted A/C unit on the S ELEV. The pier foundation is obscured by metal skirting.
