***Cultural Resource Assessment Survey
Technical Memorandum***

**STORMWATER MANAGEMENT FACILITY (SMF) SITES AND
FLOODPLAIN COMPENSATION SITES**

**US 98 / SR 35 / SR 700
From CR 54 to US 301/SR 39**

**Florida Department of Transportation
District 7**

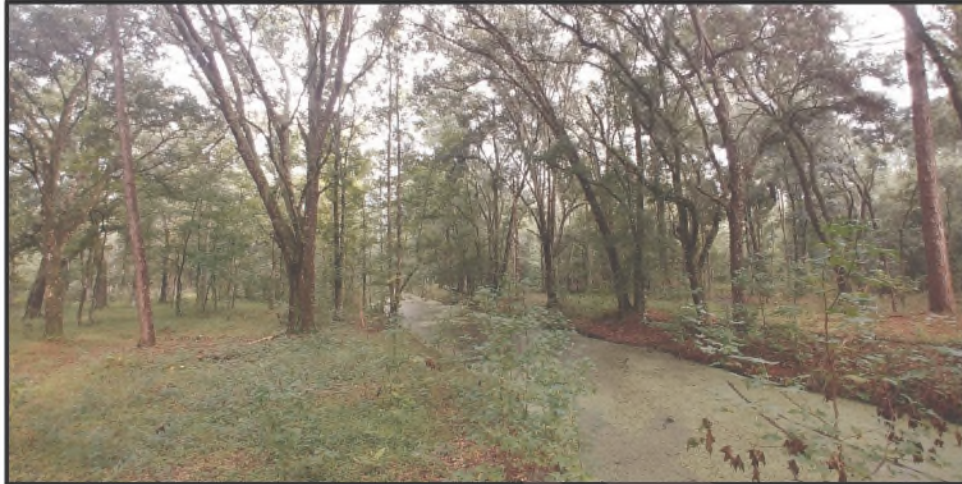
Photo 3. Northeast view of drainage ditch adjacent to pond sites.

The APE is located in Sections 11, 12, and 13 Township 25 South, Range 21 East; and Sections 19, 20, 29, 34, and 35, Township 25 South, Range 22 East; Pasco County, Florida (**Figures 4 and 5 in Section 4**). Several lakes, swamps, and seasonal wetlands are within and adjacent to the pond sites. The project area is characterized as hardwood forests and pine flatwoods, mixed with swamps (Davis 1967). Currently, the APE is primarily a rural setting with mixed agricultural and residential development. Disturbances noted within the APE include ditching, clearing for pasture, and borrow pits (**Photos 1-5**).

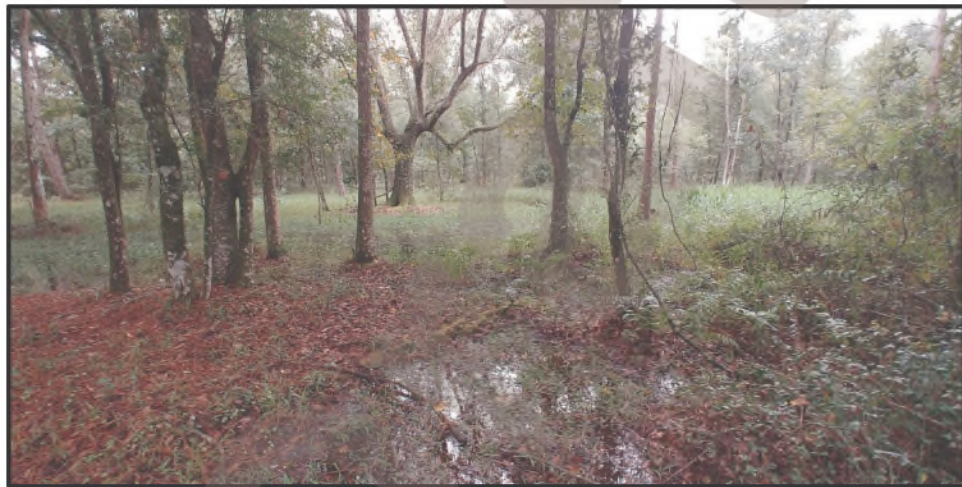
Photo 4. Sample of standing water encountered in several pond sites.

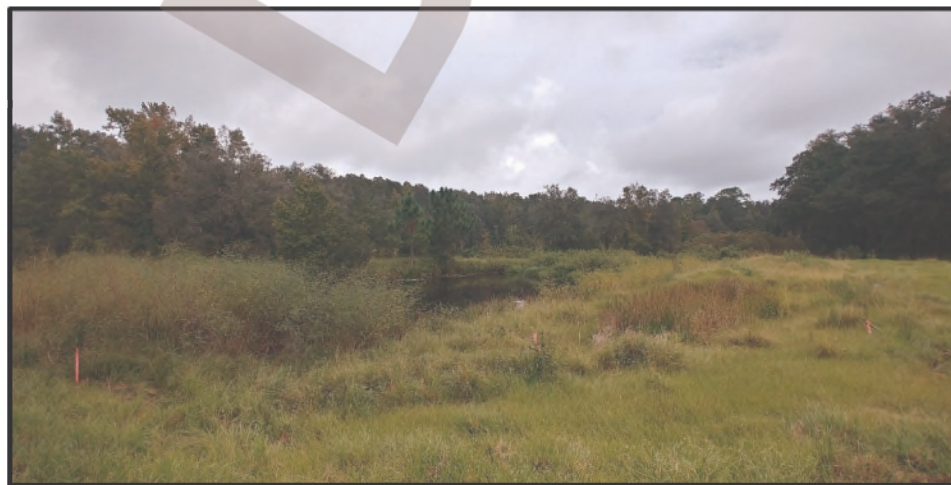
Photo 5. Looking north at a borrow pit impacting SMF 200-1.

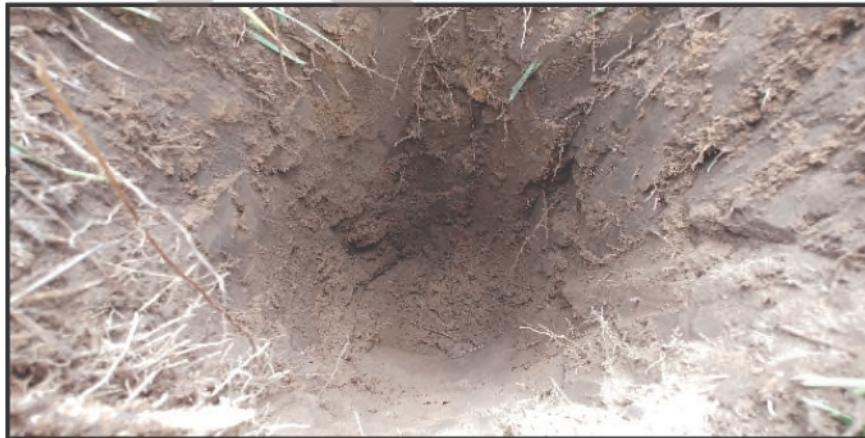
Photo 6. Sample stratigraphy within SMF 600-2.

Shovel tests stratigraphy was variable throughout the APE. Below is a representation of the types of soil stratigraphy encountered with sample photographs (**Photos 6 - 9**).

- 0 to 30 cm below surface (cmbs) of dark gray/brown sand followed by 30 to 100 cmbs of brown sand
- 0-30 cmbs of dark, brown sand followed by 30-100 cmbs of orange/brown sand with concretions
- 0-40 cmbs of gray/brown sand; 40-80 cmbs of light gray sand; and 80-100 cmbs of wet, brown sand

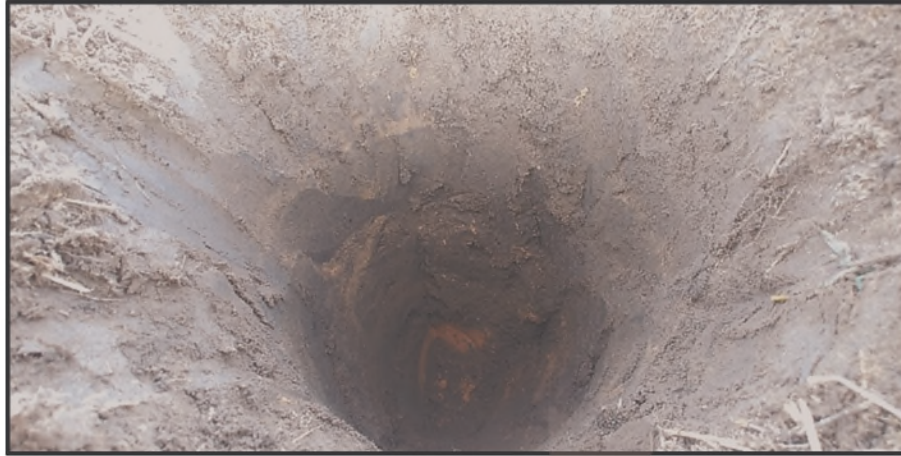
Photo 7. Stratigraphy showing disturbance to 90 cm.

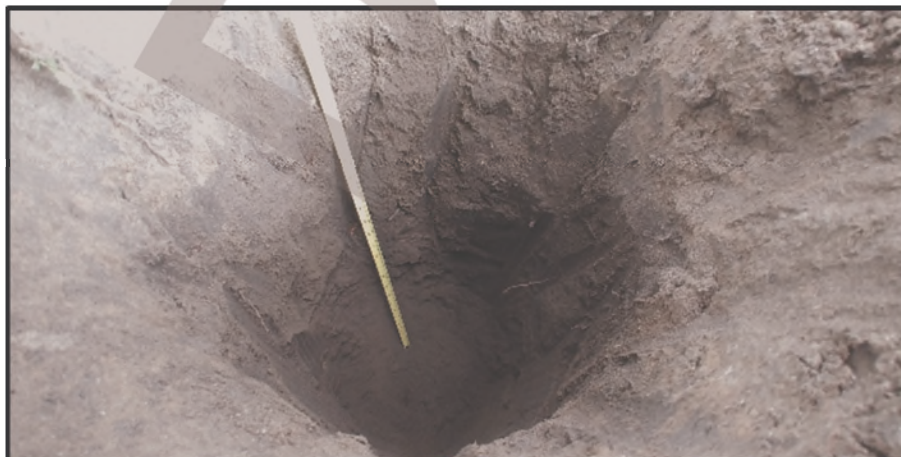
Photo 9. Stratigraphy with very little disturbance.

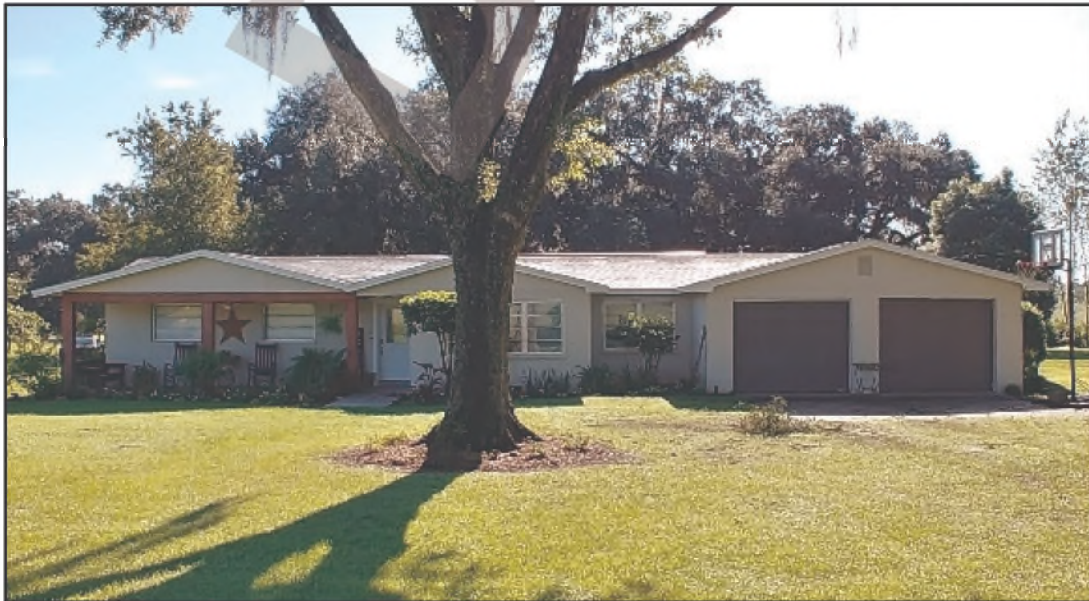
Photo 12. 9276 US Highway 98 (8PA03432), looking east.

8PA03432: The Ranch Style residence at 9276 US Highway 98 was constructed in ca. 1968 (**Photo 12**). The one-story, irregular plan building rests on a concrete slab foundation and has a concrete block structural system clad in stucco. The side gable roof with three intersecting front gables is sheathed in composite shingles. The main entrance is on the west elevation through a single door with fixed single-pane window, beneath a front gable roof. The partial-width porch is also located on the west elevation beneath a second front gable roof with square post porch supports. Visible windows include a mixture of individual metal frame three-stacked awning units, and paired and grouped (3) metal frame two-over-two and one-over-one single-hung sash units. Distinguishing architectural features include a low-pitched side gable roof, stucco windowsills, awning windows, and gable vents. Alterations include replaced siding, roofing, and main entrance door. Additions include a porch on the northwest elevation and garage on the southwest elevation. The structure is accessed via an unpaved driveway; and a short concrete sidewalk gives access to the main entrance. Overall, the building has been altered, lacks sufficient architectural features, and is not a significant embodiment of a type, period, or method of construction. In addition, background research did not reveal any historic associations with significant persons and/or events. As a result, 8PA03432 does not appear eligible for listing in the NRHP, either individually or as part of a historic district.
