***FINAL TECHNICAL MEMORANDUM  
CULTURAL RESOURCE ASSESSMENT SURVEY***

**Ponds Addendum in Support of the  
SR 56 Southbound C-D Road/Ramps to I-75/I-275  
Project Development & Environment (PD&E) Study**

**Florida Department of Transportation  
District 7**

Work Program Item Segment No. 430573-4

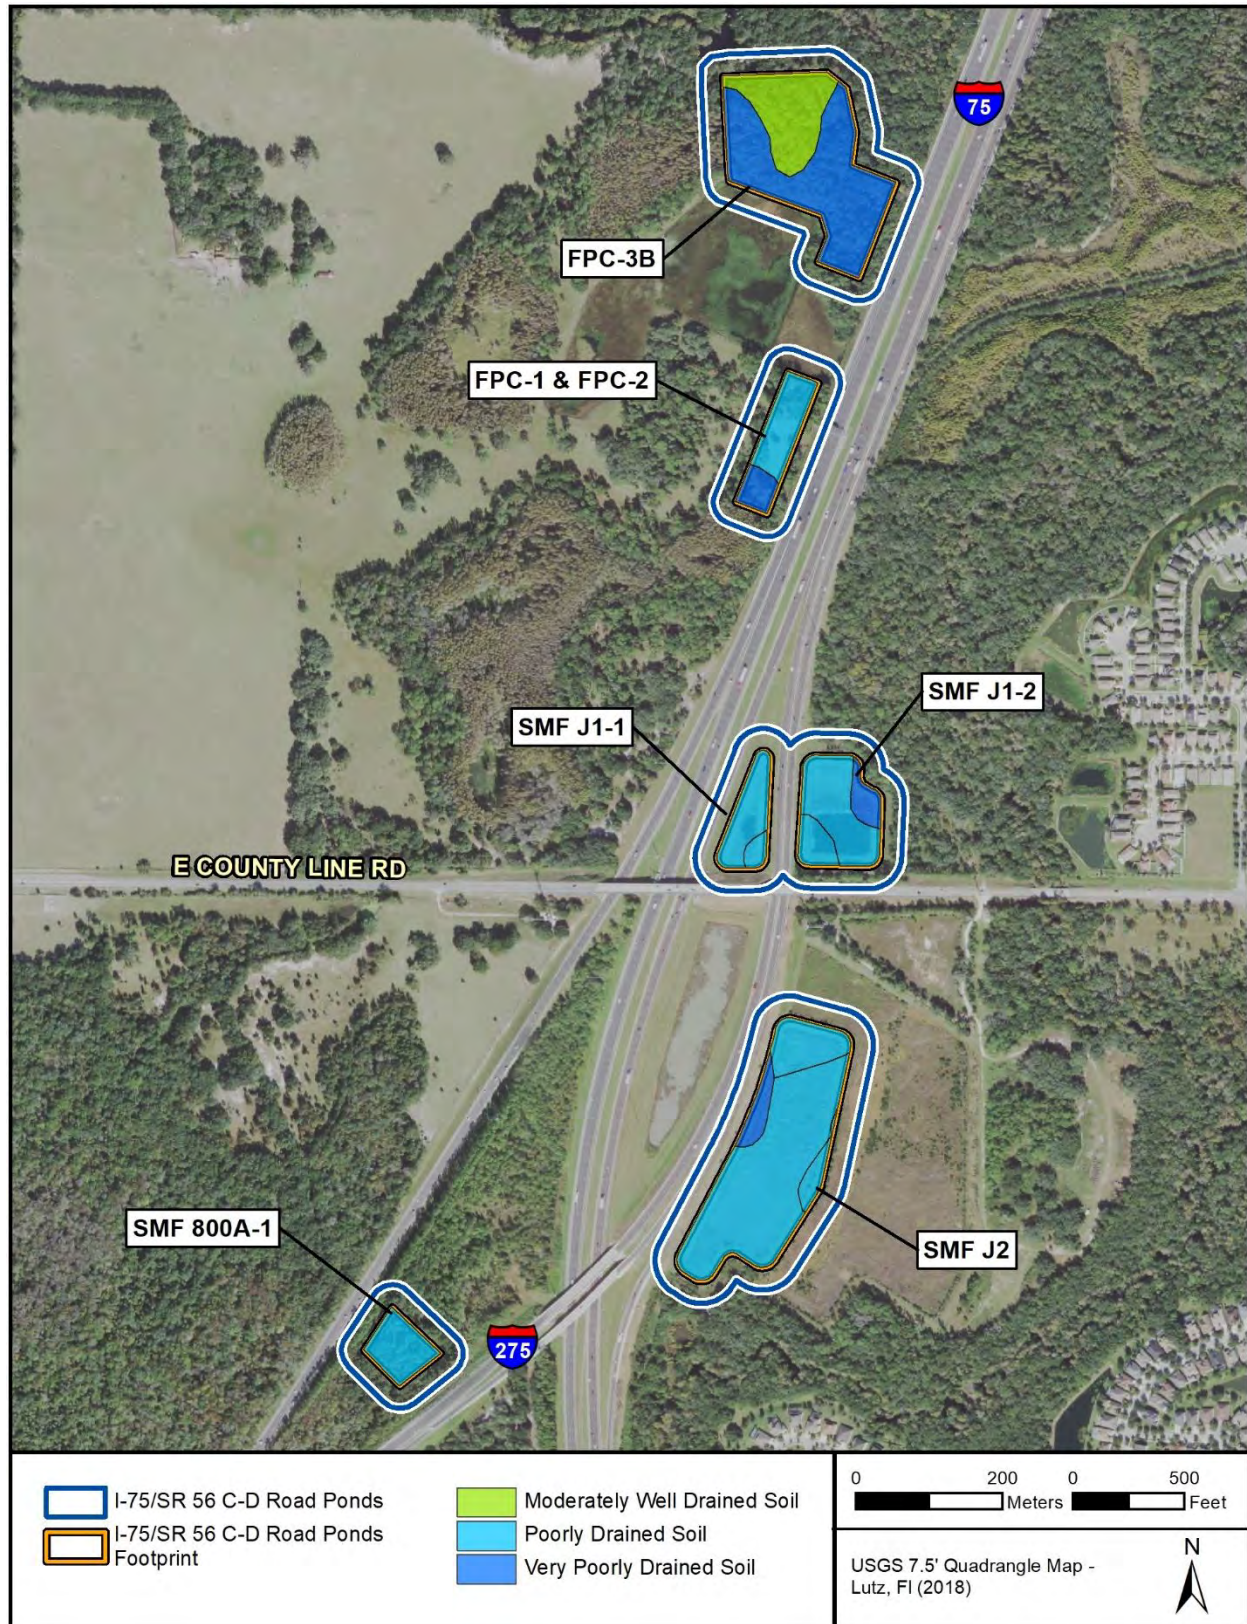
**Figure 3. Soil drainage characteristics within the I-75/SR 56 C-D Road Ponds APE.**

proposed ponds are located on either side of the I-75 corridor from south of the I-275 Apex to north of County Line Road. The project area is primarily undeveloped, with the exception of SMF J1-1, SMF J1-2, and SMF J2, which contain existing stormwater ponds. The project area is located in Section 3 of Township 27 South, Range 19 East and Section 34 of Township 26 South, Range 19 East. According to Brooks (1981), the APE falls within the Hillsborough Valley physiographic province, which is a part of the larger Ocala Uplift District. Elevations within the APE are approximately 42 to 119 feet (12.8 to 36.3 meters) above mean sea level (amsl). Soils in the project area range from moderately well drained Tavares sands to very poorly drained Anclote fine sands (**Figure 3**).

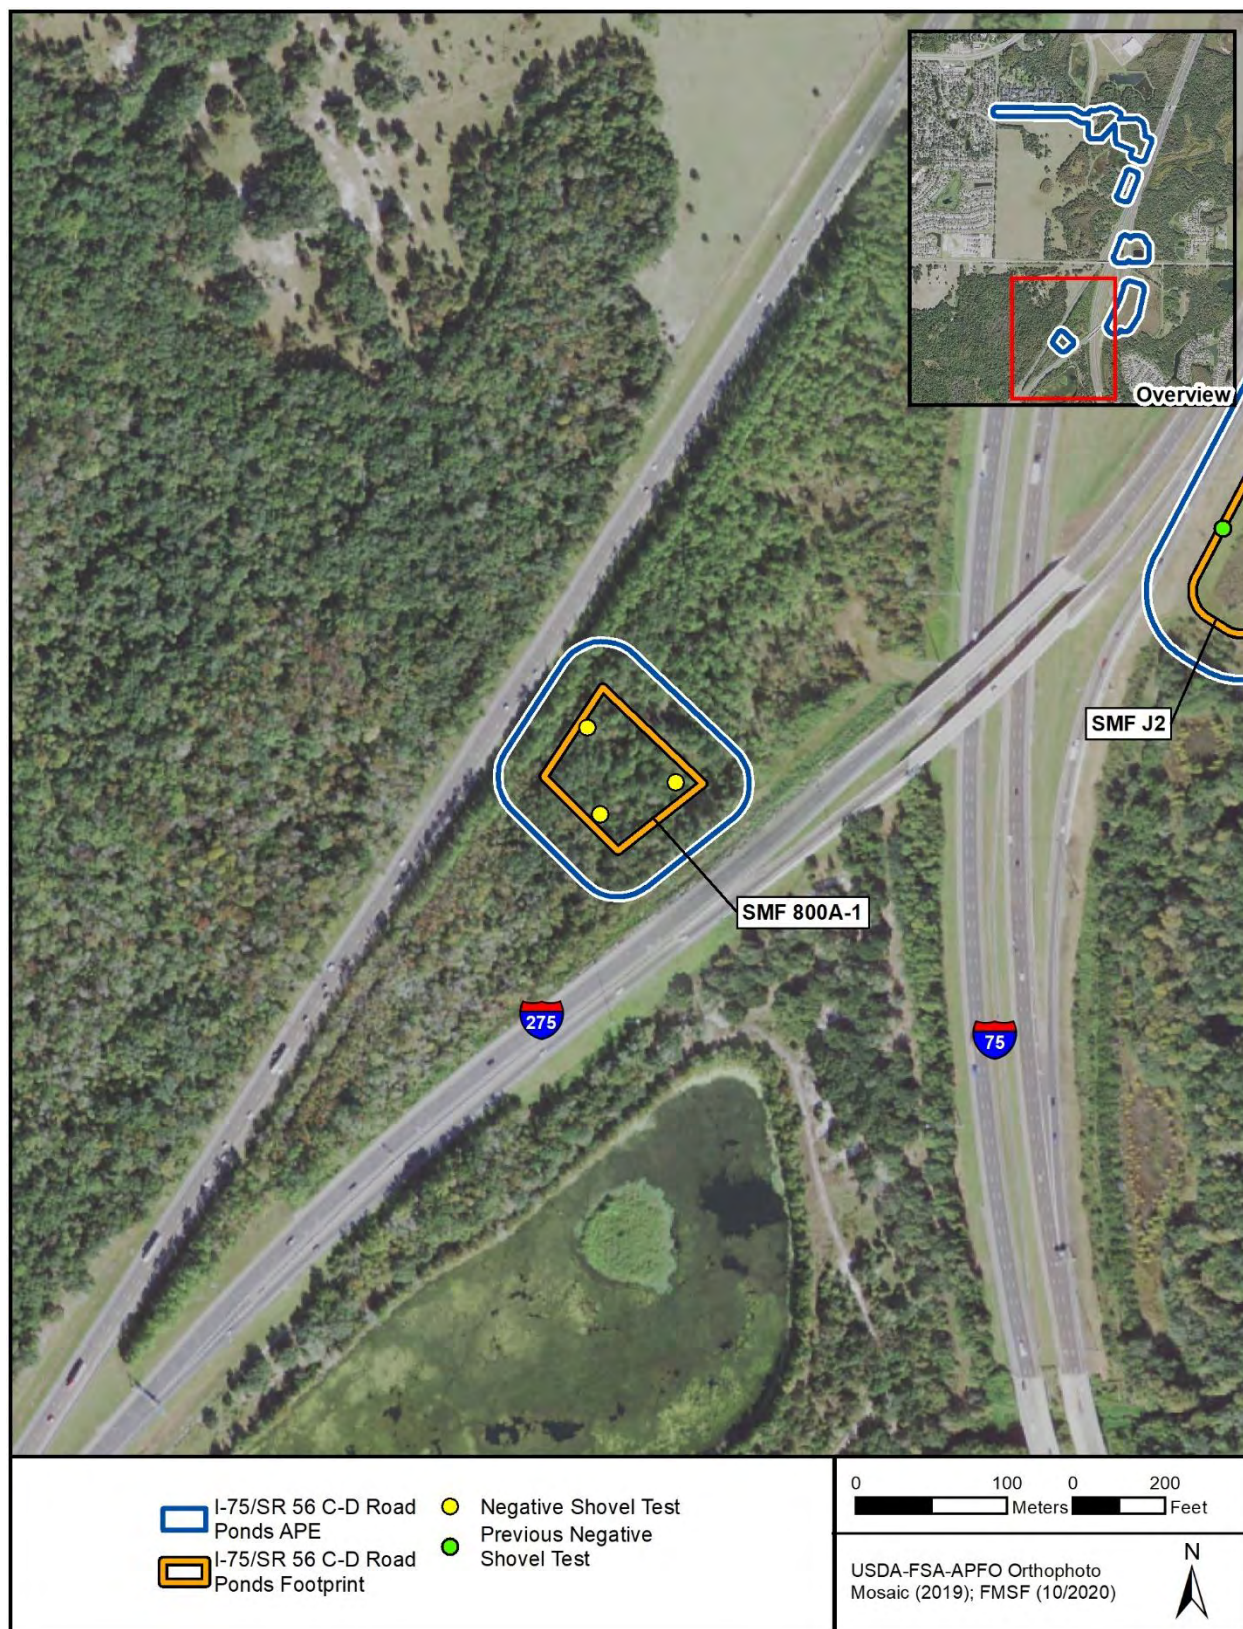
Figure 7. Shovel test results within the I-75/SR 56 C-D Road Ponds APE, map 3 of 3.

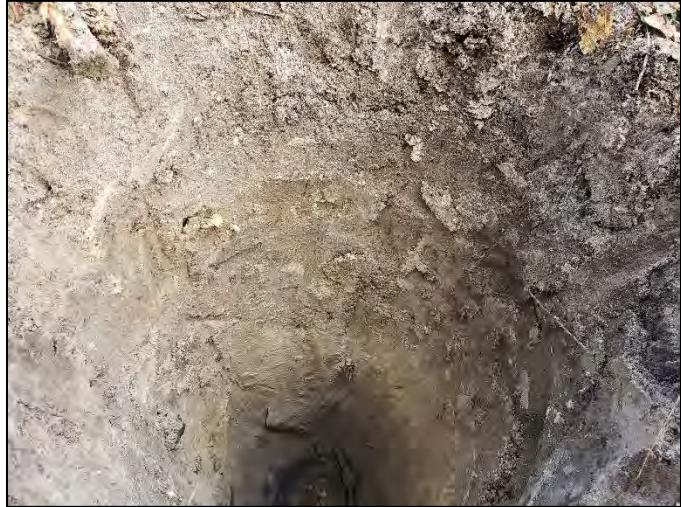
**Figure 8. Soil profile of representative shovel test within FPC-3B.**

A representative soil profile from the top of the landform (Shovel Test 33) presented 7.5YR 4/1 (dark gray) loam from 0-10 cmbs (0-4.0 inches), above 7.5YR 6/1 (gray) loam from 10-40 cmbs (4.0-16 inches), above 7.5YR 7/1 (light gray) loam from 40-60 cmbs (16-24 inches), with black spodic soils beneath 60 cmbs (24 inches) (**Figure 8**). Archaeologists noted spodic soils or encountered the water table in every shovel test.

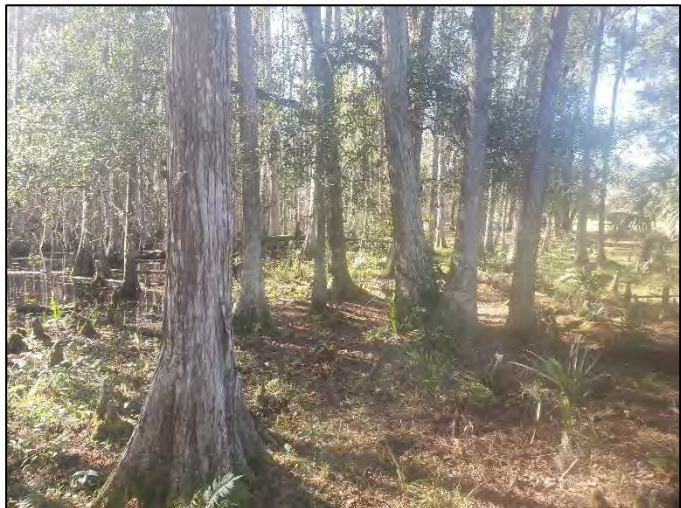
**Figure 9. Current environment within FPC-1 and FPC-2, south view at southern end of pond within 8PA00482 exhibiting swampland.**

A pedestrian survey was completed of the 2.17-acre pond, which includes FPC-1 and FPC-2, and is located in an area of wooded lowland with cypress, palmetto, and pine vegetation (**Figure 9**). Soils within FPC-1 and FPC-2 consist of poorly drained EauGallie fine sand and very poorly drained Delray mucky fine sand (see **Figure 3**). Eleven shovel tests were excavated at 25-meter intervals during the current survey (see **Figure 5**); all shovel tests were negative for cultural material. A previous survey of the pond conducted during Panamerican's 2006 survey included the excavation of two additional negative shovel tests within the pond footprint, and four shovel tests within the overall pond APE (three negative, one positive) (FMSF Survey No. 13470).

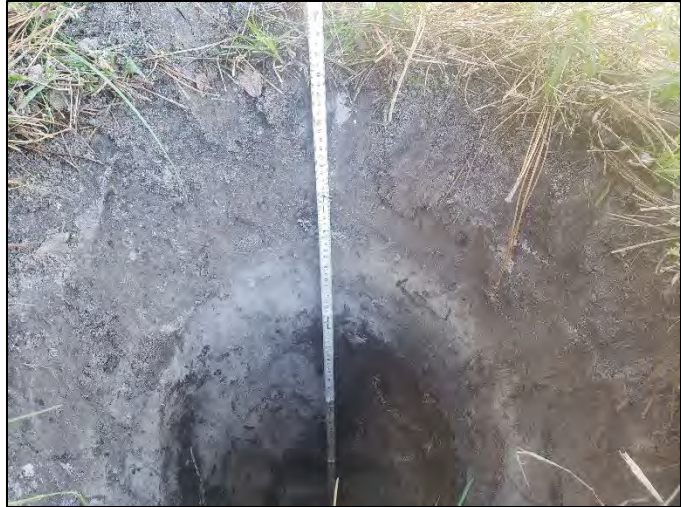
**Figure 10. Soil profile of representative shovel test within FPC-1 and FPC-2.**

A representative soil profile from the center of the pond (Shovel Test 5) presented five strata: Stratum I consisted of 7.5YR 4/1 (dark gray) sand from 0-20 cmbs (0-8.0 inches); Stratum II consisted of 7.5YR 8/1 (white) sand from 20-40 cmbs (8.0-16 inches); Stratum III consisted of 10YR 2/1 (black) sand from 40-50 cmbs (16-20 inches); Stratum IV consisted of 10YR 5/2 (grayish brown) sand from 50-80 cmbs (20-32 inches); and Stratum V consisted of 10YR 5/3 (brown) sand from 80-100 cmbs (32-39.4 inches) (**Figure 10**). The elevation of the pond ranges from 44 to 80 feet (13.4-24.4 meters) amsl.

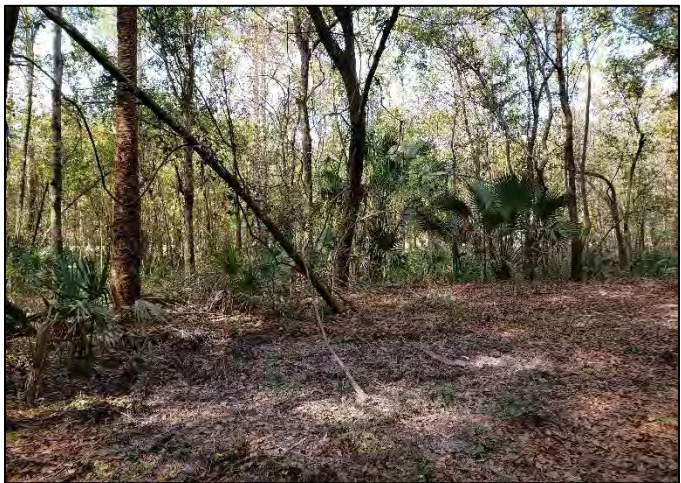
**Figure 11. Current environment within SMF 800A-1, west view showing hog activity and wetland area.**

A pedestrian survey was completed of the 1.40-acre pond, which is located in an area of thinned oak and pine woods with little to no understory vegetation (**Figure 11**). Archaeologists observed a low-lying area on the western edge of the pond that resembles a swampy wetland. On the eastern edge, the area has been built up for the construction of I-75. Other disturbance has noted within the pond footprint, including bioturbation from hogs and push piles related to past clearing activities. Soils within the pond consist of poorly drained Immokalee fine sand (see **Figure 3**). Three shovel tests were excavated at 50-meter intervals (see **Figure 5**); all shovel tests showed evidence of disturbance and were negative for cultural material.

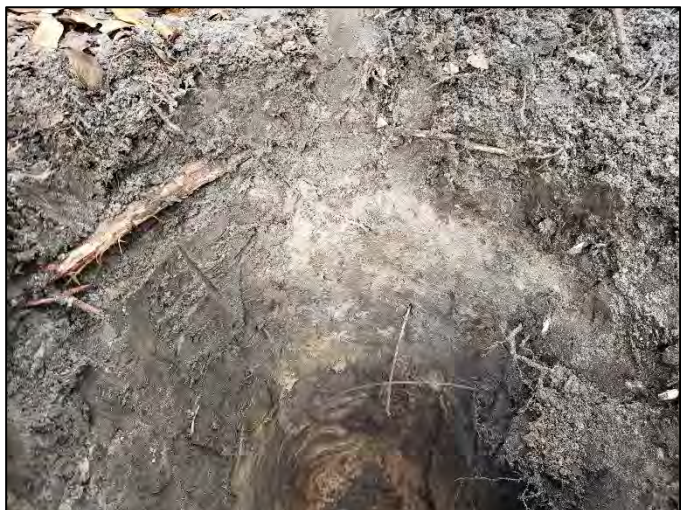
**Figure 12. Soil profile of representative shovel test within SMF 800A-1.**

A representative soil profile presented 10YR 3/2 (very dark gray brown) sand from 0-30 cmbs (0-12 inches), above 10YR 6/1 (gray) sand from 30-50 cmbs (12-20 inches), above 10YR 4/1 (dark gray) and 10YR 7/1 (light gray) sand mottled with 10YR 5/6 (yellow brown) sandy clay from 50-70 cmbs (20-28 inches) (**Figure 12**). Archaeologists noted spodic soils in every shovel test.
