CULTURAL RESOURCE ASSESSMENT SURVEY ADDENDUM

SR 56 Southbound C-D Road/Ramps to I-75/I-275

Project Development and Environment (PD&E) Study

# ***CULTURAL RESOURCE ASSESSMENT SURVEY ADDENDUM***

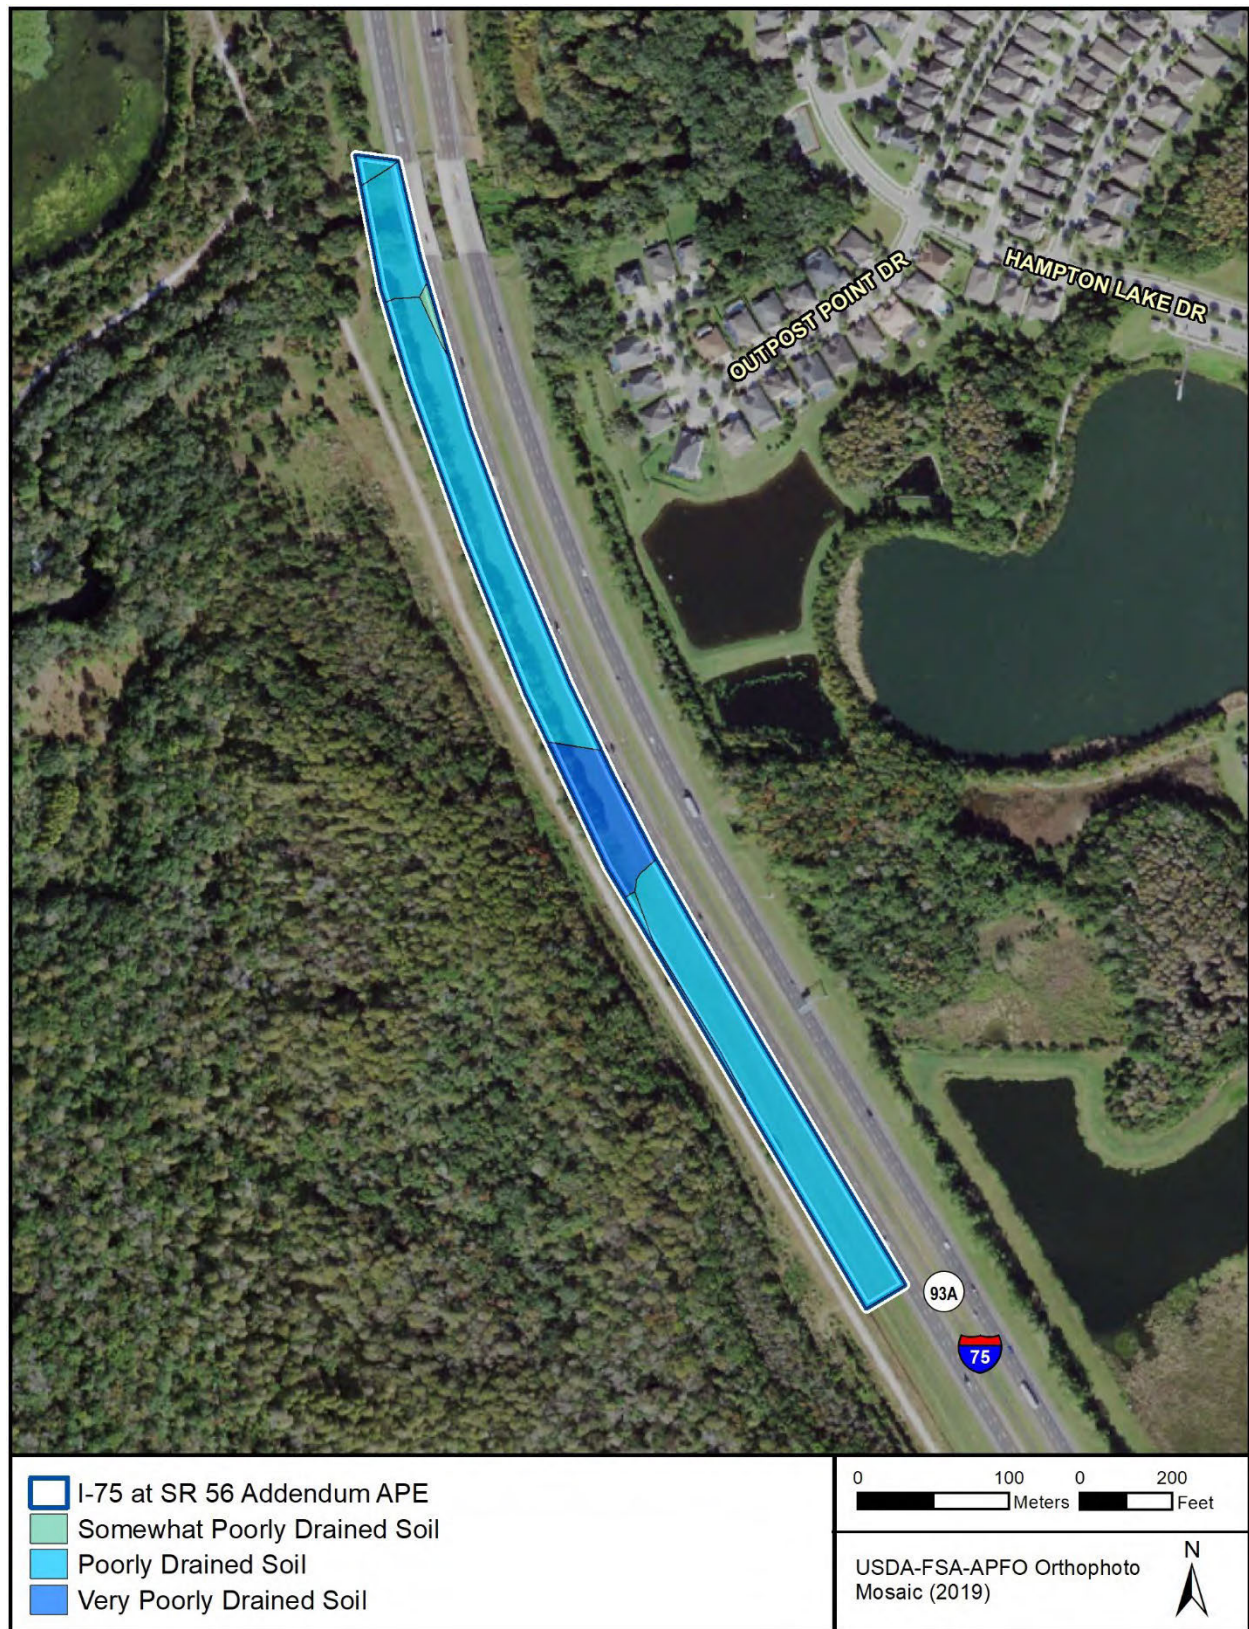
Figure 3. Soil drainage in the I-75 at SR 56 archaeological APE.

The I-75 at SR 56 Addendum APE is adjacent to the I-75 corridor and consists of a heavily modified landscape bordered by a mostly undeveloped, wooded area in Hillsborough County, Florida. The project area is an approximately 1.22-km (0.76-mi) corridor on the west side of I-75, south of the Hillsborough and Pasco County line. The project is in Sections 3 and 10 of Township 27 South, Range 19 East, found on Lutz, FL, (2021) USGS 7.5' Quadrangle map. Geologically, the I-75 at SR 56 APE is within the Hillsborough Valley physiographic province, which is a part of the larger Ocala Uplift District. This region consists of an erosional basin that is the watershed of the Hillsborough River (Brooks 1981). Elevations within the APE are approximately 35–80 ft (10.7–24.4 m) above mean sea level (amsl). Soils within the APE are primarily poorly drained Myakka, Winder, and Immokalee fine sands and very poorly drained Basinger depressional soils, with smaller amounts of poorly drained Zolfo fine sands (**Figure 3**). The corridor is adjacent to Cypress Creek, which flows southerly into the Hillsborough River, the Hillsborough Bay, the Tampa Bay, and eventually the Gulf of Mexico.

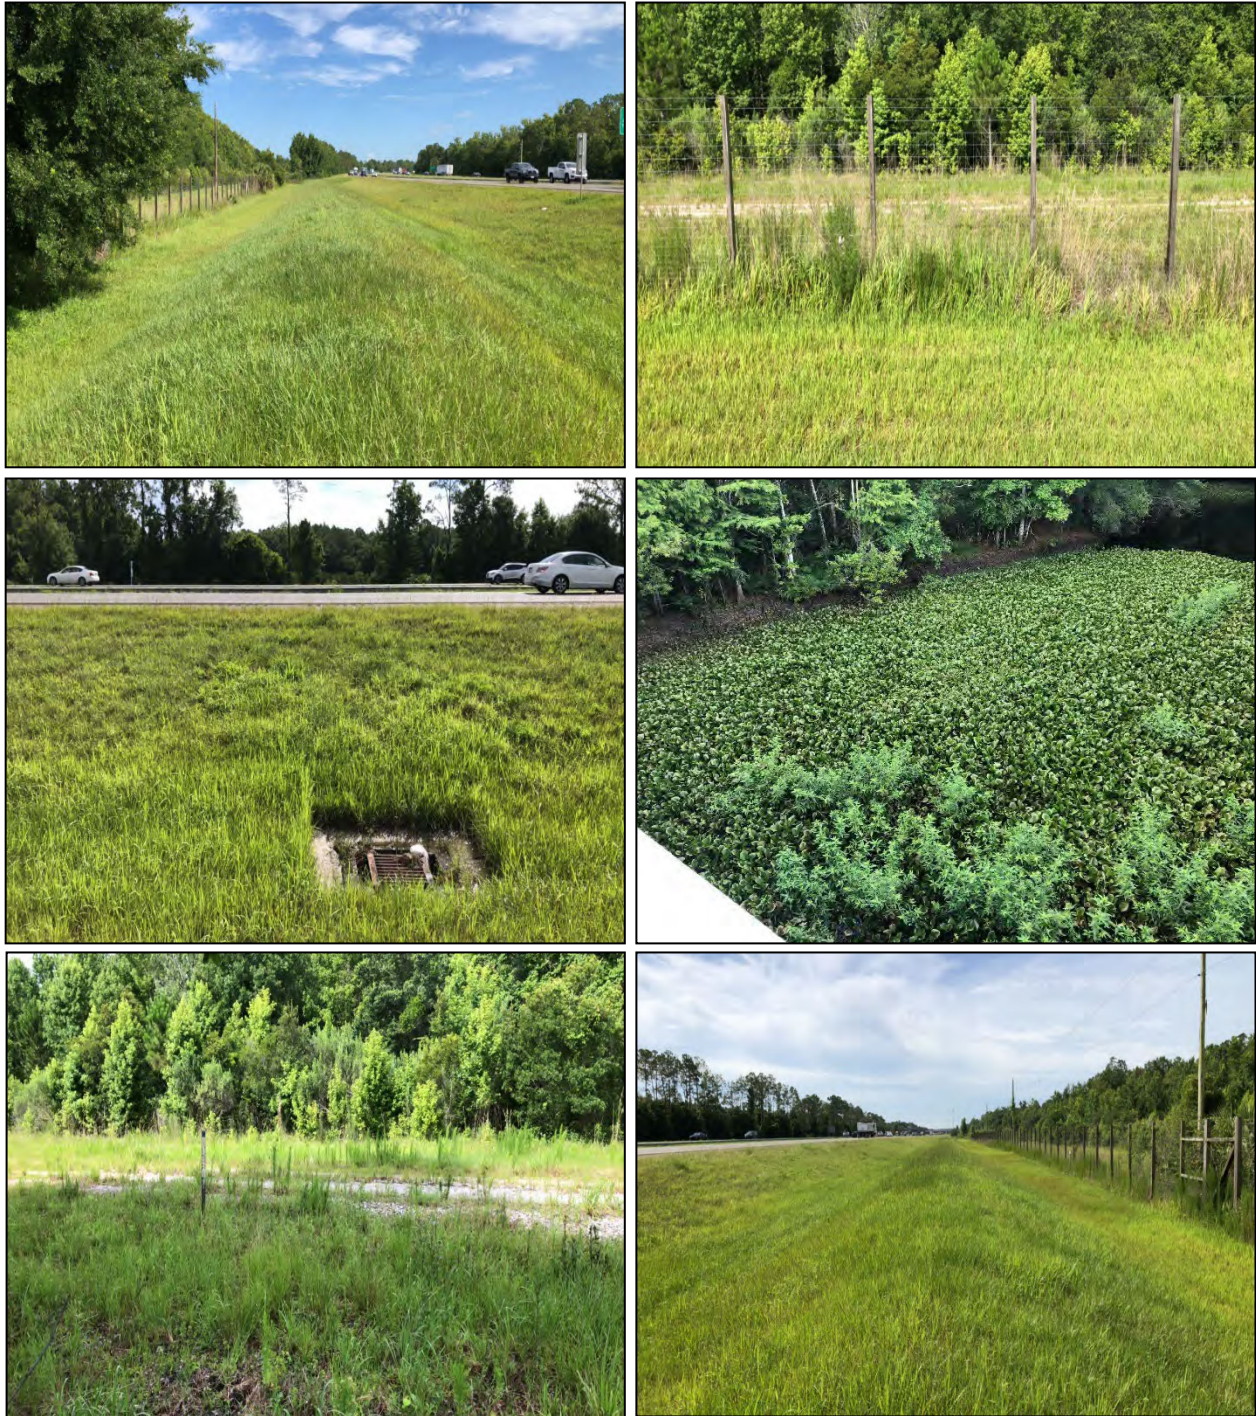
**Figure 5. Representative views of I-75 at SR 56 APE. Top left: View north at in the southern portion of the project area; Top right: Environmental conditions with fence line bordering APE near middle of APE, view west; Center left: View east of drainage grate with buried utilities adjacent to I-75 near middle of APE.; Center right: View southwest of Cypress Creek in northern portion of the APE; Bottom left: View west of buried utilities adjacent to the APE in the southern portion of the project area; Bottom right: Overview of the APE near southern end of APE, view south.**

The I-75 at SR 56 Addendum APE consists of a heavily modified interstate corridor bordered by a mostly undeveloped, wooded area in Hillsborough County, Florida. The APE consists of sloped berms adjacent to the interstate with buried utilities (**Figure 5**). In total, 32 shovel tests were excavated within the I-75 at SR 56 Addendum APE, 31 of which were negative for cultural material (**Figure 6**). One positive shovel test was excavated in the northern portion of the APE, approximately 164 ft (50 m) south of the creek and within the Cypress Creek site (8HI00471) boundary. This site is discussed in greater detail below. Three shovel tests were recorded as no-digs due to buried utilities and flooded areas adjacent to Cypress Creek. The fieldwork results of the survey are shown in **Figure 6**.

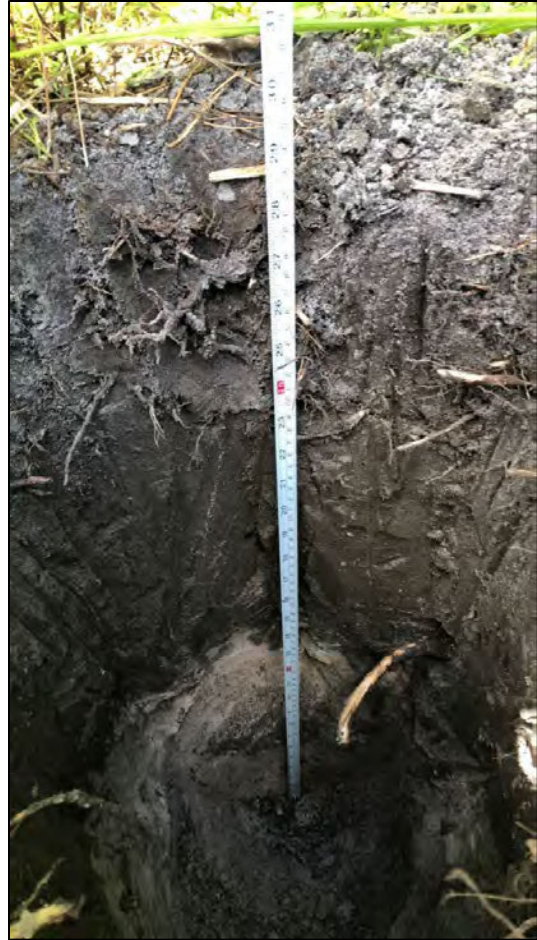
Figure 7. Representative soil profile within the I-75 at SR 56 Addendum APE.

Archaeological testing within the I-75 at SR 56 Addendum APE presented disturbed soils associated with buried utilities and roadway construction of the area. A typical soil profile consisted of dark gray (10 YR 4/1) sand from 0–45 cmbs (0–17 in) above light gray (10 YR 7/2) clay from 45–75 cmbs (17–30 inches) (**Figure 7**). Shovel tests often terminated due to extreme compaction from disturbance. Natural soils were not observed, and gravel and construction fill were present in several tests.

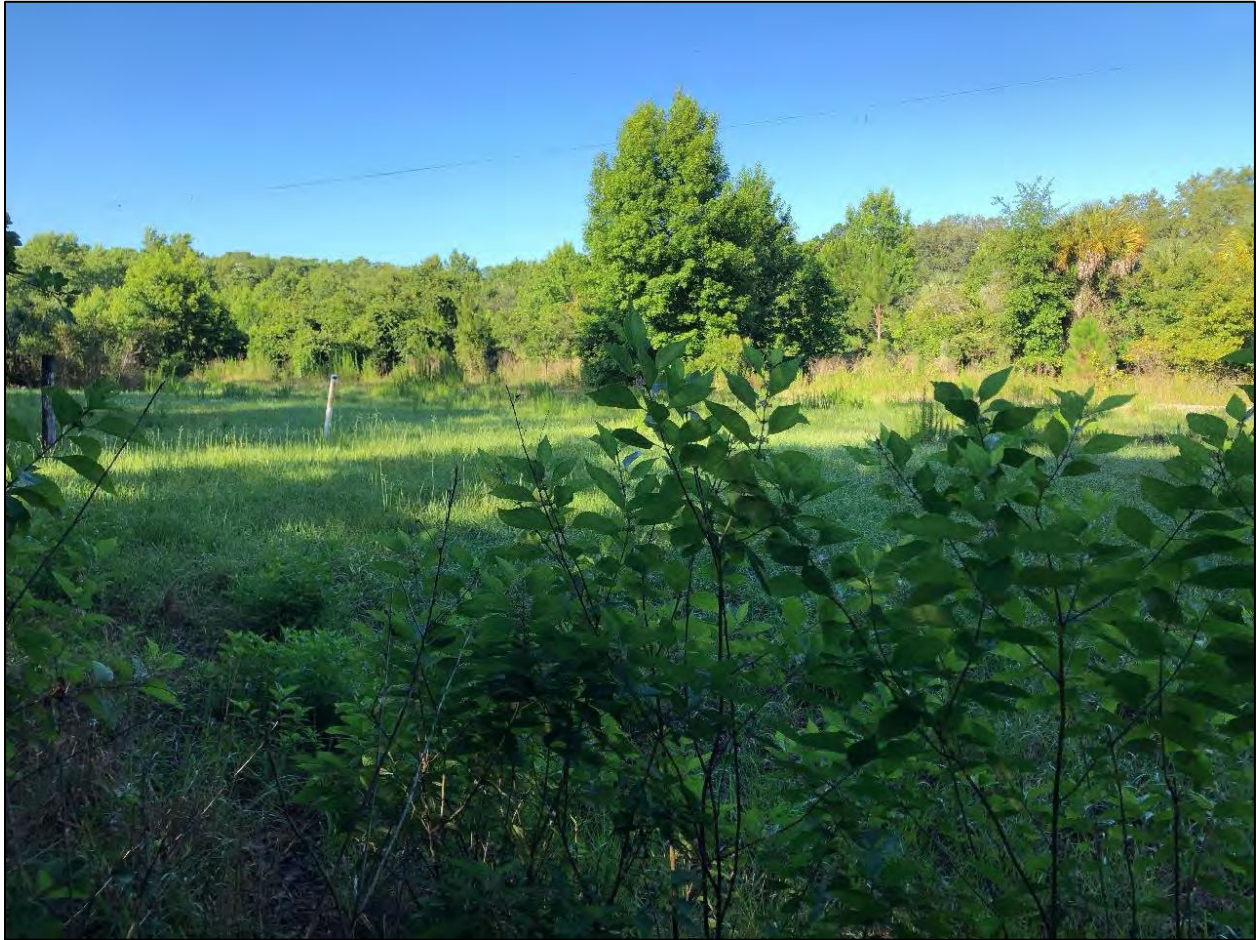
**Figure 8. Overview photo of 8HI471, the Cypress Creek Site, view west.**

Setting: Located in portion of maintained right-of-way of I-75 with gently sloping modified landscape with berm leading to bridge over Cypress Creek (**Figure 8**)

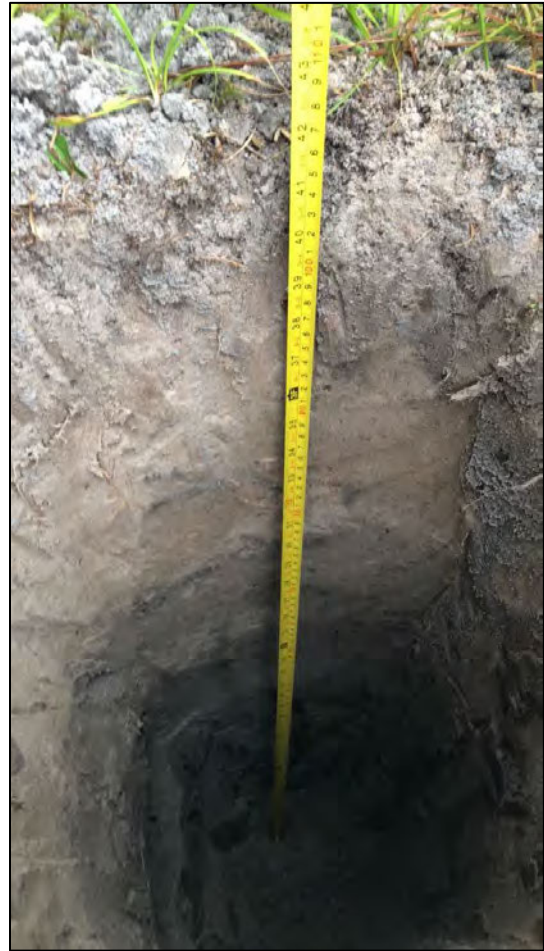
**Figure 10. Soil profile of positive shovel test ST 4 located in site 8HI00471.**

Six shovel tests were excavated within the site boundary, and five shovel tests were negative for cultural materials. The one positive shovel test (ST 4) presented a soil profile consisting of light gray (10 YR 7/2) sand from 0–40 cmbs (0–16 in) above gray (10 YR 6/1) sand from 40–110 cmbs (16–43 in) (**Figure 10**). Artifacts recovered from this shovel test consisted of 1 silicified coral flake fragment from 90–100 cmbs (35–39 in), and 3 coastal plain chert flake fragments from 100–110 cmbs (39–43 in) (**Attachment 1**). The positive shovel test was delineated to the north and south at 12.5- and 25-m (41- and 82-ft) intervals. All delineating shovel tests were negative for cultural materials. Delineating shovel tests were unable to be excavated to the east due to the I-75 roadway, and to the west due to buried utilities (see **Figure 9**).
