CONTAMINATION SCREENING EVALUATION REPORT

US 92/SR 600/Gandy Boulevard

Limits of Project: 4th Street to West Shore Boulevard

Contamination Screening Evaluation Report

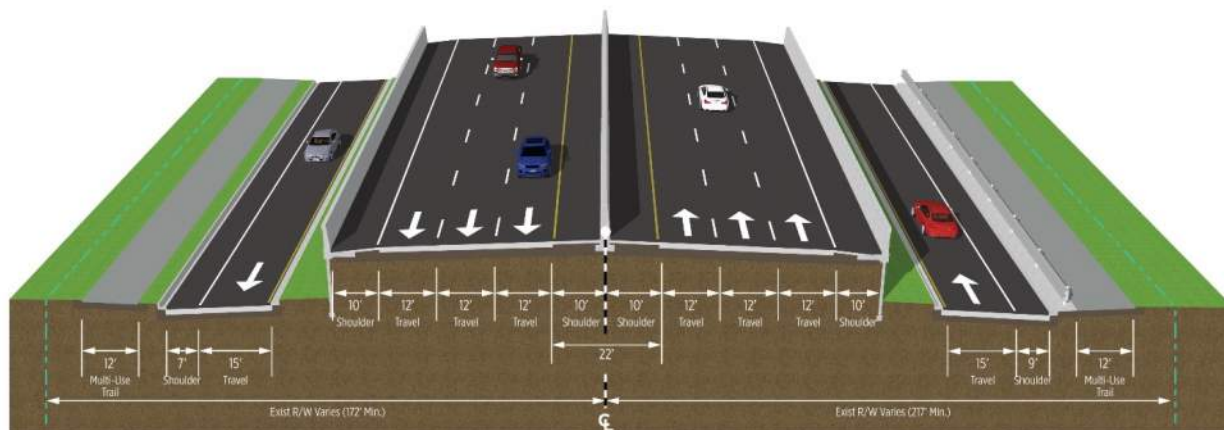
Figure 4-3 Segment 1 - Typical Section 3 from East of San Fernando Dr. to west end of Gandy bridges

Typical Section 3 is proposed from East of San Fernando Drive to the west end of the Gandy bridges. An additional travel lane in either direction is developed from the direct connect access ramps from the local frontage roads creating a six-lane typical section throughout the causeway which continues east over the Gandy bridges. Typical Section 3 consists of an elevated controlled access roadway with three 12-foot travel lanes in each direction, ten-foot paved inside shoulders, and ten-foot paved outside shoulders with barrier wall in each direction. The median transitions from 46 feet to 22 feet with opposing travel lanes separated by median barrier wall. One-lane frontage roads are proposed on the outside of the controlled access roadway in each direction with a 15-foot travel lane, varying outside shoulder widths (seven feet to nine feet paved), curb and gutter, and a 12-foot multi-use trail. One of the frontage roads will provide access to multi-use trail parking. Typical Section 3 is proposed within the existing FDOT ROW as shown in **Figure 4-3**.

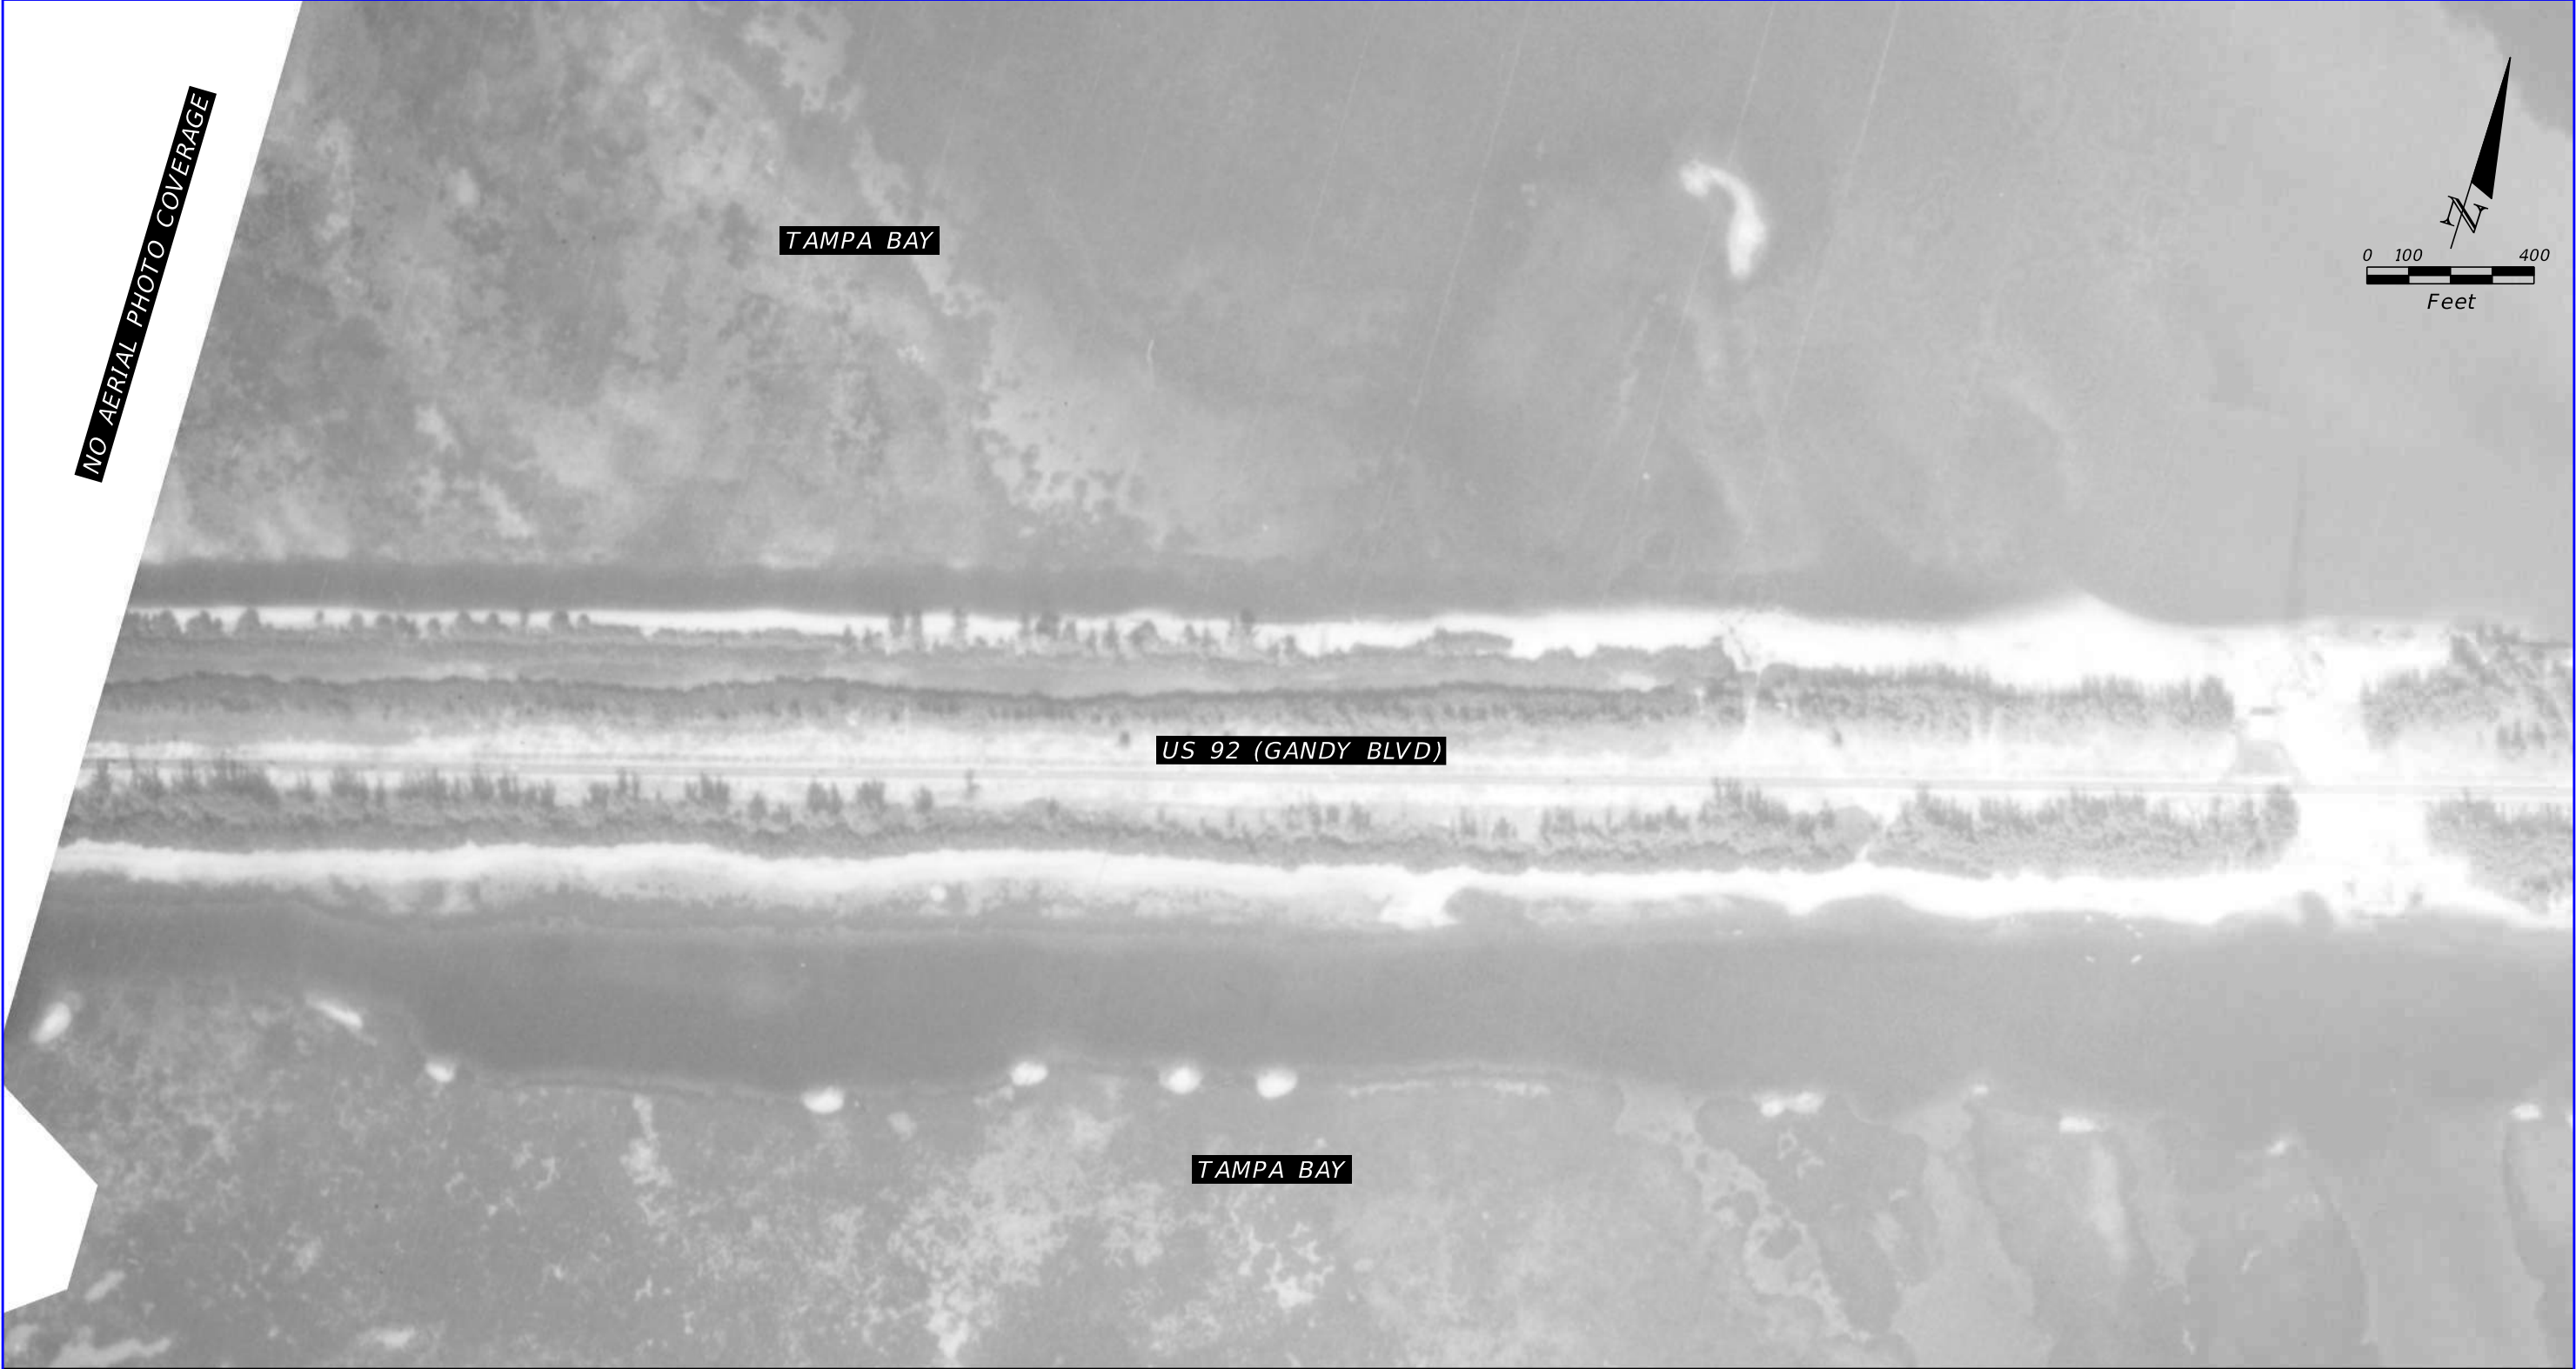
1951 HISTORICAL AERIAL PHOTOGRAPH

1951 Pinellas County: One cell tower and one building added north side of Gandy. Aerial photo coverage mostly not available. Although aerial photo coverage was mostly not available for Hillsborough County, no changes were noted for the areas of coverage.

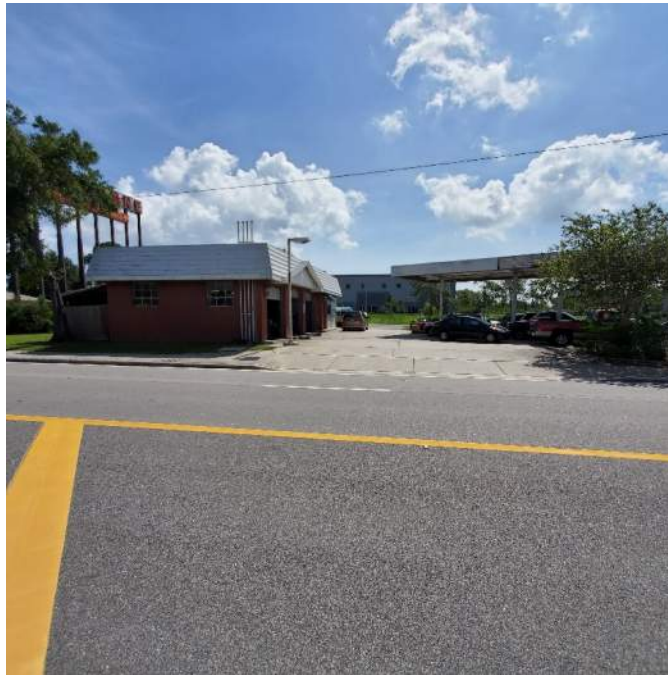
Site 2 – Former Amoco/Jim's Triangle
West of gas station looking east

2 (EDM 2)	FORMER AMOCO #1463- JIMS TRIANGLE 9901 4TH ST N	LUST/STCERC 8623518	70 feet south of 4 th Street proposed ROW 500 feet south of Gandy Boulevard ROW	Petroleum	Low	<p>During the site reconnaissance, this site was observed as Michelle’s Ultimate Car Care, an automotive repair shop. Multiple groundwater monitor wells were observed at this facility, and three were observed within the 4th Street North concrete median, west of this facility. Although the pump island and canopy were present, fuel pumps were not observed at this facility. Three hydraulic lifts were noted inside the service bays. The site was first depicted on the 1970 aerial photograph.</p> <p>EDM’s report states remedial action is ongoing for one diesel fuel discharge dated November 30, 1988. This discharge is eligible in the State’s cleanup program (Early Detection Incentive (EDI)) with a score/rank of 11/8060, effective since 1997. According to the FDEP <i>Deliverable (Supplemental Site Assessment Report (SSAR)) Approval</i> letter dated April 2, 2021, although the FDEP agrees soil and groundwater assessment should continue, it has been put on hold due to funding.</p> <p>Based on figures included in the SSAR dated March 16, 2021, the soil and groundwater petroleum contamination plumes were depicted 100 feet south of the southernmost point of the 4th Street North proposed ROW. The groundwater plume is depicted within the 4th Street North ROW (100 feet south of project limits). Groundwater flow is depicted generally to the east and west, cross-gradient to the project limits. See excerpts in Appendix F. A total of eight USTs were removed from this facility.</p> <p>According to the FDEP letter dated March 26, 2021, two offsite contamination notification emails were emailed to the FDOT District Seven on March 26, 2021. The email notifications were provided to advise the FDOT that contamination was “detected or suspected” within the FDOT ROW both east and west of this site. The contaminant plume maps depict the plumes located over 100 feet south of the southern limit of this project.</p> <p>Given the separation distance of 100 feet, and cross-gradient groundwater flow directions, this site is assigned a risk rating of Low. Although Level II testing is not recommended/warranted, this site may trigger additional evaluation for NPDES permitting if dewatering is performed within 500 feet.</p>

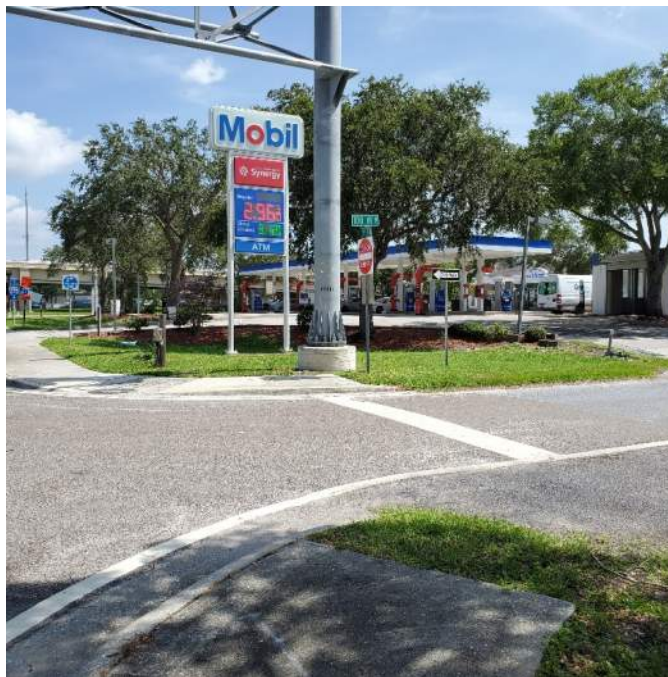
Site 3 – Mobil Whiteway #545
Southwest of Mobil looking northeast

TABLE 1: CONTAMINATION SITES						
Site Number/ EDM Number	Site Name & Address	Databases/ Facility ID/ Or Other Source	Distance to Gandy Boulevard ROW	Contaminants of Concern	Risk Rating	Comments
3 (EDM 3)	MOBIL-WHITWAY #545 10021 4TH ST N	LUST/STCERC 8623360CLN	Adjoining south	Petroleum	High	<p>During the site reconnaissance, this location was observed as an active Mobil gas station. The pump island is located 20 feet south, and tank farm is 80 feet south of the Gandy Boulevard ROW. The site was first depicted on the 1986 aerial photograph. It is important to note, ROW acquisition is anticipated along the west side of this gas station.</p> <p>EDM's report states remedial action is ongoing for one discharge dated November 28, 1988. This discharge is eligible in the EDI petroleum cleanup program with a score/rank of 8/8533, effective since 2008. Two other reported discharges (dated December 29, 1989 and October 23, 1993) have been included under a combined cleanup in the EDI program. According to the Natural Attenuation Monitoring Report (NAMR) dated June 3, 2019, laboratory groundwater results from the May 2019 sampling event were below Groundwater Cleanup Target Levels (GCTLs). However, in the previous sampling event, benzene exceeded the GCTL at MW-6 (located 30 feet south of Gandy Boulevard ROW, and 50 feet east of 4th Street ROW) in December 2018. Groundwater reportedly flows to the west (towards 4th Street). See excerpts in Appendix F. No SRCO was found for this facility. Based on an email from Jennifer Rogers, FDEP dated September 28, 2021, the FDEP has been awaiting a Declaration of Restrictive Covenant (DRC) for over a year so a Conditional Site Rehabilitation Completion Order (SRCO) can be issued after the DRC has been approved. See email in Appendix F. The Conditional SRCO acknowledges that contamination will remain at the site but further rehabilitation will not be required.</p> <p>Given the status as an active retail gas station, and laboratory results above the GCTL for benzene at MW-6 (in 2018), this site is assigned a risk rating of High.</p>

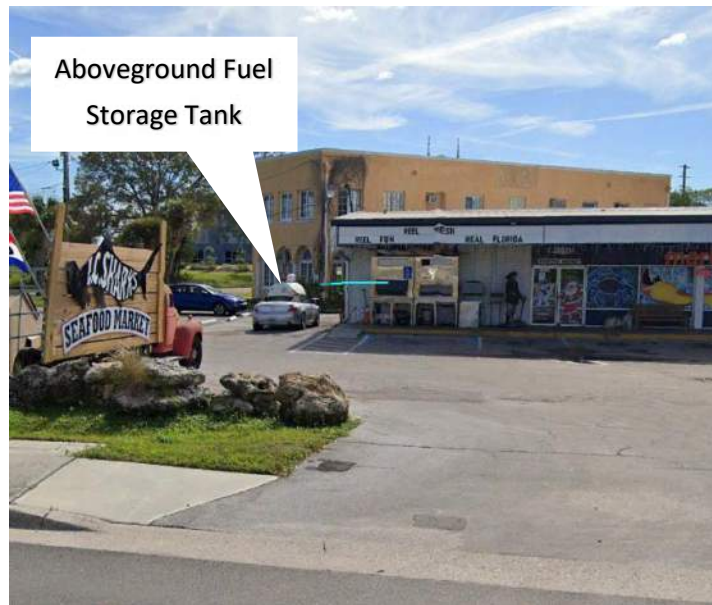
Site 4 – IC Sharks
Gandy Boulevard looking south
(from Google Earth Street View image dated January 2020)

4	I C SHARKS 10020 GANDY BOULEVARD	NA	Adjoining south	Petroleum	Low	<p>During the site reconnaissance, this location was observed as IC Sharks seafood market. Although this site appears typical of a convenience store which often are retail fuel facilities, no monitor wells, fill ports, vent pipes or evidence of other contamination concerns were noted.</p> <p>No regulatory files were found.</p> <p>The site was first depicted in the current configuration on the 1970 aerial photograph. No pump island was noted on aerial photographs. However, one petroleum 550-gallon AST was depicted on the Google Earth Street View image dated January 2020. See image in Appendix E.</p> <p>Although it appears that an AST operated at this site, there is no evidence of a discharge or spill. This site is assigned a risk rating of Low.</p>
5 (EDM 4)	BARNEY'S MOTORCYCLE SALES INC 10375 OAK ST NE 10411 GANDY BOULEVARD	LUST/STCERC 8943143 9200368CLN	Adjoining north	Petroleum	Low	<p>During the site reconnaissance, this location was observed as Barneys Motorcycle and Marine, sales and service. Service areas were noted in the north end of the building, and at locations west of this facility which appear to be owned/operated by Barney's. The nearest service bays/areas are located 250 feet north of the Gandy Boulevard ROW.</p> <p>EDM's report identified two discharges. For the discharge (type and quantity not given) dated December 30, 1988, no cleanup is required. For the leaded gasoline (quantity not given) discharge dated December 5, 1991, cleanup was completed and a SRCO was issued on January 2, 2019. Based on figures included with the Natural Attenuation Quarterly Monitoring Report dated July 6, 2018, the former 1,000-gallon diesel UST is depicted 200 feet north of the Gandy Boulevard ROW. The UST was removed in 1991.</p> <p>The site was first depicted in the current configuration on the 2002 aerial photograph.</p> <p>Given the separation distance of 200 feet, source removal, regulatory status, this site is assigned a risk rating of Low.</p>

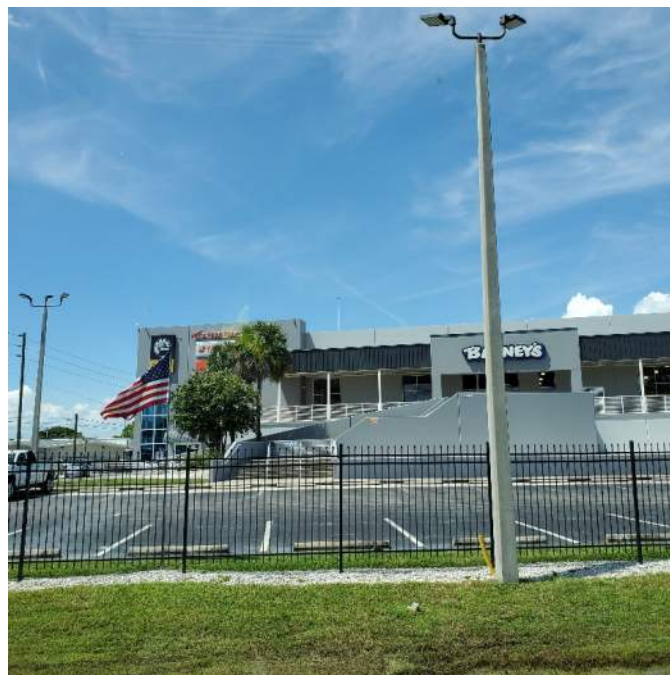
Site 5 – Barney's Motorcycle Sales, Inc.
South of Barney's looking north

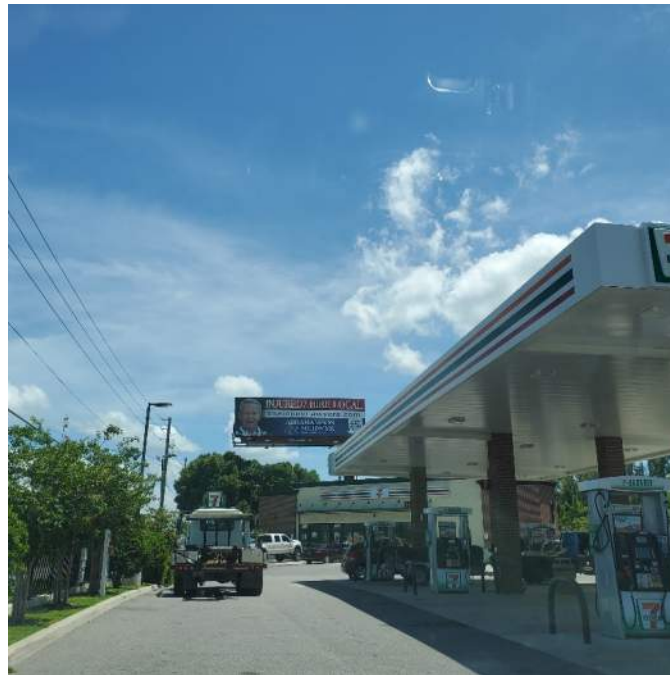
Site 8 – 7-Eleven #38123
Adjacent south of Gandy Boulevard looking east

8	7-ELEVEN #38123 10820 GANDY BLVD N	TANKS 9815159	Adjoining south	Petroleum	Medium	<p>During the site reconnaissance, this location was observed as an active 7-Eleven gasoline station. The pump island is located 20 feet south of the ROW, and the tank farm is 60 feet south.</p> <p>This site was not identified in EDM’s report. No discharges were identified on the FDEP OCULUS database. The tank inspection form dated March 17, 2019 states this facility is in compliance, and has two USTs filled with diesel and unleaded gasoline.</p> <p>This site is first depicted on the 2019 aerial photograph.</p> <p>Given the status as an active gasoline station, this site is assigned a risk rating of Medium.</p>

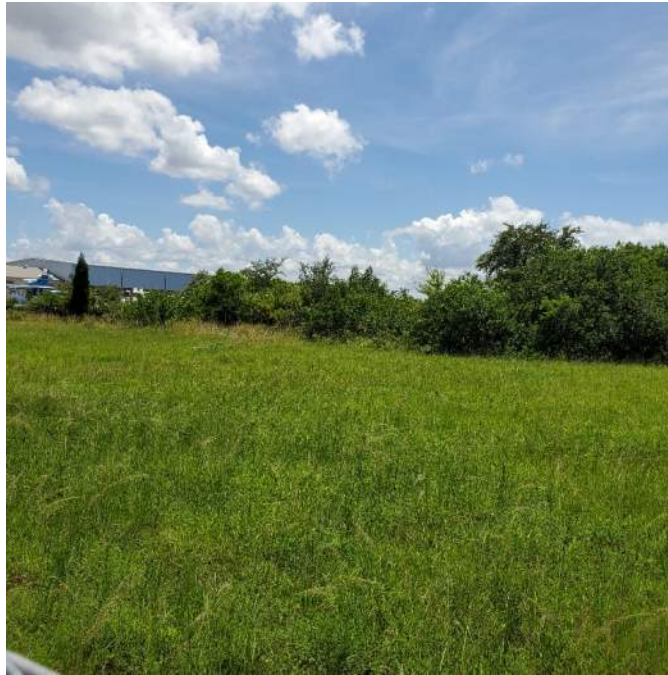
Site 10 – Vicinity of Former Gandy Boat Yard
(Thomas A. King Estate – West Parcel)
South of Gandy Boulevard looking southeast

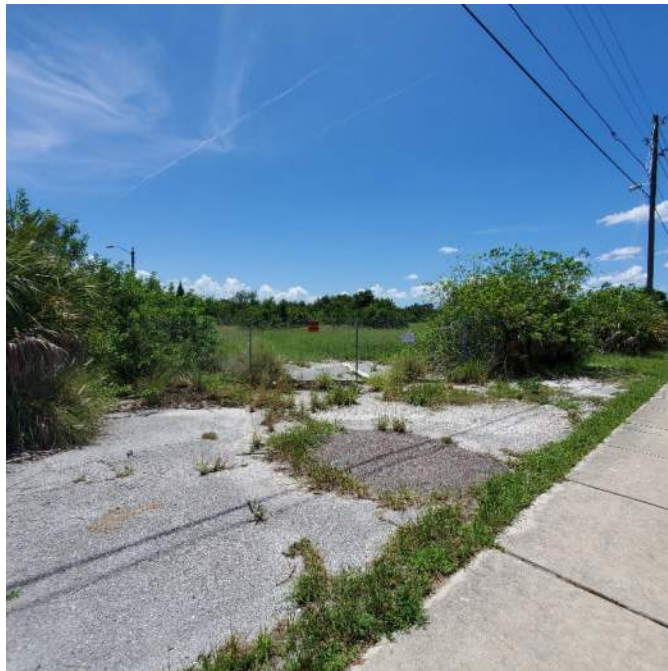
Site 11 – Former Pirate's Landing Bait Shop
(Thomas A. King Estate – East Parcel)
South of Gandy Boulevard looking southwest

TABLE 1: CONTAMINATION SITES						
Site Number/ EDM Number	Site Name & Address	Databases/ Facility ID/ Or Other Source	Distance to Gandy Boulevard ROW	Contaminants of Concern	Risk Rating	Comments
11 (EDM 7)	FORMER PIRATES LANDING BAIT SHOP (THOMAS A. KING ESTATE – EAST PARCEL) FORMERLY 12020 GANDY BLVD	LUST 9600674	Adjoining south	Petroleum	Low	<p>During the site reconnaissance, this location was overgrown and surrounded by fencing. No structures or address were noted.</p> <p>EDM’s report states an SRCO was issued on December 16, 1996 for the February 12, 1996 discharge. No other discharges were reported, and no tanks were registered for this facility.</p> <p>OCULUS 9600674 – Based on information found in the LCAR (for the Thomas A. King Estate) dated May 1996, no soil or groundwater testing was performed at 12020 Gandy Boulevard. Soil and groundwater assessment activities were limited to 12016 Gandy Boulevard, located west of this site, Pirates Landing Bait Shop. Figures depict the nearest boring location over 100 feet west of this parcel. Based on laboratory results, although petroleum constituents were detected, the concentrations were below GCTLs. No further action was recommended. Groundwater flow was reported to the southeast, away from the Gandy Boulevard ROW. See excerpts in Appendix F.</p> <p>The former bait shop was depicted on aerial photographs from 1957 to 2004.</p> <p>In conclusion, no tanks were registered for this site. The discharge was reported based on laboratory results contained the Phase II ESA. However, based on boring and well locations depicted in the Phase II ESA, CTL exceedances were limited to 12016 Gandy Boulevard. No CTL exceedances were identified at 12020 Gandy Boulevard.</p> <p>Therefore, this site is assigned a risk rating of Low.</p>

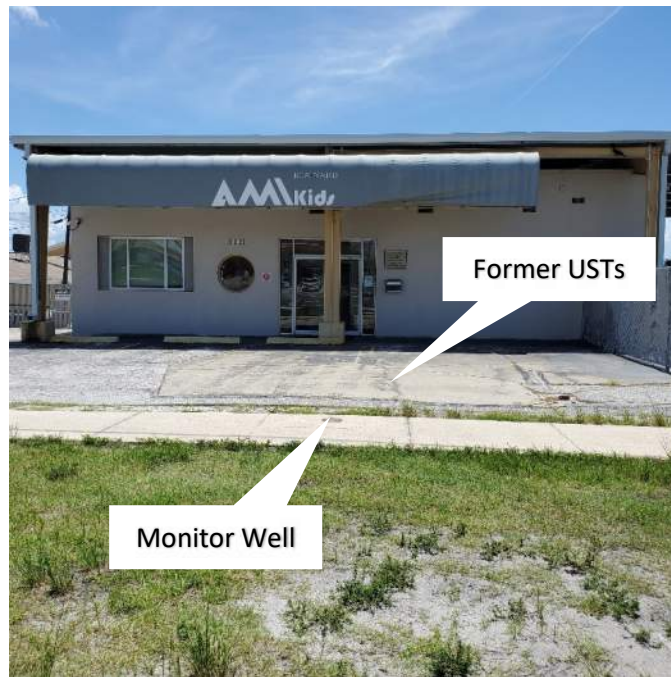
Site 12 – Former Mariner Yacht Sales, Inc.
South of Gandy Boulevard looking south

12 (EDM 9)	FORMER MARINER YACHT SALES INC 12022 GANDY BLVD	LUST 9202351	Adjacent south	Petroleum	Low	<p>During the site reconnaissance, this location was observed as AmiKids, a maritime nonprofit organization for youth. The facility did not appear to be in operation during the site reconnaissance. Multiple groundwater monitor wells were noted on the north side of the building.</p> <p>EDM’s report states an SRCO was issued on December 15, 1995 for the May 18, 1982 discharge. No other discharges were reported.</p> <p>The CAR dated March 1995 states this facility was associated with Orange State Oil Company from 1947 to 1960, and has been used for yacht sales since 1977. A Phase I ESA dated 1992 identified four USTs at this facility. All four USTs (three 10,000-gallon leaded gasoline, one 550-gallon kerosene), and five cubic yards of contaminated soil were removed in 1993. Groundwater reportedly flows south, away from the Gandy Boulevard ROW. The highest OVA reading was 80 ppm located at MW-5 (south of building). Figures included in the CAR depict the former USTs located within and adjoining south of the Gandy Boulevard ROW. Laboratory results were below GCTLs, and no further assessment was recommended.</p> <p>The CAR Addendum dated November 1995 was prepared in response to FDEP comments. Additional soil and groundwater testing was performed in the drum storage area located on the west side of the building, and at the former UST location on the north side of the building, and south of the building where the highest OVA reading (80 ppm) was identified. Testing results were below CTLs, and no further action was recommended.</p> <p>Given the source removal, laboratory results below CTLs and regulatory status, this site is assigned a risk rating of Low.</p>

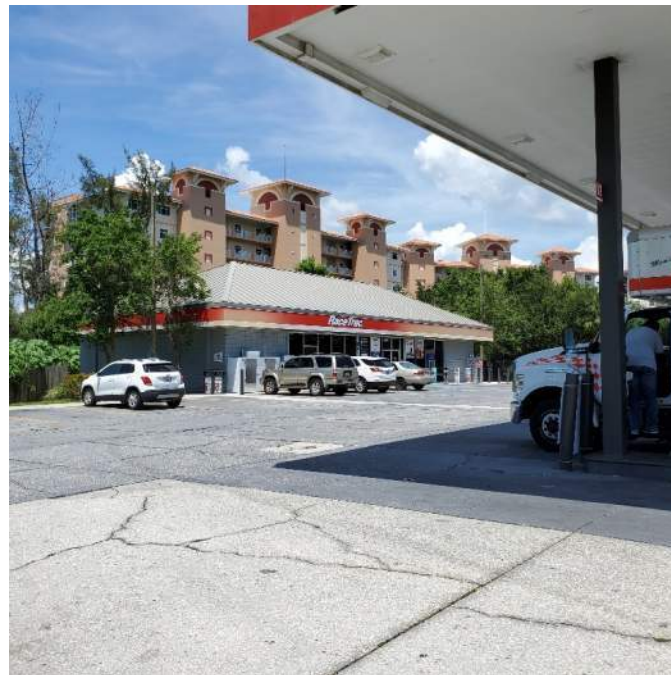
Site 13 – RaceTrac #441
Southwest of Mobil looking northeast

13 (EDM 8)	RACETRAC #441 12025 GANDY BLVD	LUST 9201309	Within proposed ROW and adjoining north	Petroleum	Medium	<p>During the site reconnaissance, this location was observed as an active RaceTrac gasoline station. While the pump island is located within the proposed Gandy Boulevard ROW, the tank farm is located 20 feet north of the proposed ROW.</p> <p>EDM’s report states an SRCO was issued on August 24, 2012 for the November 14, 2007 unleaded gasoline discharge. See excerpts in Appendix F. No other discharges were reported. However, according to the Pinellas County Health Department Return to Compliance letter dated June 15, 2020, the documentation reviewed was sufficient to support this facility’s return to compliance for pre and post spill bucket repair testing. This facility has three 12,000-gallon USTs were installed in 1992.</p> <p>Given the active status as a retail gasoline station, this site is assigned a risk rating of Medium. Additionally, it is important to note, the pump island is located within proposed ROW. Therefore, Level II testing may be warranted if construction impacts and/or dewatering are anticipated at or near the pump island.</p>

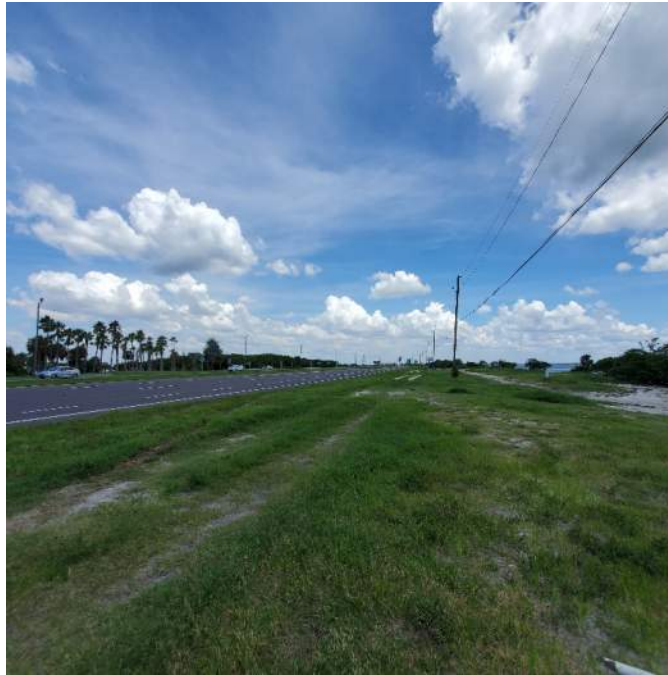
Site 15 – Vicinity of Former Gandy Bridge Park and Ride
Southwest of former Park and Ride looking east

15 (EDM 11)	FORMER GANDY BRIDGE PARK AND RIDE WEST GANDY BLVD	VOLCLNUP ERIC_9917	Within ROW	Petroleum, Pesticides, PCBs, Solid Waste	Low	<p>During the site reconnaissance, this location was observed as Gandy Boulevard causeway, including grassy ROW.</p> <p>According to the Soil Quality Investigation report dated May 3, 1994, a soil investigation was performed “in response to an article in the Tampa Tribune that alleged possibly contamination fill material had been inadvertently utilized by the FDOT subcontractor at this location.” The reported location was the median on the west side of the Gandy Bridge. Soil samples were collected at depths of 6-inches and one-foot from a total of 93 boring locations within an area 2,000-feet long and 100-feet wide. See excerpts in Appendix F. “Field screening using the OVA-FID found no volatile organic hydrocarbons.” A total of five composite samples were submitted for laboratory analysis. Fill materials included a mixture of “shell, concrete and building materials.” No details of the “building materials” were provided. An FDEP letter dated July 5, 1994 states “all soil levels in the composite samples were BDL and the grids were small enough that we determined additional sampling is not necessary for this site.” EDM’s report states the site status is “closed.”</p> <p>This site was depicted on the 1986 aerial photograph.</p> <p>Given the laboratory results below CTLs, and regulatory status, this site is assigned a risk rating of Low.</p>

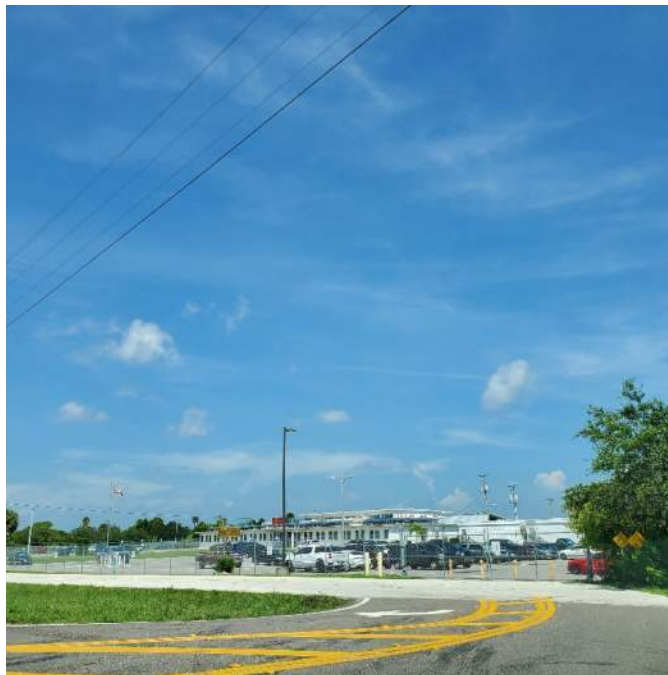
Site 16 – U.S. Marine Corps Reserve
Southeast of facility looking northwest

HILLSBOROUGH COUNTY						
16 (EDM 12)	US MARINE CORPS RESERVE 5121 W GANDY BLVD	LUST 8625404	Adjoining north	Petroleum	Low	<p>During the site reconnaissance, this location was observed as a USMC 4th Assault Amphibian Battalion facility.</p> <p>This facility is identified as a Leaking Underground Storage Tank (LUST) site in EDM’s report. EDM’s report further states no cleanup is required for the discharge dated January 12, 1995.</p> <p>OCULUS - The Discharge Report Form dated January 12, 1995 states no cleanup was required for the diesel fuel discharge (quantity not given). The most recent tank registration form dated January 4, 1995 states this facility has four registered fuel storage tanks: one AST, and three USTs. All four tanks were reportedly removed by January 4, 1995. Tank contents included diesel, leaded gasoline, and waste oil. Based on a sketch included in the combined documents (32 pages) found on OCULUS, two USTs were located 550 feet north of the Gandy Boulevard ROW. No maps or sketches were found for the remaining tank locations. Tierra presumes they were located in the same vicinity, at least 500 feet north of the Gandy Boulevard ROW.</p> <p>Given the separation distance to contamination concerns, this site is assigned a risk rating of Low.</p>

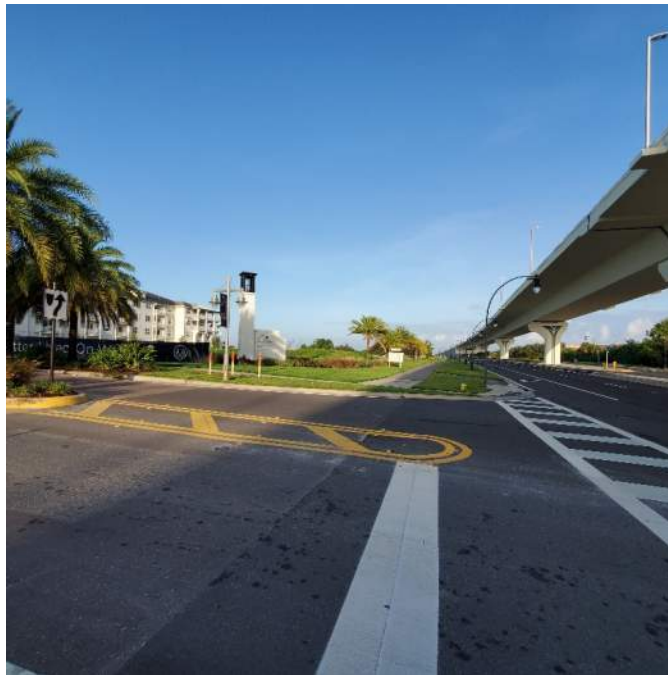
Site 17 – Former Coastal Mart gas station
Northeast of former gas station looking southwest

TABLE 1: CONTAMINATION SITES						
Site Number/ EDM Number	Site Name & Address	Databases/ Facility ID/ Or Other Source	Distance to Gandy Boulevard ROW	Contaminants of Concern	Risk Rating	Comments
17 (EDM 13)	FORMER COASTAL MART #603 5002 W GANDY BLVD	LUST 8625224	Adjoining south	Petroleum	Low	<p>During the site reconnaissance, this site was observed as the grassy south Gandy Boulevard ROW, and a landscape area with a sign monument.</p> <p>EDM’s report states this site has two discharges: 1) an SRCO was issued on February 27, 2015 for the discharge dated August 19, 1991, and 2) no cleanup was required for the unleaded gasoline (no quantity given) discharge dated January 25, 1988. Based on aerial photographs, the former pump island was located within the existing Gandy Boulevard ROW, and the former USTs were located adjacent south of the existing Gandy Boulevard ROW.</p> <p>The <i>Natural Attenuation Monitoring Report & Response to HCEPC Comments</i> dated February 3, 2015 states laboratory results are below GCTL, groundwater flow is southwest, away from the ROW. Therefore, an SRCO without conditions was recommended. See excerpts in Appendix F. No groundwater monitor wells were noted during the site reconnaissance.</p> <p>This site is depicted on aerial photographs from 1976 to 2004.</p> <p>Given the source removal, groundwater flow away from the ROW, and regulatory status, this site is assigned a risk rating of Low.</p>

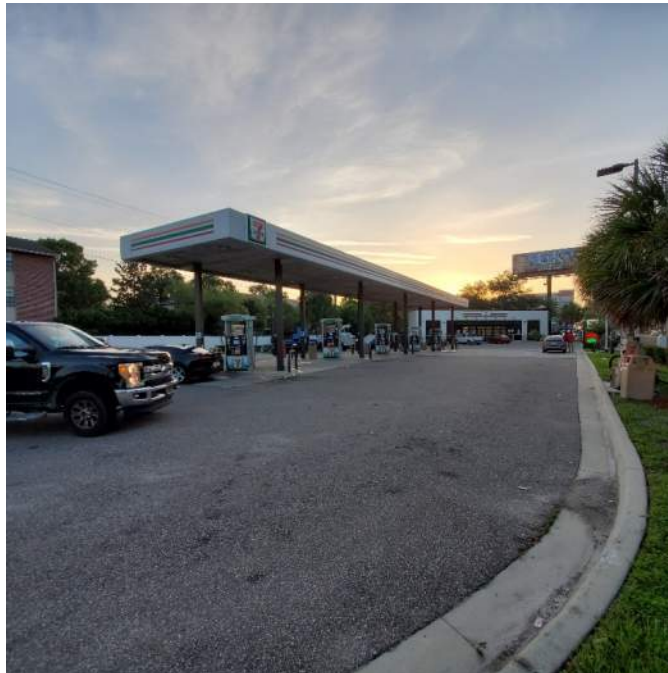
Site 21 – 7-Eleven
Near southwest corner looking east

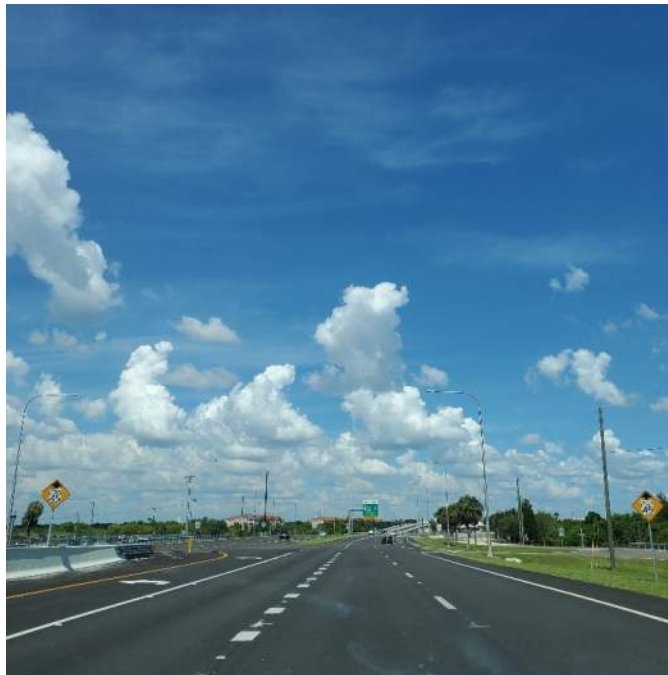
Hillsborough County – East-central area
Gandy Boulevard looking east
