# **CULTURAL RESOURCE ASSESSMENT SURVEY**

## **US 41 (SR 45) AT SR 54 PROJECT DEVELOPMENT AND ENVIRONMENT (PD&E) STUDY, PASCO COUNTY, FLORIDA**

**Work Program Item Segment No.: 419182-1**

**December 2024**

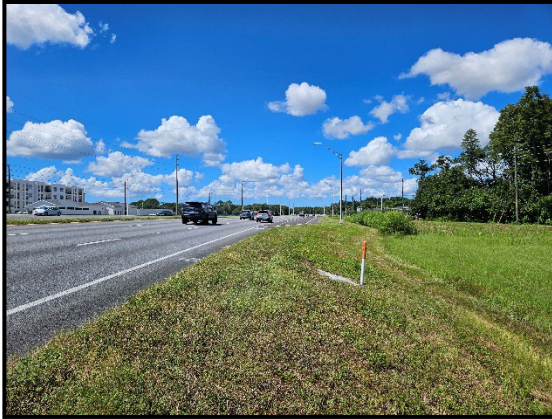
**Photo 2.3.** View of drainage and utilities along north side of SR 54 toward west end of the west corridor, facing west.

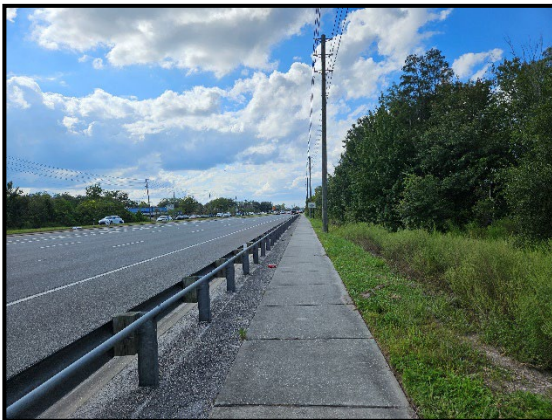
**Photo 2.7.** View of guardrail, sidewalk, and drainage ditch along north side of east SR 54 corridor, facing west.

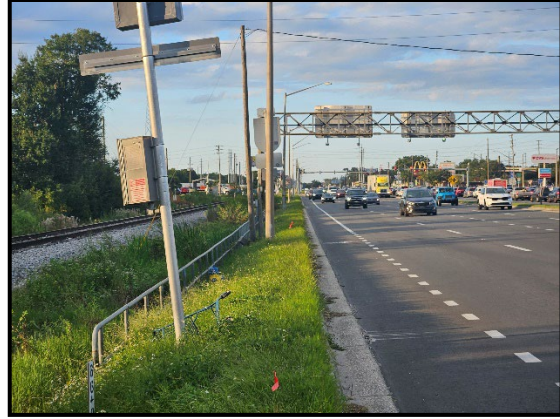
**Photo 2.10.** View of drainage/utilities along west side of south US 41 corridor adjacent Seaboard Coastline Railroad, facing north.

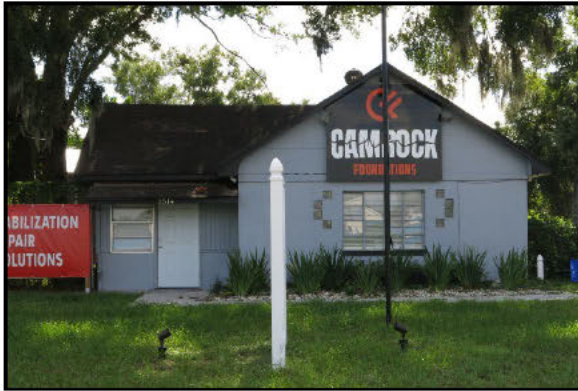
**Photo 5.6.** 2514 U.S. Highway 41 (8PA01498), looking east.

**8PA01498:** The Masonry Vernacular style building at 2514 U.S. Highway 41 was constructed ca. 1940 (**Photo 5.6**). The one-story, L-shaped plan building rests on a continuous concrete block foundation and has a concrete block structural system clad in stucco and wood siding and the gable ends are clad in asbestos shingles. The intersecting gable roof and shed roof are covered with composition shingles. The main entryway is on the west elevation through a single vinyl door with paneling within an open porch beneath a separate shed roof with brackets. Visible windows include a mixture of individual, two-over-two metal single-hung sash units and an individual eight-pane metal fixed unit flanked by two four-pane metal casement units. Distinguishing architectural features include glass block ornamentation, concrete sills, and closed eaves with moderate overhang. Alterations include replacement roofing materials, doors, and windows. There is a non-historic outbuilding to the northeast and a non-historic multiple vehicle carport with an attached open storage area to the east. Overall, the building has been altered, lacks sufficient architectural features, and is not a significant embodiment of a type, period, or method of construction. In addition, background research did not reveal any historic associations with significant persons and/or events. As a result, 8PA01498 does not appear eligible for listing in the NRHP, either individually or as part of a historic district.

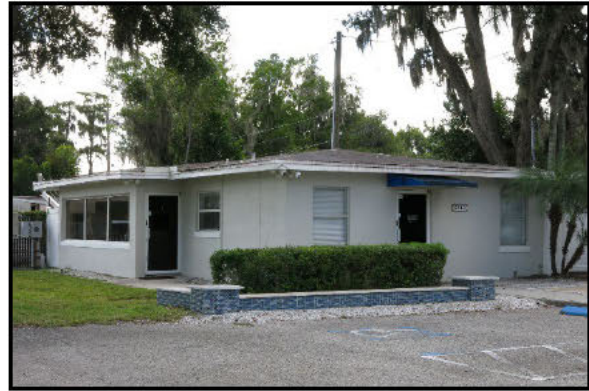
**Photo 5.7.** 2810 U.S. Highway 41 (8PA01500), looking southeast.

**8PA01500:** The Masonry Vernacular style building at 2810 U.S. Highway 41 was constructed ca. 1954 (**Photo 5.7**). The one-story, irregular plan building rests on a concrete slab foundation and has a concrete block structural system clad in stucco. The hip roof is covered with composition shingles. The main entryway is on the west elevation through a single metal-frame full-view glass door beneath a fabric awning. Visible windows include a mixture of individual, one-over-one metal single-hung sash

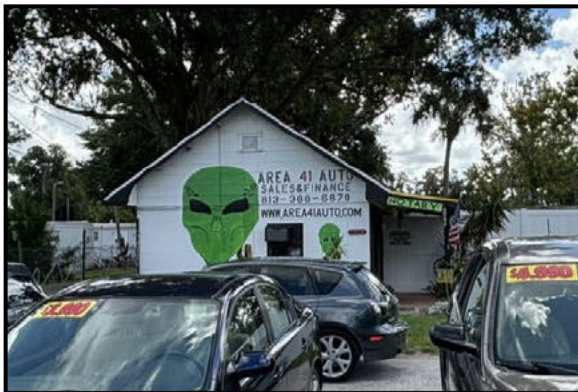
**Photo 5.8.** 2838 U.S. Highway 41 (8PA01502), looking east.

**8PA01502:** The Masonry Vernacular style building at 2838 U.S. Highway 41 was constructed ca. 1945 and is comprised of two commercial units (**Photo 5.8**). The one-story, rectangular plan building rests on a continuous concrete foundation and has a concrete block structural system with painted concrete block walls and the gable ends are clad in asbestos shingles. The side gable roof and shed roof are covered with composition shingles. There are two separate entryways on the south elevation through single doors within an open porch beneath a shed roof with squared wood supports. Visible windows include a mixture of individual, one-over-one wood double-hung sash units and individual, 4- and 8-light metal casement units. Distinguishing architectural features include moderate overhang with both enclosed eaves on the eave ends and exposed rafter tails on the gable ends, gable vents, and concrete sills. Alterations include replacement roofing materials. Overall, the building has been altered, lacks sufficient architectural features, and is not a significant embodiment of a type, period, or method of construction. In addition, background research did not reveal any historic associations with significant persons and/or events. As a result, 8PA01502 does not appear eligible for listing in the NRHP, either individually or as part of a historic district.

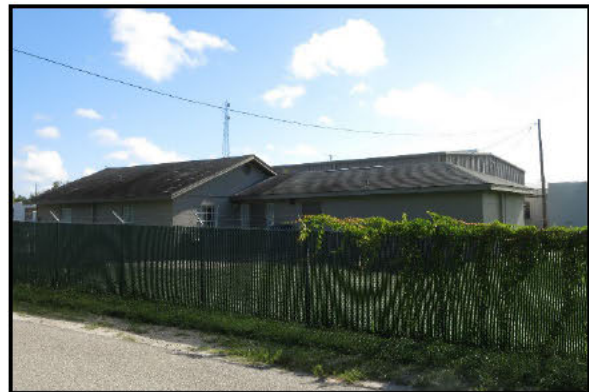
**Photo 5.9.** 2522 Hunt Road (8PA02112), looking northeast.

**8PA02112:** The Masonry Vernacular style building at 2522 Hunt Road was constructed ca. 1946 (**Photo 5.9**). The one-story, irregular plan building rests on a concrete slab foundation and has a concrete block structural system clad in stucco and painted concrete block walls. The gable and hip roof are covered with composition shingles and the shed roof of the porch is covered in standing seam sheet metal. The main entryway is on the east elevation through a single metal door. There is an open porch with half stucco and half screen walls on the east elevation that was constructed ca. 2007 to connect the building to an adjacent non-historic warehouse. Visible windows include a mixture of individual, four-over-four, six-over-six, and eight-over-eight vinyl single-hung sash units. Distinguishing architectural features include closed eaves with moderate overhang, gable vents, and concrete sills. Alterations include replacement roofing materials, doors and windows. Additions include the east elevation porch and the south elevation addition, which was constructed ca. 2012. There are eight non-historic buildings on the parcel related to the construction company that owns the property. Overall, the building has been altered, lacks sufficient architectural features, and is not a significant embodiment of a type, period, or method of construction. In addition, background research did not reveal any historic associations with significant persons and/or events. As a result, 8PA01502 does not appear eligible for listing in the NRHP, either individually or as part of a historic district.

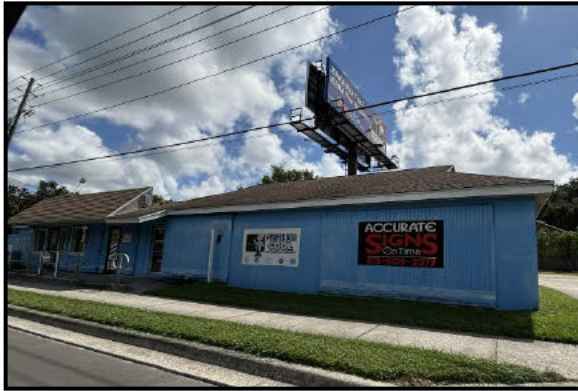
**Photo 5.10.** 2914-2922 US Highway 41 (8PA02830), looking northeast.

**8PA02830:** The Masonry Vernacular style commercial building at 2914-2922 US Highway 41 was constructed ca. 1952 (**Photo 5.10**). The one-story, irregular plan building rests on a continuous concrete foundation and has a concrete block structural system clad wood siding with painted concrete block walls. The gable-on-hip roof and hip style parapet are covered with composition shingles and the flat roof is covered in a composition roll. The building is comprised of four businesses with three entrances on the west elevation and an entrance on the south elevation, all through single metal framed full-view glass doors. There is an open porch on the west elevation beneath the parapet and an open porch on the east elevation beneath a flat roof with six squared wood supports. Visible windows include a mixture of individual, single pane metal fixed units and an individual, six-over-six metal single-hung sash unit. Distinguishing architectural features include closed eaves with moderate overhang, hip style parapet, gable vents, and wood window and door trim. Alterations include replacement roofing materials, doors and windows. Additions include north elevation which was constructed in the 1960s and expanded eastward by 1982. Overall, the building has been altered, lacks sufficient architectural features, and is not a significant embodiment of a type, period, or method of construction. In addition, background research did not reveal any historic associations with significant persons and/or events. As a result, 8PA02830 does not appear eligible for listing in the NRHP, either individually or as part of a historic district.

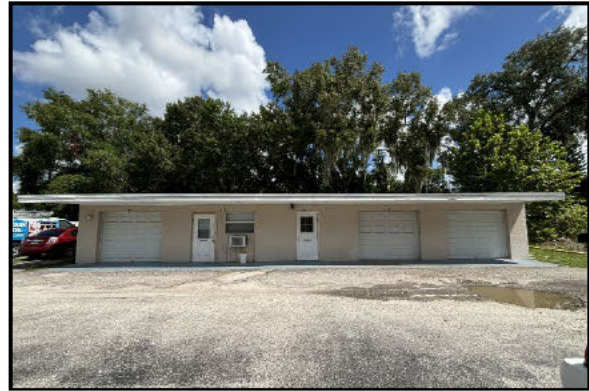
**Photo 5.11.** 21305-21315 Paoli Drive (8PA02831), looking north.

**8PA02831:** The Masonry Vernacular style garage at 21305-21315 Paoli Drive was constructed ca. 1979 (**Photo 5.11**). The one-story, rectangular plan building rests on a concrete slab foundation and has a concrete block structural system with painted concrete block walls. The flat roof is covered in a

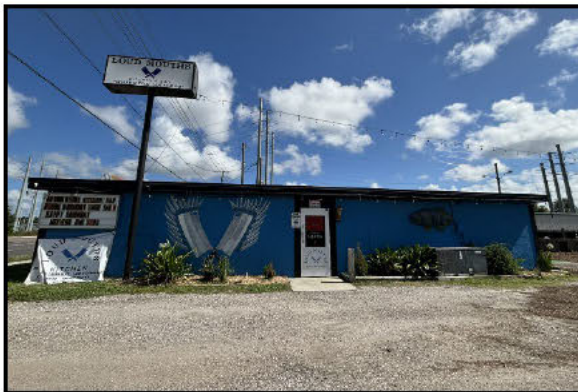
**Photo 5.12.** 2624 Land O' Lakes Boulevard (8PA02834), looking north.

**8PA02834:** The Masonry Vernacular style building at 2624 Land O' Lakes Boulevard was constructed ca. 1950 (**Photo 5.12**). The one-story, irregular plan building rests on a concrete slab foundation and has a concrete block structural system clad in stucco. The intersecting gable roof is covered in composition shingles and the hip-style parapet is covered in corrugated metal. The main entrance is on the south elevation through a single metal framed full-view glass door. Visible windows include individual, single pane wood fixed units. Distinguishing architectural features include closed eaves, a moderate overhang, and a hip-style parapet. Alterations include replacement roofing materials and doors. Additions include the north and south elevations. There is a non-historic residence to the east of the building. Overall, the building has been altered, lacks sufficient architectural features, and is not a significant embodiment of a type, period, or method of construction. In addition, background research did not reveal any historic associations with significant persons and/or events. As a result, 8PA02834 does not appear eligible for listing in the NRHP, either individually or as part of a historic district.

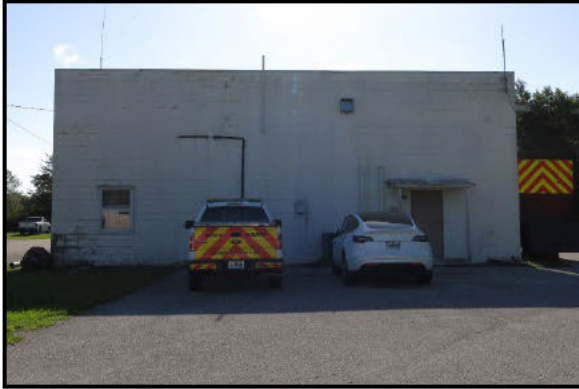
**Photo 5.14.** 21300 State Road 54 (8PA03789), looking east.

**8PA03789:** The Masonry Vernacular style building at 21300 State Road 54 was constructed ca. 1968 (**Photo 5.14**). The resource is located within Pond C(1). The one-story, rectangular plan building rests on a concrete slab foundation and has a concrete block structural system with painted concrete block walls. The flat roof is sheathed in a built-up membrane. The main entrance is on the west elevation through a single metal door with an open porch beneath a separate shed roof that features two squared porch supports. There is an open porch on the north elevation beneath a separate shed roof. Visible windows include an individual, one-over-one metal single-hung sash unit. Distinguishing architectural features include no eave overhang, garage doors, pilasters, and concrete sills. Alterations include a replacement window. The Pasco County fire rescue station is located just north of the building. Overall, the building has been altered, lacks sufficient architectural features, and is not a significant embodiment of a type, period, or method of construction. In addition, background research did not reveal any historic associations with significant persons and/or events. As a result, 8PA03789 does not appear eligible for listing in the NRHP, either individually or as part of a historic district.

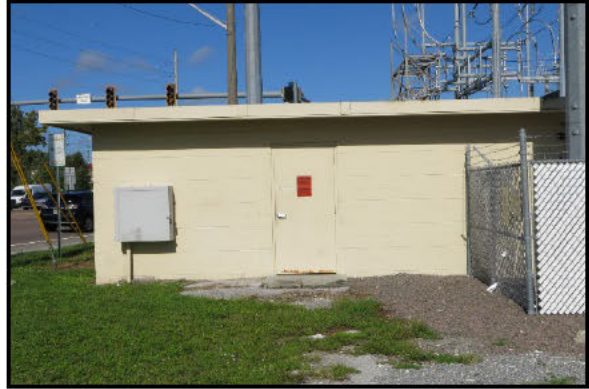
**Photo 5.15.** 21315 State Road 54 (8PA03790), looking west.

**8PA03790:** The Masonry Vernacular style building at 21315 State Road 54 was constructed ca. 1970 (**Photo 5.15**). The one-story, rectangular plan building rests on a concrete slab foundation and has a concrete block structural system with painted concrete block walls. The flat roof is sheathed in a built-up membrane. The main entrance is on the east elevation through a single metal door. There are no windows. Distinguishing architectural features include closed eaves with a moderate overhang. Alterations include replacement roofing materials. The electrical plant associated with the building is located to the north. Overall, the building has been altered, lacks sufficient architectural features, and

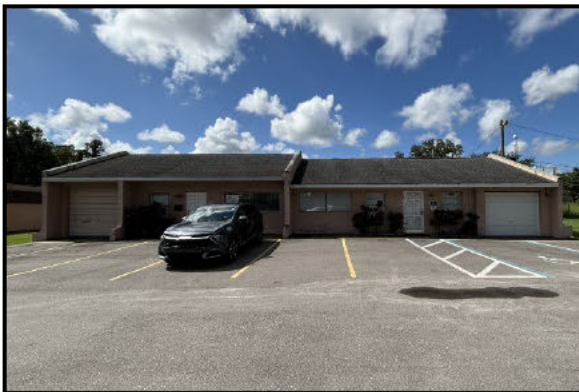
**Photo 5.16.** 21326 Coakley Lane (8PA03792), looking south.

**8PA03792:** The Masonry Vernacular style duplex at 21326 Coakley Lane was constructed ca. 1974 (**Photo 5.16**). The one-story, rectangular plan building rests on a concrete slab foundation and has a concrete block structural system clad in stucco and wood siding. The side gable roof is covered in composition shingles. There are two separate units in the building with two main entrances on the north elevation through single wood doors with paneling within a full-width open porch beneath the principal roof. There are integrated garages located on the east and west sides of the north elevation. Visible windows include a mixture of individual, two-over-two metal single-hung sash units and individual, single pane metal fixed units. Distinguishing architectural features include closed eaves with moderate overhang, a parapet wall on gable ends and between units, wing walls, gable vents, and inset windows with wood surrounds. Alterations include replacement roofing materials. There is a non-historic wood frame shed to the east. Overall, the building has been altered, lacks sufficient architectural features, and is not a significant embodiment of a type, period, or method of construction. In addition, background research did not reveal any historic associations with significant persons and/or events. As a result, 8PA03792 does not appear eligible for listing in the NRHP, either individually or as part of a historic district.

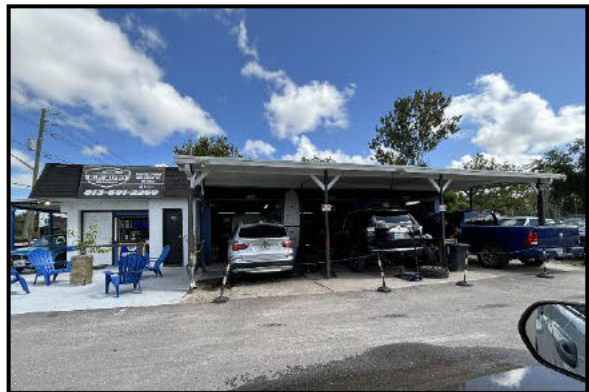
**Photo 5.17.** 2282 Land O' Lakes Boulevard (8PA03794), looking north.

**8PA03794:** The Masonry Vernacular style building at 2282 Land O' Lakes Boulevard was constructed ca. 1973 (**Photo 5.17**). The one-story, irregular plan building rests on a concrete slab foundation and has a concrete block structural system clad in painted concrete block walls and stucco. The flat principal roof is sheathed in a built-up membrane while the two flat porch roofs are covered in corrugated metal. The main entryway is on the south elevation through a single vinyl door with paneling within an incised porch beneath a hip style parapet. There is a porch on the south elevation beneath a flat roof that was added ca. 2013 with six metal supports with braces and a porch on the west elevation beneath a flat roof with five metal supports. There is an integrated three car garage on the east elevation. Visible windows include a mixture of individual, single pane metal fixed units. Distinguishing architectural features include no eave overhang and a hip style parapet. Alterations include replacement roofing materials and doors. Overall, the building has been altered, lacks sufficient architectural features, and is not a significant embodiment of a type, period, or method of construction. In addition, background research did not reveal any historic associations with significant persons and/or events. As a result, 8PA03794 does not appear eligible for listing in the NRHP, either individually or as part of a historic district.

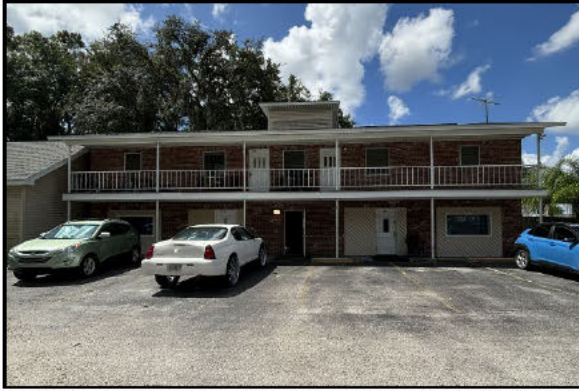
**Photo 5.18.** 21312-21318 Paoli Drive (8PA03803), looking south.

**8PA03803:** The Masonry Vernacular quadraplex at 21312-21318 Paoli Drive was constructed ca. 1979 (**Photo 5.18**). The two-story, rectangular plan building rests on a concrete slab foundation and has a masonry structural system clad in brick and wood siding. The side gable roof and hip roof cupola are covered in composition shingles. There are four separate entryways on the north elevation through single wood doors with paneling and inset lights. The entryways are within a full-width two-level porch beneath the principal roof supported by six columns and featuring a wood railing on the second story. Visible windows include a mixture of individual, eight-over-eight metal single-hung sash units and individual, single-pane metal fixed units. Distinguishing architectural features include closed eaves with moderate overhang, a cupola, and cupola vents. Alterations include replacement roofing materials and siding. There is a historic residence (8PA02832) to the east. Overall, the building has been altered, lacks sufficient architectural features, and is not a significant embodiment of a type, period, or method of construction. In addition, background research did not reveal any historic associations with significant persons and/or events. As a result, 8PA03803 does not appear eligible for listing in the NRHP, either individually or as part of a historic district.

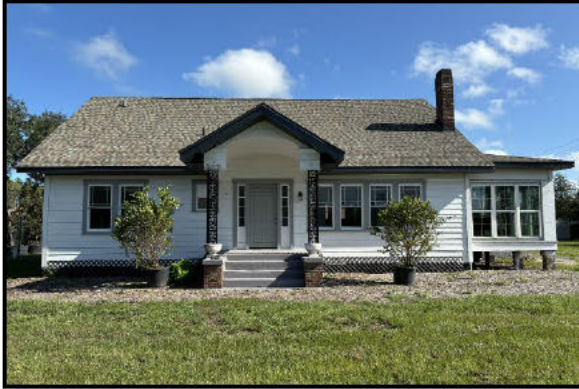
**Photo 5.22.** 2515 Hunt Road (8PA00303), looking north.

**8PA00303:** The Frame Vernacular style building at 2515 Hunt Road was constructed ca. 1935 (**Photo 5.22**). The resource is located within FPC E2 E1. The one-story, irregular plan building rests on a foundation of brick piers and has a wood frame structural system clad in weatherboard. The side gable roof and hip roof are covered with composition shingles, while the shed roof on the north elevation is covered in composition roll. There is a brick chimney on the gable end of the east elevation. The main entryway is on the south elevation through a single wood door with paneling flanked by two 4-pane sidelights within an open porch, accessed by four concrete steps with brick piers at the bottom topped with stone urns. The open porch is beneath a gabled portico and features two decorative metal

corner supports. There is an enclosed porch on the east elevation beneath a hip and gable roof. Visible windows include a mixture of individual, one-over-one wood single-hung sash units; individual and paired one-over-one vinyl single-hung sash units; paired and grouped (4) one-over-one wood single-hung sash units; and individual, paired, and grouped (4) four-over-four vinyl single-hung sash units. Distinguishing architectural features include overhanging eaves with boxed rafter tails, wood window and door trim, corner boards, gable vents, and latticework around the foundation. Alterations include the enclosure of the east elevation porch and the rafter tails, which were originally exposed, along with replacement windows, doors, and roofing materials. Overall, the building has been altered, lacks sufficient architectural features, and is not a significant embodiment of a type, period, or method of construction. In addition, background research did not reveal any historic associations with significant persons and/or events. As a result, 8PA00303 does not appear eligible for listing in the NRHP, either individually or as part of a historic district.

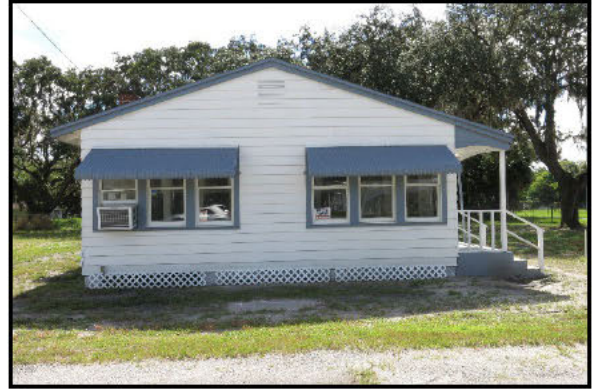
**Photo 5.23.** 2720 U.S. Highway 41 (8PA01499), looking east.

**8PA01499:** The Frame Vernacular style building at 2720 U.S. Highway 41 was constructed ca. 1916 (**Photo 5.23**). The one-story, irregular plan building rests on a foundation of brick piers and has a wood frame structural system clad in aluminum siding. The intersecting gable roof is covered with composition shingles. There is a brick chimney on the gable end of the north elevation. The main entryway is on the south elevation through a single vinyl door with paneling within an open porch beneath the principal roof that features wooden railings and two squared supports. There is an open porch on the north elevation beneath a metal awning with a wood deck and railing and an open porch on the east elevation beneath the principal roof with a wood railing and two squared supports. Visible windows include a mixture of individual and paired, four-stacked metal awning units; individual two-over-two metal single-hung sash units; and paired and grouped (3) one-over-one wood single-hung sash units. Distinguishing architectural features include overhanging eaves with boxed rafter tails, wood window and door trim, gable vents, metal awnings, and latticework around the foundation. Alterations include replacement windows, doors, siding, and roofing materials. There is a non-historic utility building to the east. Overall, the building has been altered, lacks sufficient architectural features, and is not a significant embodiment of a type, period, or method of construction. In addition, background research did not reveal any historic associations with significant persons and/or events. As a result, 8PA01499 does not appear eligible for listing in the NRHP, either individually or as part of a historic district.

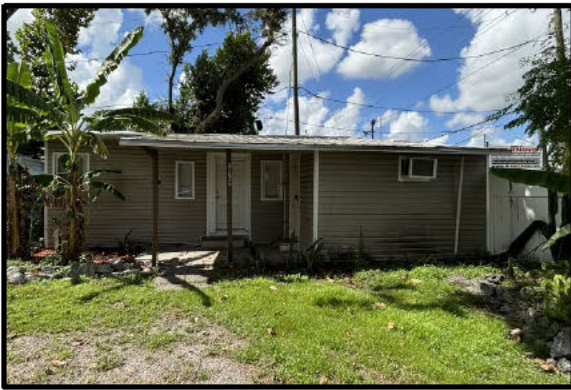
**Photo 5.24.** 2836 U.S. Highway 41 (8PA01501), looking south.

**8PA01501:** The Frame Vernacular style building at 2836 U.S. Highway 41 was constructed ca. 1935 (**Photo 5.24**). The one-story, irregular plan building rests on a foundation of concrete block piers and has a wood frame structural system clad in vinyl. The side gable roof and shed roof are covered with 5V crimp sheet metal. The main entryway is on the north elevation through a single vinyl door with paneling within an open porch beneath a shed roof with two squared wood supports. Visible windows include a mixture of individual, one-over-one metal single-hung sash units and individual, one-over-one vinyl single-hung sash units. Distinguishing architectural features include moderate overhang with both enclosed and exposed rafter tails, vinyl corner boards, and window and door trim. Alterations include replacement roofing materials, doors, and windows. Overall, the building has been altered, lacks sufficient architectural features, and is not a significant embodiment of a type, period, or method of construction. In addition, background research did not reveal any historic associations with significant persons and/or events. As a result, 8PA01501 does not appear eligible for listing in the NRHP, either individually or as part of a historic district.

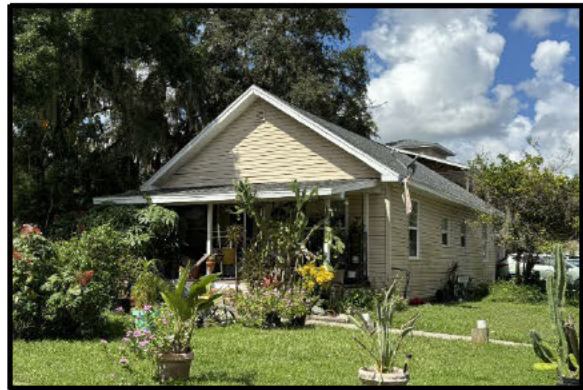
**Photo 5.25.** 21324-21326 Paoli Drive (8PA02832), looking southwest.

**8PA02832:** The Frame Vernacular style residence at 21324-21326 Paoli Drive was constructed ca. 1936 (**Photo 5.25**). The one-story, rectangular plan building rests on a continuous concrete block foundation and has a wood frame structural system clad in vinyl. The gable and shed roof are covered in composition shingles. There are two main entrances on the east elevation through single doors within a full-width open porch beneath a shed roof. Visible windows include individual, one-over-one, six-

over-six, and four-over-one vinyl single-hung sash units. Distinguishing architectural features include closed eaves, a moderate overhang, vinyl corner boards, and gable vents. Alterations include replacement roofing materials, siding, doors and windows. There is an historic building (8PA03803) to the west. Overall, the building has been altered, lacks sufficient architectural features, and is not a significant embodiment of a type, period, or method of construction. In addition, background research did not reveal any historic associations with significant persons and/or events. As a result, 8PA02832 does not appear eligible for listing in the NRHP, either individually or as part of a historic district.

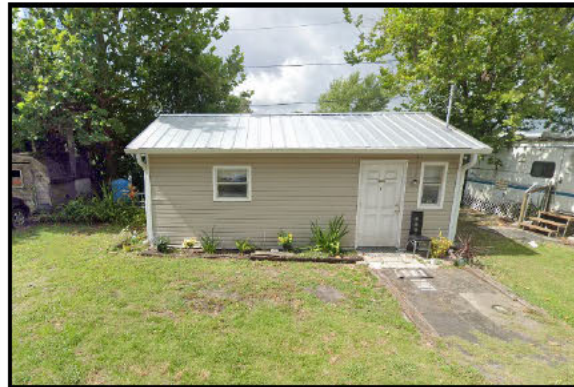
**Photo 5.26.** 21306 McKaig Lane (8PA03795), looking south.

**8PA03795:** The Frame Vernacular building at 21306 McKaig Lane was constructed ca. 1964 (**Photo 5.26**). The one-story, rectangular plan building rests on an obscured pier foundation and has a wood frame structural system clad in vinyl. The side gable roof is covered in 5V crimp sheet metal. The main entryway is on the north elevation through a single vinyl door with paneling. Visible windows include individual, one-over-one metal single-hung sash units. Distinguishing architectural features include no eave overhang and faux shutters. Alterations include replacement roofing materials, siding, and windows. Overall, the building has been altered, lacks sufficient architectural features, and is not a significant embodiment of a type, period, or method of construction. In addition, background research did not reveal any historic associations with significant persons and/or events. As a result, 8PA03795 does not appear eligible for listing in the NRHP, either individually or as part of a historic district.

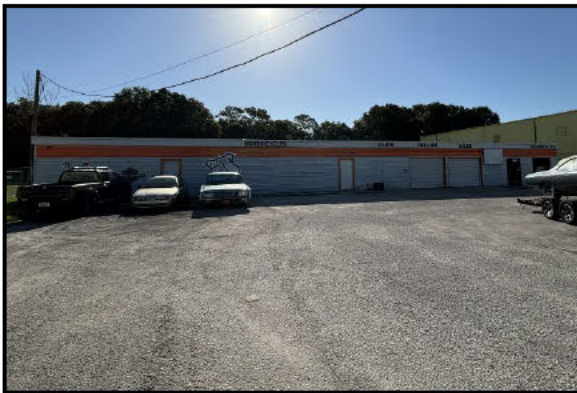
**Photo 5.27.** 1704 Land O' Lakes Boulevard (8PA03788), looking east.

**8PA03788:** The Industrial Vernacular style building at 1704 Land O' Lakes Boulevard was constructed ca. 1973 (**Photo 5.27**). The one-story, rectangular plan building rests on a concrete slab foundation and has a metal structural system clad in metal. The flat roof is sheathed in a built-up membrane. The main entrance is on the west elevation through a single metal full-view glass door with a full-length sidelight. Visible windows include individual, single pane metal fixed units. Distinguishing architectural features include no eave overhang and a parapet. Alterations include replacement roofing materials, windows, and doors. There is a non-historic building to the west and east. Overall, the building has been altered, lacks sufficient architectural features, and is not a significant embodiment of a type, period, or method of construction. In addition, background research did not

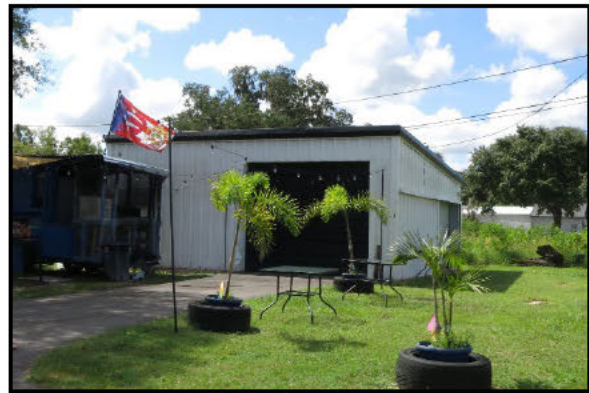
**Photo 5.28.** 21301 Coakley Lane (8PA03793), looking southeast.

**8PA03793:** The Industrial Vernacular style garage at 21301 Coakley Lane was constructed ca. 1973 (**Photo 5.28**). The one-story, square plan building rests on a concrete slab foundation and has a metal structural system clad in metal. The flat roof is covered in corrugated sheet metal. The main entryway is on the north elevation through a garage door. A secondary garage bay is located on the west elevation. There are no visible windows. Distinguishing architectural features include closed eaves with a slight overhang. Overall, the building has been altered, lacks sufficient architectural features, and is not a significant embodiment of a type, period, or method of construction. In addition, background research did not reveal any historic associations with significant persons and/or events. As a result, 8PA03793 does not appear eligible for listing in the NRHP, either individually or as part of a historic district.

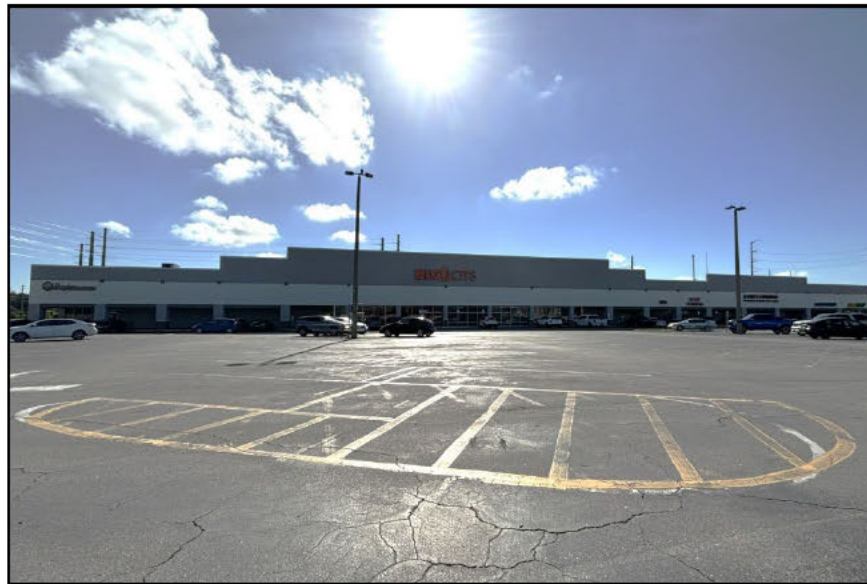
**Photo 5.29.** 2404 Land O' Lakes Boulevard (8PA03791), looking east.

One historic resource (8PA03791) within the APE is of the Commercial style and was constructed ca. 1974 (**Photo 5.29**). Commercial style buildings commonly consist of one or more units beneath a flat roof and parapet. Most entrances are through metal doors with full-view glass panels, fronted by a full-width open, entryways. Full-length, fixed pane windows with metal frames are most common, and exterior ornamentation is minimal.

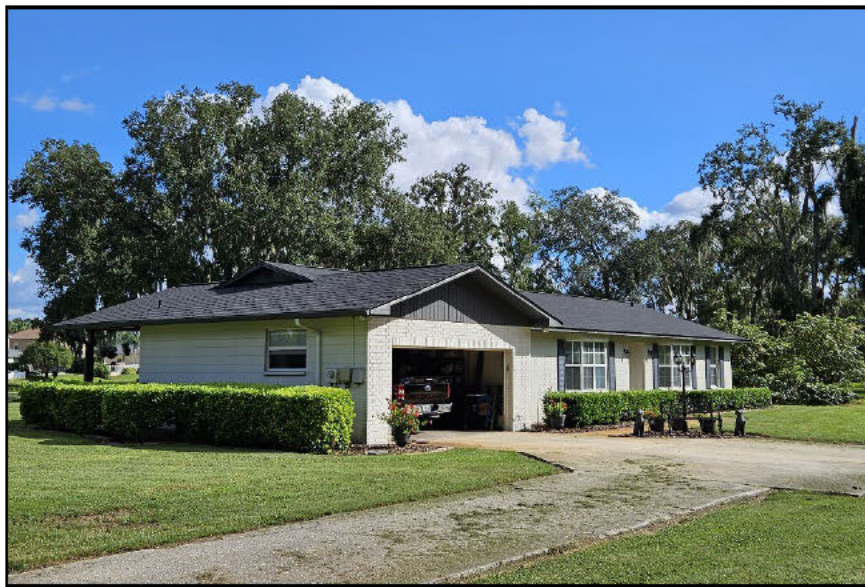
**Photo 5.30.** 20430 SR 54 (8PA03807), looking south.

One historic resource (8PA03807) within the APE is of the Ranch style and was constructed ca. 1974 (**Photos 5.30**). The style, which gained popularity after World War II, features low-slung buildings and a low-pitched roof with large windows (McAlester 2013). The Ranch style resource (8PA03807) within the APE is a single-family residence.

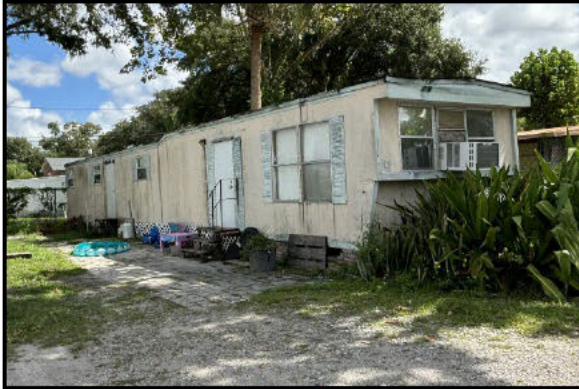
**Photo 5.31.** 21307 McKaig Lane (8PA03796), looking northeast.

**8PA03796:** The mobile home with no style at 21307 McKaig Lane was constructed ca. 1970 (**Photo 5.31**). The one-story, rectangular plan building rests on a brick pier foundation and has a wood frame structural system clad in aluminum. The side low-pitch gable roof is covered in 5V crimp sheet metal. The main entryway is on the west elevation through a single vinyl door. Visible windows include a mixture of individual and grouped (3), one-over-one metal single-hung sash units. Distinguishing architectural features include closed eaves with a moderate overhang, gable vents, vinyl window and door trim, and vinyl corner boards. Overall, the building has been altered, lacks sufficient architectural features, and is not a significant embodiment of a type, period, or method of construction. In addition, background research did not reveal any historic associations with significant persons and/or events. As a result, 8PA03796 does not appear eligible for listing in the NRHP, either individually or as part of a historic district.

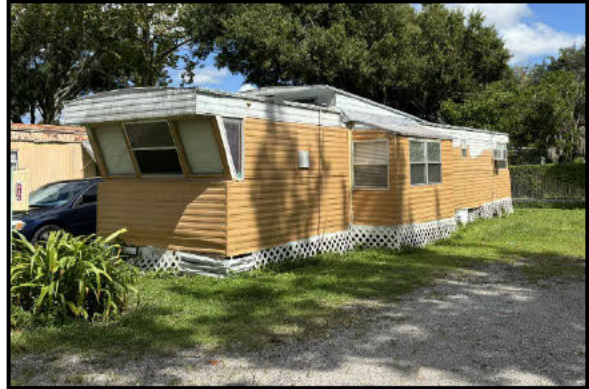
**Photo 5.32.** 21311 McKaig Lane (8PA03797), looking northwest.

**8PA03797:** The mobile home with no style at 21311 McKaig Lane was constructed ca. 1970 (**Photo 5.32**). The one-story, irregular plan building rests on a pier foundation obscured by metal and latticework and has a wood frame structural system clad in aluminum. The side low-pitch gable roof, shed roof, and shed dormer are covered in a built-up membrane. The main entryway is on the west elevation through a single vinyl door. Visible windows include a mixture of individual and paired, one-over-over metal single-hung sash units and individual and paired, single pane metal fixed units. Distinguishing architectural features include a slight eave overhang, cantilever, and latticework. Overall, the building has been altered, lacks sufficient architectural features, and is not a significant embodiment of a type, period, or method of construction. In addition, background research did not reveal any historic associations with significant persons and/or events. As a result, 8PA03797 does not appear eligible for listing in the NRHP, either individually or as part of a historic district.

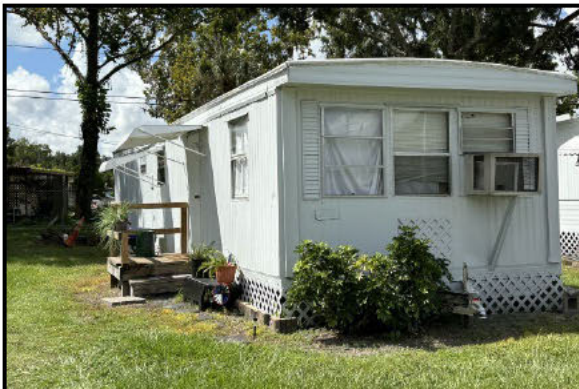
**Photo 5.33.** 21304 Rustic Lodge Lane (8PA03798), looking south.

**8PA03798:** The mobile home with no style at 21304 Rustic Lodge Lane was constructed ca. 1970 (**Photo 5.33**). The one-story, rectangular plan building rests on a pier foundation obscured by latticework and has a wood frame structural system clad in aluminum. The side low-pitch gable roof is covered in a built-up membrane. The main entryway is on the east elevation through a single vinyl door beneath a metal awning accessed by a wood deck. Visible windows include a mixture of individual, one-over-over metal single-hung sash units, one of which is flanked by two three-stacked metal triple-hung sash units. Distinguishing architectural features include a slight eave overhang, metal awnings, aluminum pilasters, faux shutters, and latticework. Alterations include replacement roofing materials and windows. Overall, the building has been altered, lacks sufficient architectural features, and is not a significant embodiment of a type, period, or method of construction. In addition, background research did not reveal any historic associations with significant persons and/or events. As a result, 8PA03798 does not appear eligible for listing in the NRHP, either individually or as part of a historic district. It is a contributing resource to the Whipple's Rustic Lodge Mobile Home Park resource group (8PA02829).

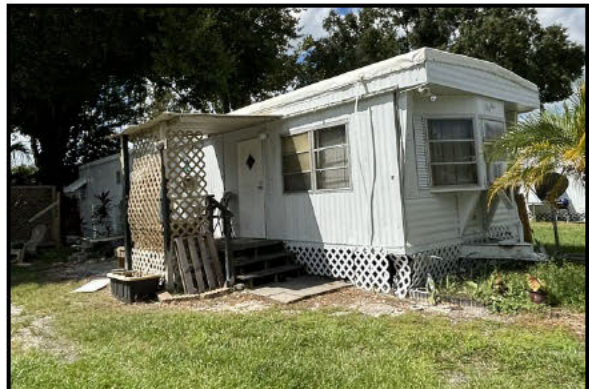
**Photo 5.34.** 21306 Rustic Lodge Lane (8PA03799), looking southwest.

**8PA03799:** The mobile home with no style at 21306 Rustic Lodge Lane was constructed ca. 1973 (**Photo 5.34**). The one-story, irregular plan building rests on a pier foundation obscured by latticework and has a wood frame structural system clad in aluminum. The side low-pitch gable roof is covered in a built-up membrane and the flat porch roof is covered in corrugated sheet metal. The main entryway is on the east elevation through a single vinyl door with an inset diamond-shaped light within an open porch beneath a flat roof, which was added in the early 2000s and features two squared wood supports and a wood deck. Visible windows include a mixture of paired, one-over-one-over-one metal triple-hung sash units and a bay window comprised of grouped (3), three-stacked metal triple-hung sash units. Distinguishing architectural features include a slight eave overhang, metal awnings, faux shutters, and latticework. Alterations include replacement roofing materials. Overall, the building has been altered, lacks sufficient architectural features, and is not a significant embodiment of a type, period, or method of construction. In addition, background research did not reveal any historic associations with significant persons and/or events. As a result, 8PA03799 does not appear eligible for listing in the NRHP, either individually or as part of a historic district. It is a contributing resource to the Whipple's Rustic Lodge Mobile Home Park resource group (8PA02829).

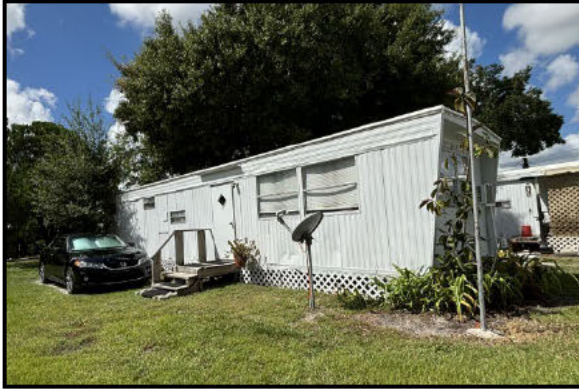
**Photo 5.35.** 21308 Rustic Lodge Lane (8PA03800), looking southwest.

**8PA03800:** The mobile home with no style at 21308 Rustic Lodge Lane was constructed ca. 1970 (**Photo 5.35**). The one-story, irregular plan building rests on a pier foundation obscured by latticework and has a wood frame structural system clad in aluminum. The side low-pitch gable roof is covered in a built-up membrane. The main entryway is on the east elevation through a single vinyl door with an inset diamond-shaped light accessed by a wood deck. Visible windows include a mixture of individual and paired, one-over-one metal single-hung sash units. Distinguishing architectural features include a slight eave overhang and latticework. Alterations include replacement roofing materials. Overall, the building has been altered, lacks sufficient architectural features, and is not a significant

embodiment of a type, period, or method of construction. In addition, background research did not reveal any historic associations with significant persons and/or events. As a result, 8PA03800 does not appear eligible for listing in the NRHP, either individually or as part of a historic district. It is a contributing resource to the Whipple's Rustic Lodge Mobile Home Park resource group (8PA02829).

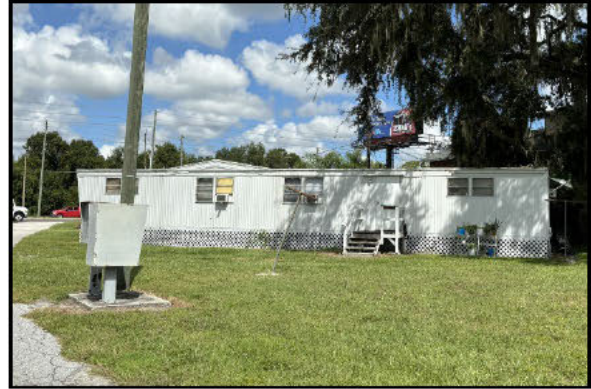
**Photo 5.36.** 21303 Rustic Lodge Lane (8PA03801), looking northeast.

**8PA03801:** The mobile home with no style at 21303 Rustic Lodge Lane was constructed ca. 1970 (**Photo 5.36**). The one-story, rectangular plan building rests on a pier foundation obscured by latticework and has a wood frame structural system clad in aluminum. The cross-gable roof is covered in a built-up membrane. The main entryway is on the south elevation through a single vinyl door accessed by a wood deck. There is an additional wood deck on the north elevation. Visible windows include a mixture of individual and paired, one-over-one metal single-hung sash units; paired, 3-stacked metal triple-hung sash units; and individual, single-pane metal fixed units. Distinguishing architectural features include a slight eave overhang, metal awnings, and latticework. Alterations include replacement roofing materials, windows, and doors. Overall, the building has been altered, lacks sufficient architectural features, and is not a significant embodiment of a type, period, or method of construction. In addition, background research did not reveal any historic associations with significant persons and/or events. As a result, 8PA03801 does not appear eligible for listing in the NRHP, either individually or as part of a historic district. It is a contributing resource to the Whipple's Rustic Lodge Mobile Home Park resource group (8PA02829).

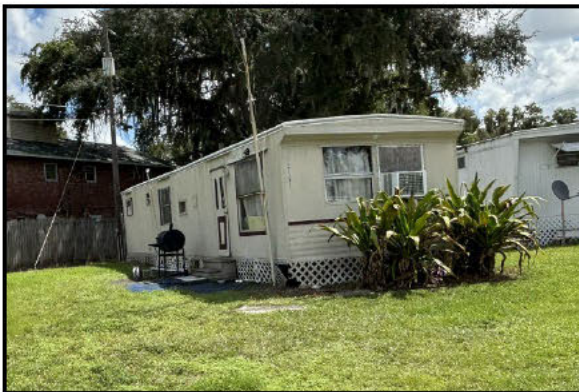
**Photo 5.37.** 21301 Rustic Lodge Lane (8PA03802), looking northeast.

**8PA03802:** The mobile home with no style at 21301 Rustic Lodge Lane was constructed ca. 1970 (**Photo 5.37**). The one-story, rectangular plan building rests on a pier foundation obscured by latticework and has a wood frame structural system clad in aluminum. The low-pitch gable roof is covered in a built-up membrane. The main entryway is on the west elevation through a single vinyl door with faux paneling. Visible windows include a mixture of individual and paired, one-over-one metal single-hung sash units and individual, single-pane metal fixed units. Distinguishing architectural features include a slight eave overhang and latticework. Alterations include replacement roofing materials. Overall, the building has been altered, lacks sufficient architectural features, and is not a significant embodiment of a type, period, or method of construction. In addition, background research did not reveal any historic associations with significant persons and/or events. As a result, 8PA03802 does not appear eligible for listing in the NRHP, either individually or as part of a historic district. It is a contributing resource to the Whipple's Rustic Lodge Mobile Home Park resource group (8PA02829).

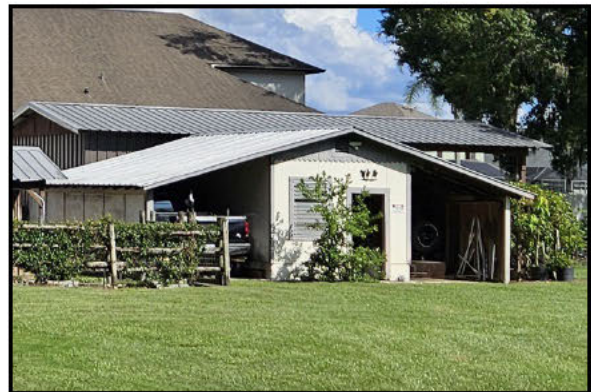
**Photo 5.38.** 20430 SR 54 (Outbuilding 1) (8PA03808), looking east.

**8PA03808:** The outbuilding with no style at 20430 SR 54 was constructed ca. 1974 (Outbuilding 1) (**Photo 5.38**). The one-story, rectangular plan building rests on a concrete slab foundation with a wood frame structural system clad in wood siding and plywood and the gable ends are clad in wood siding. The front gable roof is clad in 3V crimp sheet metal. The main entryway is on the west elevation through a single door opening. There are open air areas beneath the principal roof on the north and south elevations. Visible windows include an individual, 13-stacked metal jalousie unit. Distinguishing architectural features include overhanging eaves with exposed rafters, wood window and door trim, and gable vents. Alterations include replacement roofing materials. There is a historic residence to the west (8PA03807) and a historic outbuilding (8PA03809) to the north. Overall, the building has been altered, lacks sufficient architectural features, and is not a significant embodiment of a type, period, or method of construction. In addition, background research did not reveal any historic associations with significant persons and/or events. As a result, 8PA03808 does not appear eligible for listing in the NRHP, either individually or as part of a historic district.

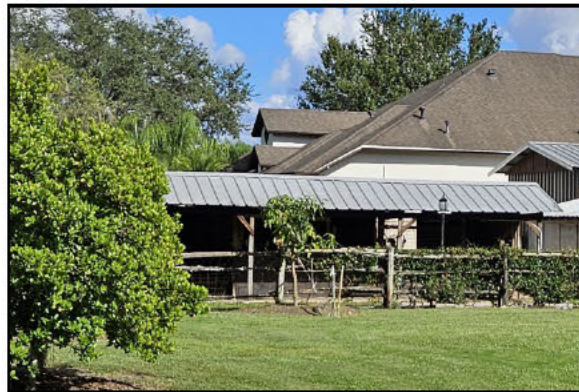
**Photo 5.39.** 20430 SR 54 (Outbuilding 2) (8PA03809), looking east.

**8PA03809:** The outbuilding with no style at 20430 SR 54 was constructed ca. 1974 (Outbuilding 2) (**Photo 5.39**). The one-story, rectangular plan building rests on a concrete slab foundation with a wood frame structural system clad in plywood. The side gable roof is clad in 3V crimp sheet metal. The main entryway is on the west elevation through an open-air entrance within an

open porch beneath the principal roof with four squared wood supports. There are no visible windows. Distinguishing architectural features include overhanging eaves with exposed rafters. Alterations include replacement roofing materials. There is a historic residence to the southwest (8PA03807) and a historic outbuilding (8PA03808) to the south. Overall, the building has been altered, lacks sufficient architectural features, and is not a significant embodiment of a type, period, or method of construction. In addition, background research did not reveal any historic associations with significant persons and/or events. As a result, 8PA03809 does not appear eligible for listing in the NRHP, either individually or as part of a historic district.

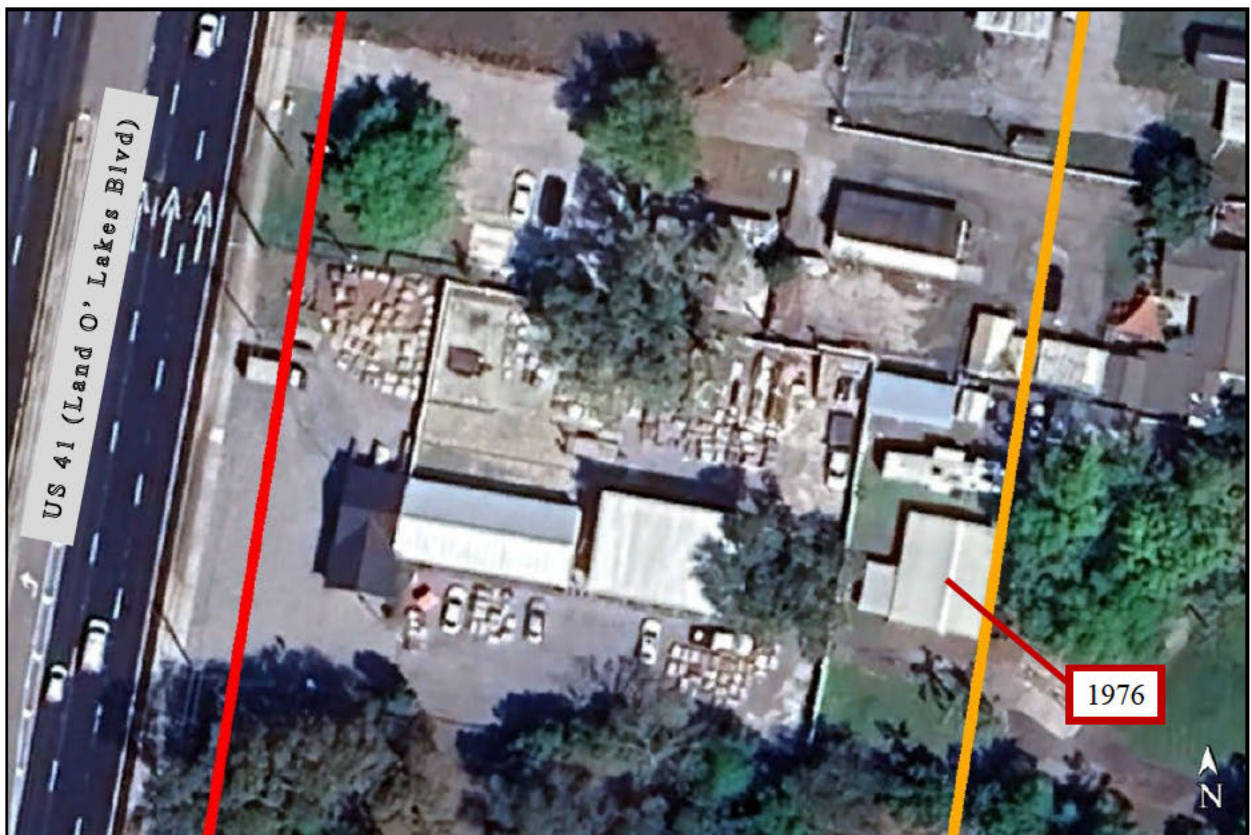
building located at 2736 Land O' Lakes Boulevard and a ca. 1950 Masonry Vernacular style building (8PA01489) located at 20826 SR 54. The ca. 1976 building at 2736 Land O' Lakes Boulevard is set back from the public ROW and positioned behind a large concrete privacy wall with a gated entrance (**Figure 5.5**). In addition to its location behind a concrete privacy wall, a commercial parcel is located between US 41 (Land O' Lakes Boulevard) and the 2736 Land O' Lakes Boulevard parcel. The ca. 1950 Masonry Vernacular style building (8PA01489) located at 20826 SR 54 is set back from the public ROW down a private drive and the building is heavily overgrown with surrounding vegetation (**Figure 5.6**). The resource is located immediately adjacent to unused Alternative Pond P1 E2; however, the resource and alternative pond site are located on two separate parcels. In addition, the heavy vegetation surrounding the building obscures the view of the resource from within the pond site. Based on available information, including the previous FMSF forms completed for 20826 SR 54 (8PA01489), these resources are probably typical examples of vernacular style buildings; however, because the resources are not visible or accessible from the ROW, the status and condition of the resources are unknown.

**Figure 5.5.** Inaccessible ca. 1976 building located at 24181 2736 Land O' Lakes Boulevard. The red boundary depicts the proposed ROW, and the orange boundary represents the APE.

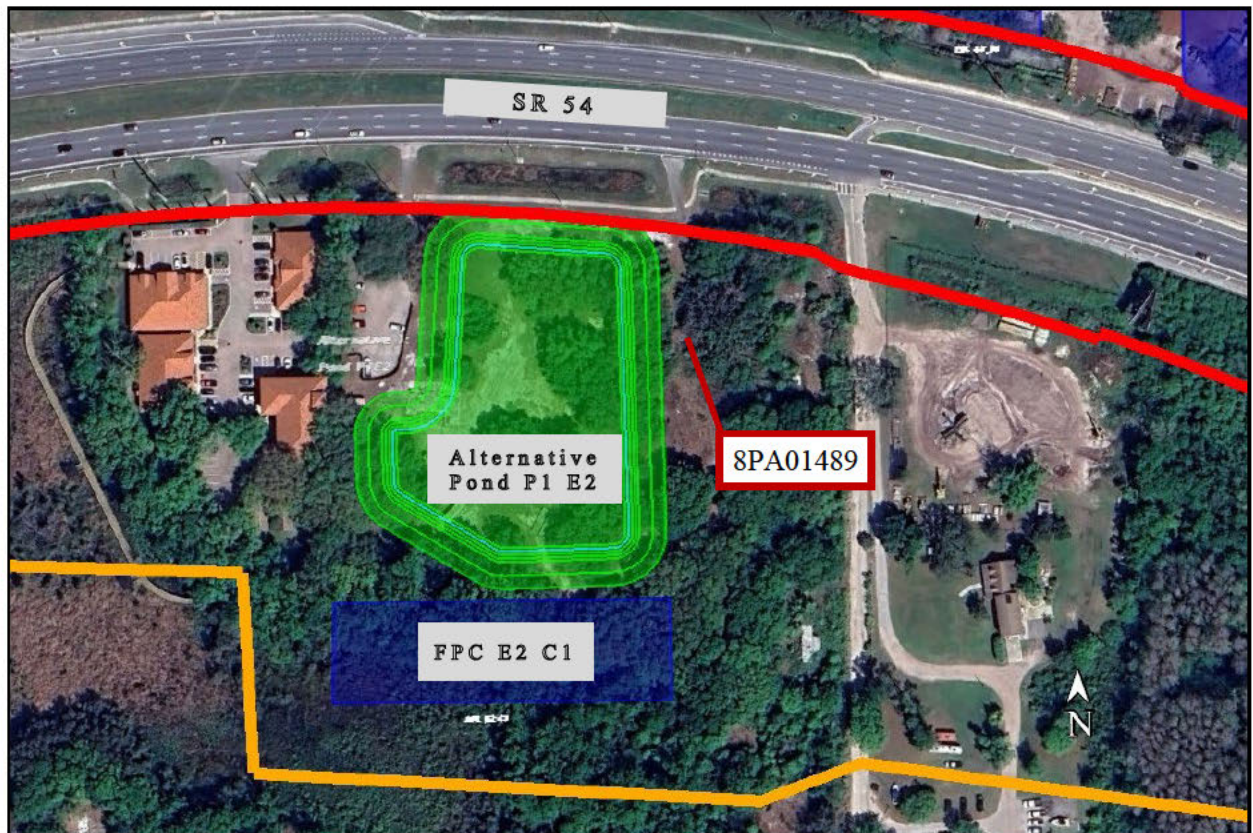
**Figure 5.6.** Inaccessible ca. 1950 building located at 20826 SR 54 (8PA01489). The red boundary depicts the proposed ROW, and the orange boundary represents the APE. Note location immediately adjacent to Alternative Pond P1 E2 (8PA01489 is located on a separate parcel).
