# **CULTURAL RESOURCE ASSESSMENT SURVEY**

## **US 41 (SR 45) AT SR 54 PROJECT DEVELOPMENT AND ENVIRONMENT (PD&E) STUDY, PASCO COUNTY, FLORIDA**

**Work Program Item Segment No.: 419182-1**

**December 2024**

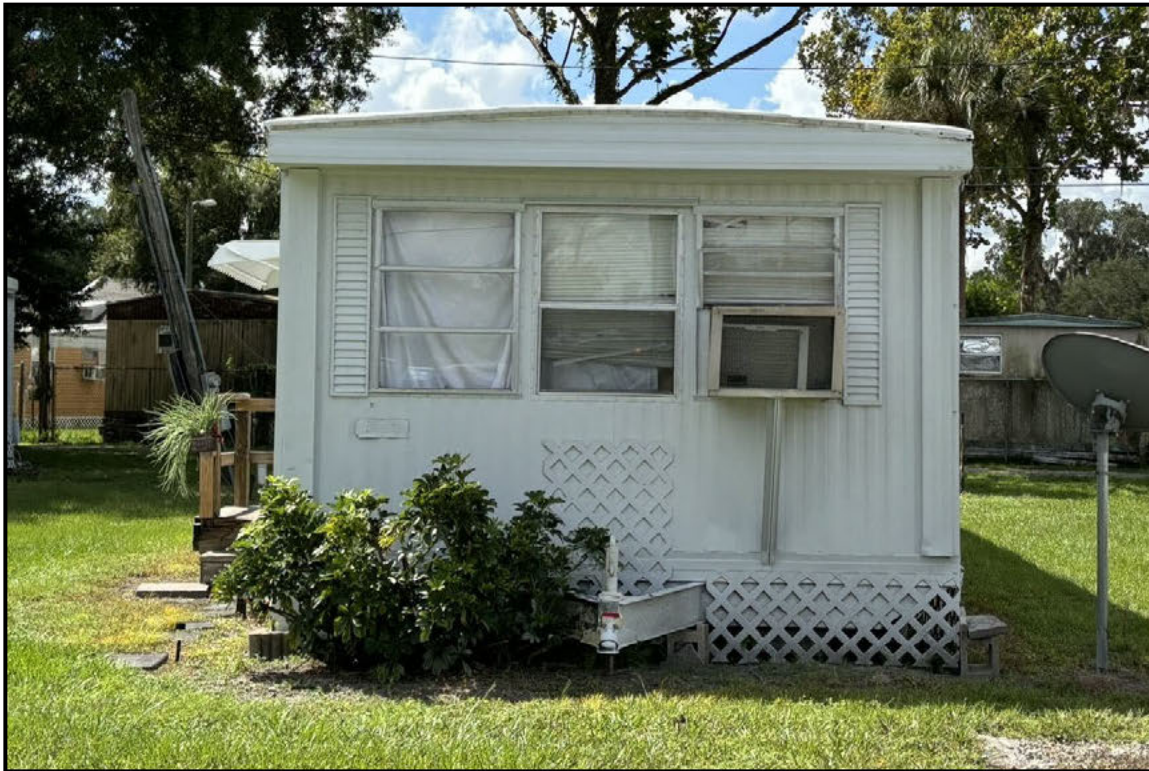
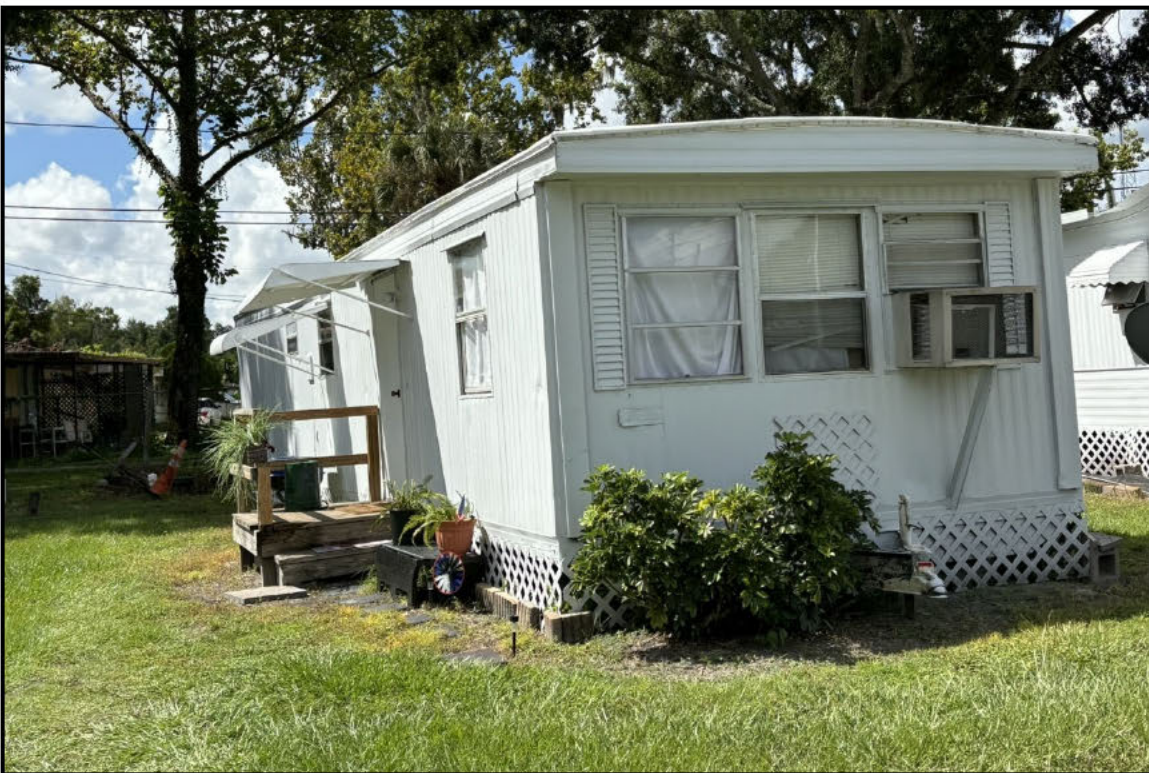
**PHOTOGRAPHS**

Chimney: No. \_\_\_\_\_ Chimney Material(s): 1. \_\_\_\_\_ 2. \_\_\_\_\_  
 Structural System(s): 1. Wood frame 2. \_\_\_\_\_ 3. \_\_\_\_\_  
 Foundation Type(s): 1. Piers 2. \_\_\_\_\_  
 Foundation Material(s): 1. Obscured 2. \_\_\_\_\_

Condition (overall resource condition): ☐ excellent ☐ good ☒ fair ☐ deteriorated ☐ ruinous

The building is not a significant embodiment of a type, period, or method of construction; and has no known significant historic associations. It is a contributing resource to Whipple's Rustic Lodge MHP (8PA02829).

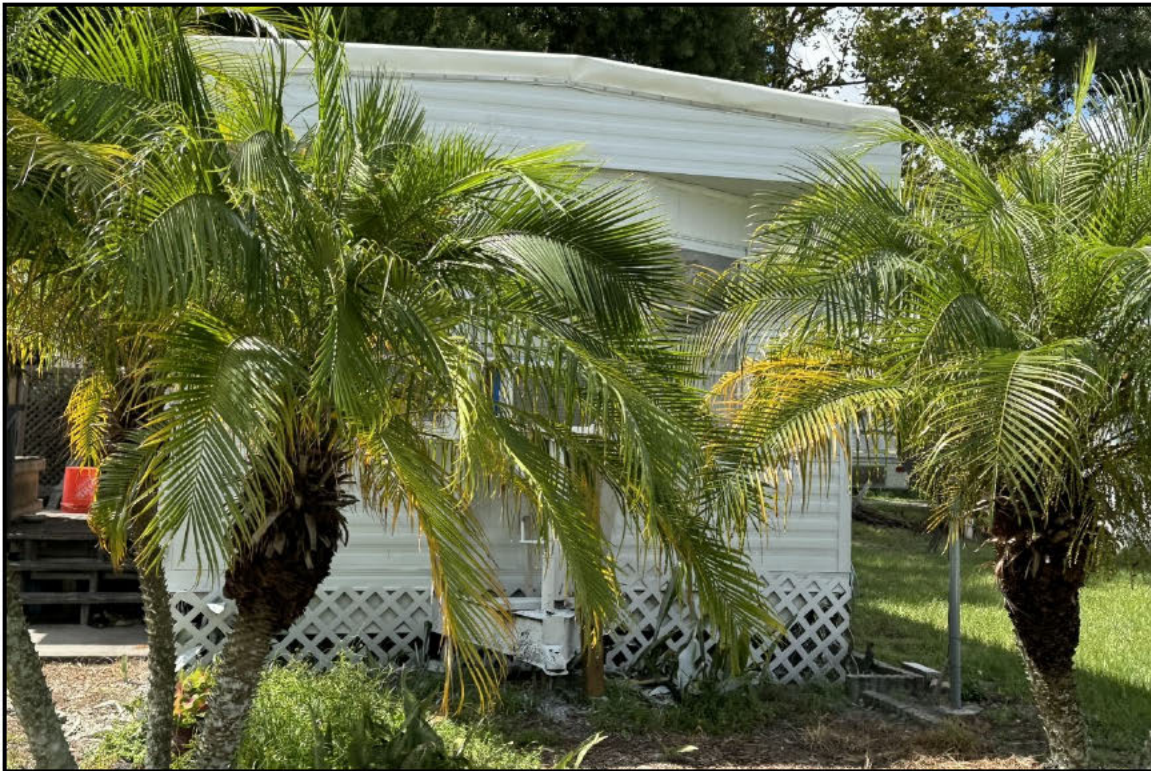
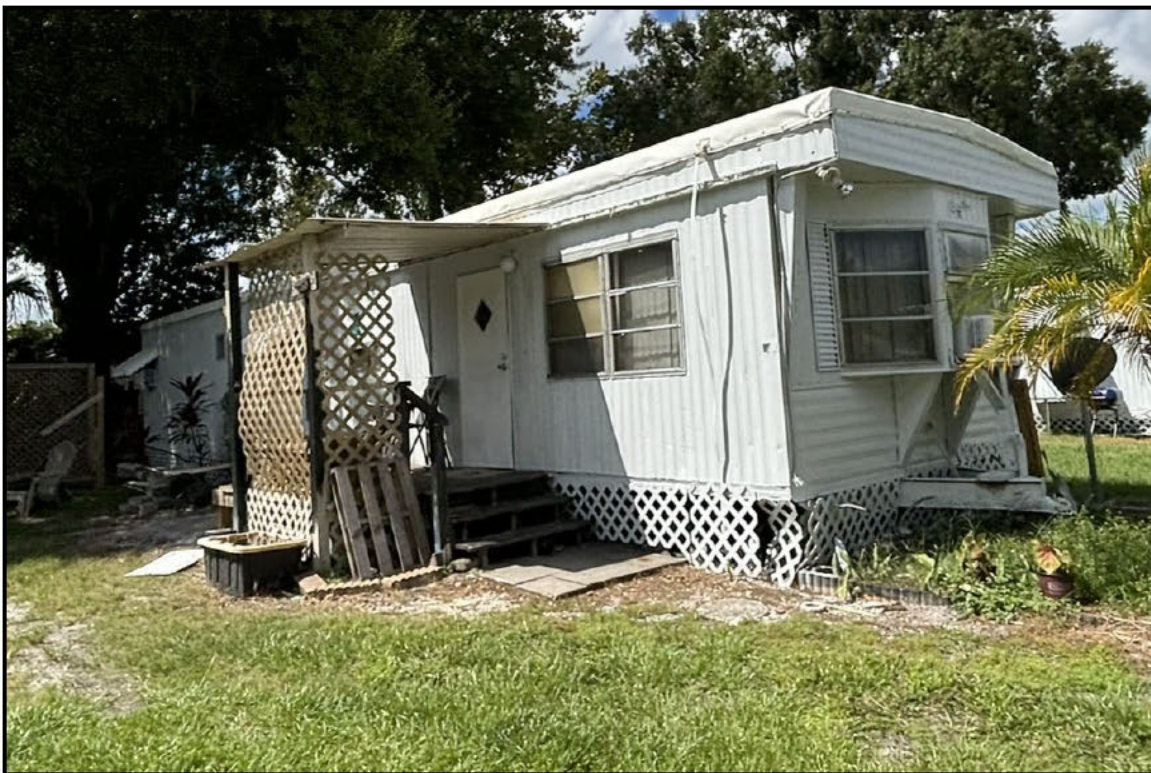
**PHOTOGRAPHS**

Chimney: No. \_\_\_\_\_ Chimney Material(s): 1. \_\_\_\_\_ 2. \_\_\_\_\_ 3. \_\_\_\_\_  
 Structural System(s): 1. Wood frame 2. \_\_\_\_\_ 3. \_\_\_\_\_  
 Foundation Type(s): 1. Piers 2. \_\_\_\_\_  
 Foundation Material(s): 1. Obscured 2. \_\_\_\_\_

Condition (overall resource condition): ☐ excellent ☐ good ☒ fair ☐ deteriorated ☐ ruinous

The building is not a significant embodiment of a type, period, or method of construction; and has no known significant historic associations. It is a contributing resource to Whipple's Rustic Lodge MHP (8PA03800).

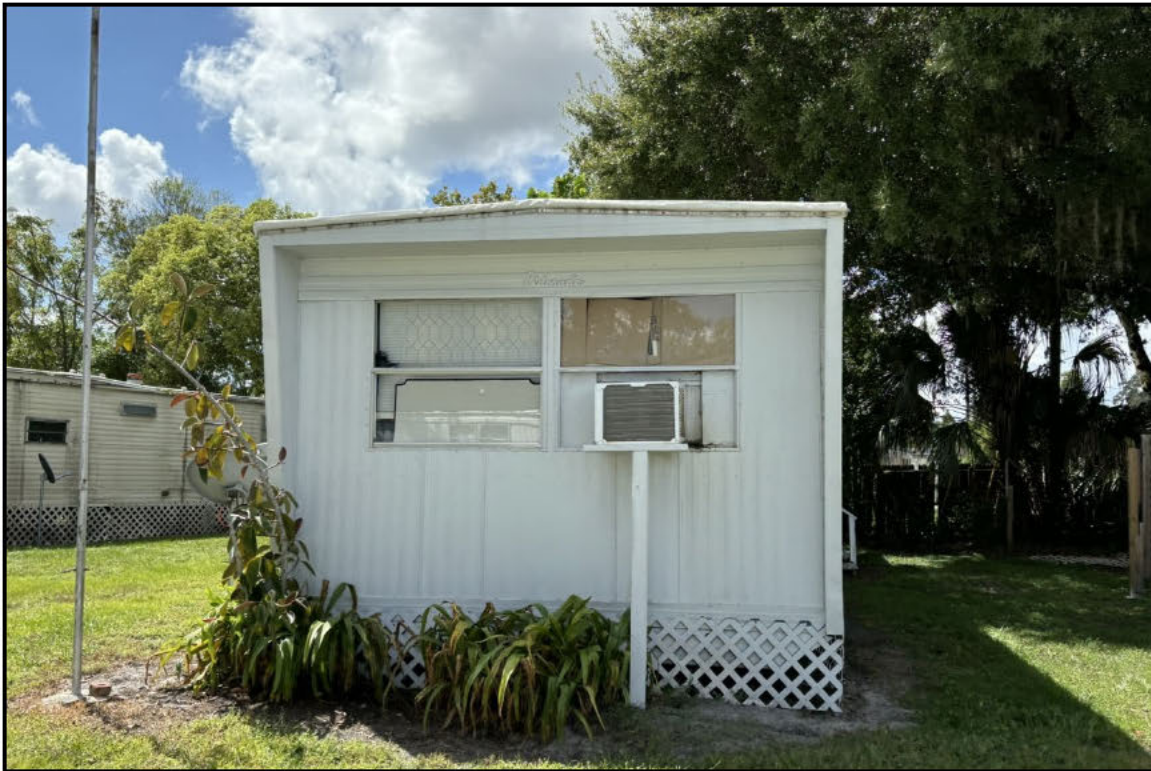
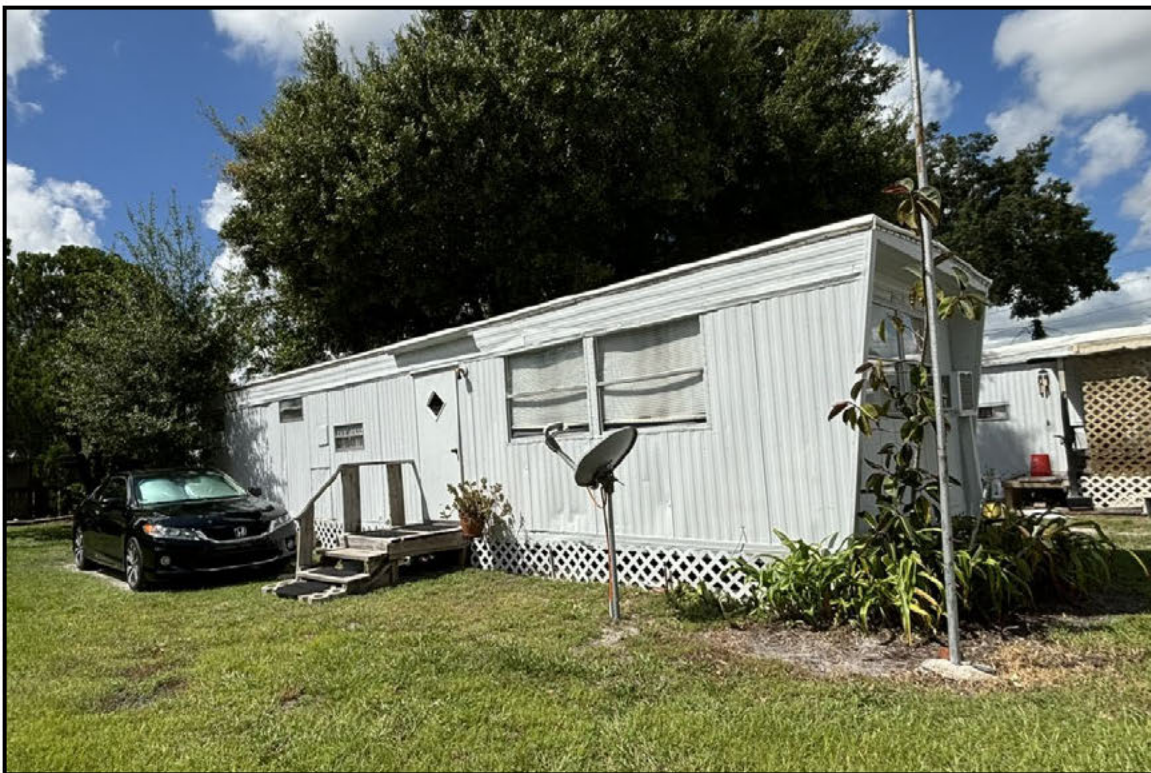
**PHOTOGRAPHS**

Chimney: No. \_\_\_\_\_ Chimney Material(s): 1. \_\_\_\_\_ 2. \_\_\_\_\_  
 Structural System(s): 1. Wood frame 2. \_\_\_\_\_ 3. \_\_\_\_\_  
 Foundation Type(s): 1. Piers 2. \_\_\_\_\_  
 Foundation Material(s): 1. Obscured 2. \_\_\_\_\_

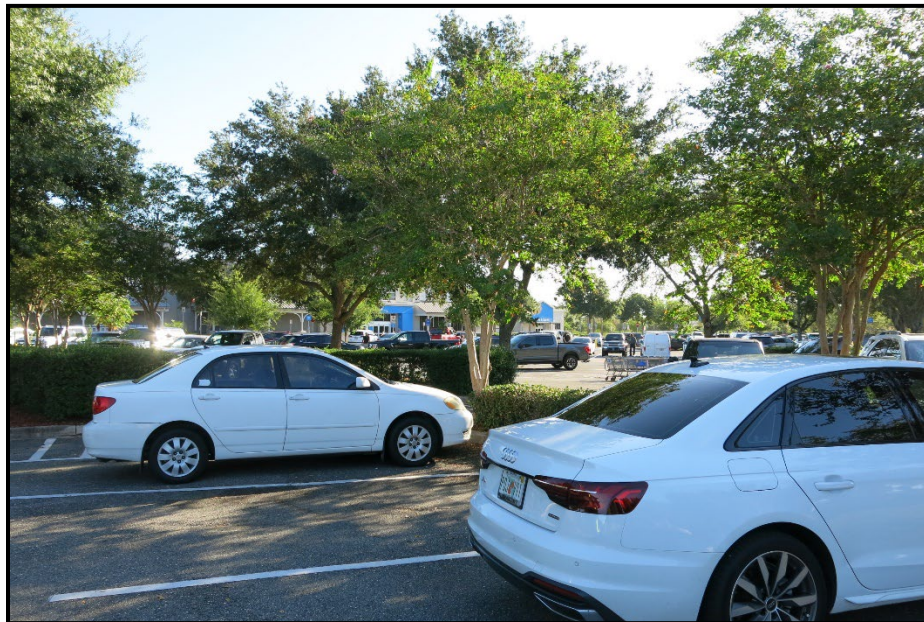
**Photo 1.** Looking northeast from the Walmart parking lot (constructed ca. 2009) at the former location of 1525 U.S. Highway 41 (8PA01474).

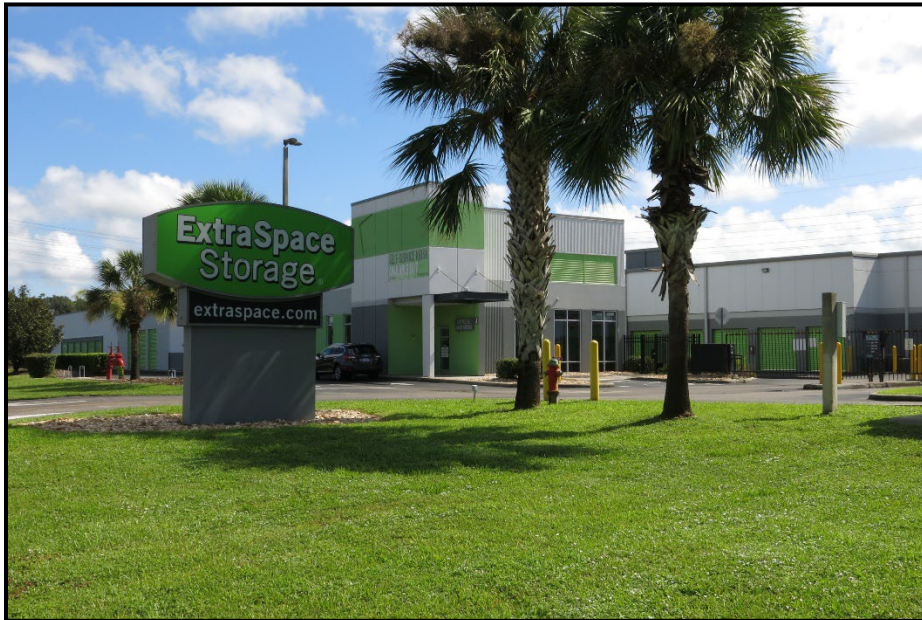
**Photo 2.** Looking northeast at Extra Space Storage (constructed ca. 2009) at the former location of 2530 U.S. Highway 41 (8PA01497).
