Beckett Bridge

Project Development & Environment (PD&E) Study

January 2016

Preliminary Engineering Report Volume 2: Appendices

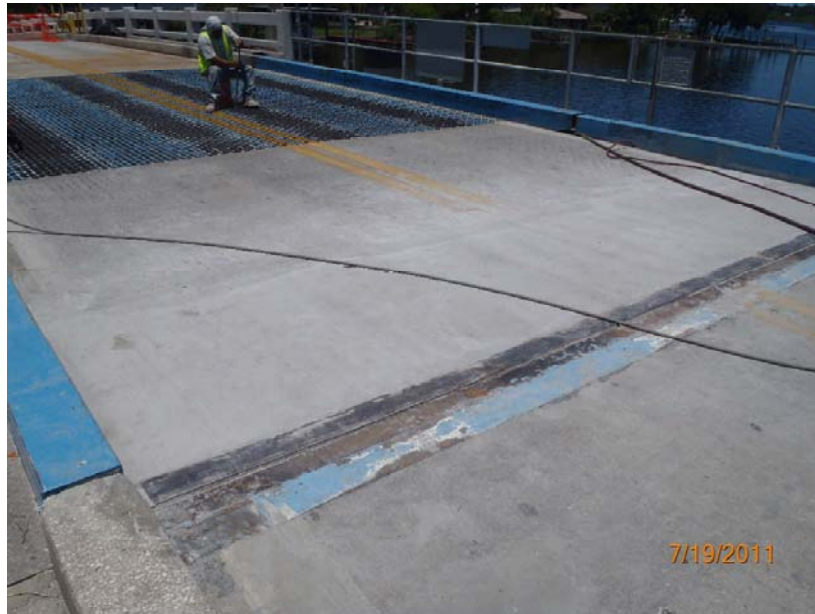
CS3: There are several exposed grate bars with moderate to heavy surface corrosion within 2 ft. of the open grid. Refer to Photo 5. REPAIR

PHOTO 5: 29/4 Steel Deck/Conc Grid

There are several exposed grate bars with moderate to heavy surface corrosion within 2 ft. of the open grid.

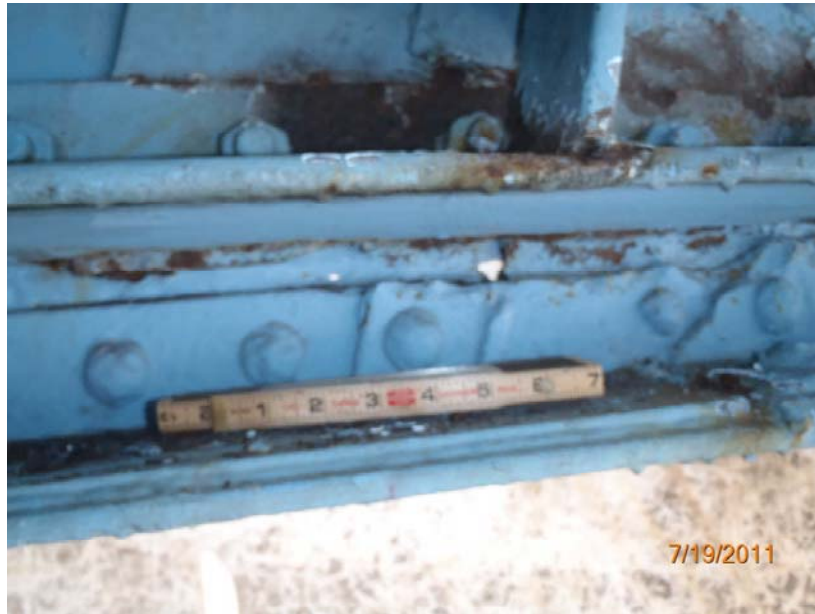
CS2: The top flanges, lower portions of the webs and bottom flanges exhibit painted over pitting with corrosion holes up to 1/4 in. diameter near the curve tracks – INCREASE. Refer to Photo 7. REPAIR.

PHOTO 7: 107/4 Paint Stl Opn Girder

The top flanges, lower portions of the webs and bottom flanges exhibit painted over pitting with corrosion holes up to 1/4 in. diameter near the curve tracks.

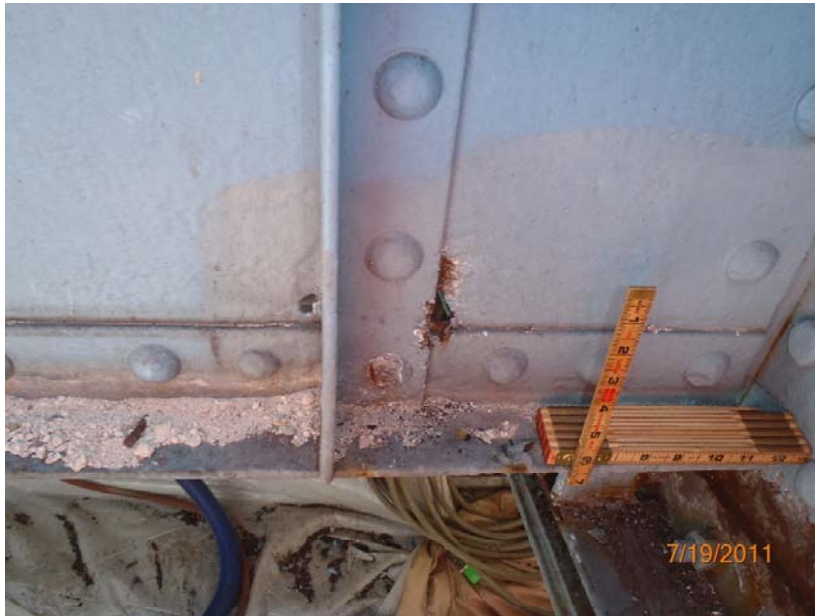
CS4: Floor Beam 6-3 exhibits three small corrosion holes up to 3/4 in. in the lower portion of the web at the two southernmost vertical stiffeners and painted over pitting up to 1/4 in. deep throughout the remainder of the floor beam. Refer to Photo 10. REPAIR.

PHOTO 10: 152/4 Paint Stl Floor Beam

Floor Beam 6-3 exhibits three small corrosion holes up to 3/4 in. in the lower portion of the web at the two southernmost vertical stiffeners and painted over pitting up to 1/4 in. deep throughout the remainder of the floor beam.

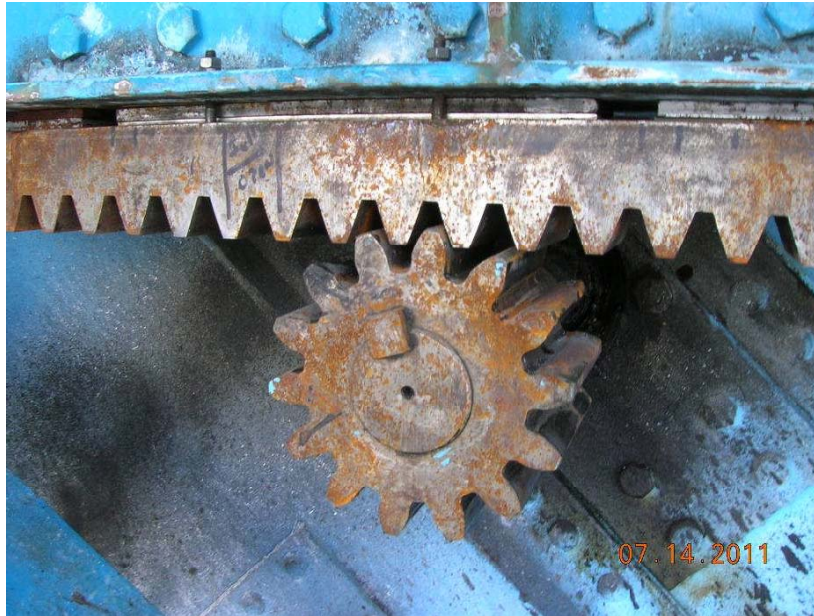
The teeth of the north rack pinion gear sets exhibits erratic contact due to the bent pinion shaft (See Elm. 542 Shafts). Refer to Photo 11.

The racks and pinions are forming corrosion on unpainted surfaces. Refer to Photo 11. REPAIR.

CS3: The north pinion shaft (S-5N) is noticeably bent causing erratic tooth contact throughout operation – NEW. Refer to Photo 11. REPAIR.

PHOTO 11: 540/4 Open Gearing & 542/4 Shafts

Poor engagement of north pinion (P-5N) with rack due to bent shaft. Corrosion forming on all unpainted areas for all rack and pinion assemblies.

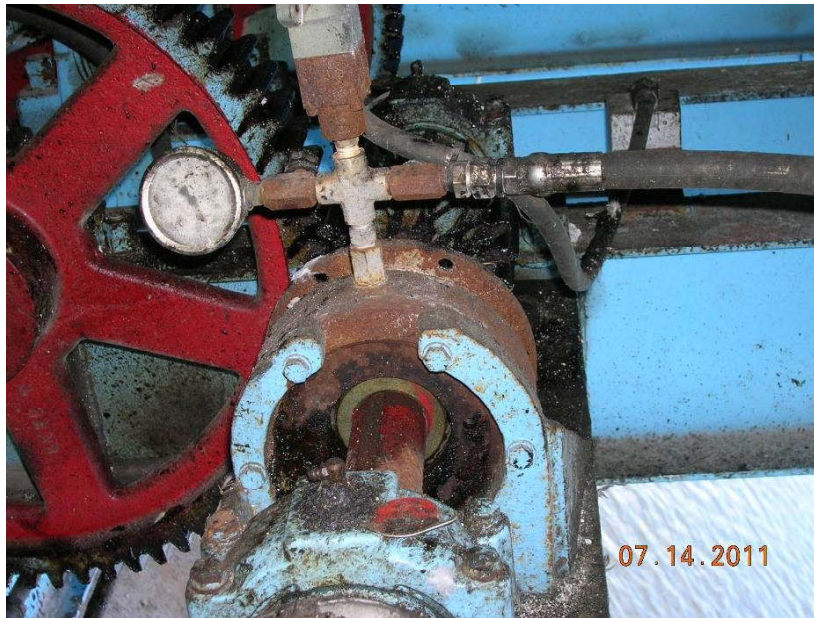
CS3: The motor brake (brake 1) is not grabbing when set. The shaft that the brake is on can be moved within the backlash of the gear sets up to the machinery brake (brake 2). The motor brake was also not releasing, intermittently. Refer to Element 548 for additional comments regarding this deficiency. Refer to Photo 12. REPAIR.

CS2: The motor brake was not releasing intermittently, there was no pressure shown on the gauge when the brake was not releasing, indicating a problem with the valve since the emergency brake (brake 2) is on the same pressure line and was releasing. Refer to Photo 12. REPAIR.

PHOTO 12: 544/4 Brakes & 548/4 Hydraulic Piping Sys

Motor brake (brake 1) does not hold and does not release, intermittently.

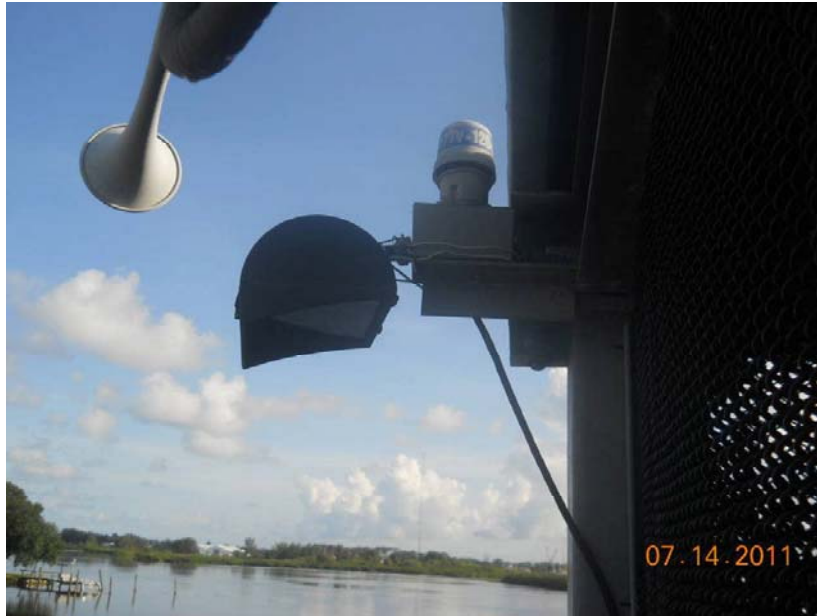
CS1: Waterway flood light is improperly fastened with electrical wire. Refer to Photo 14. REPAIR.

PHOTO 14: 563/4 Acc Ladd & Plat

Waterway floodlight held in place with electrical wire.

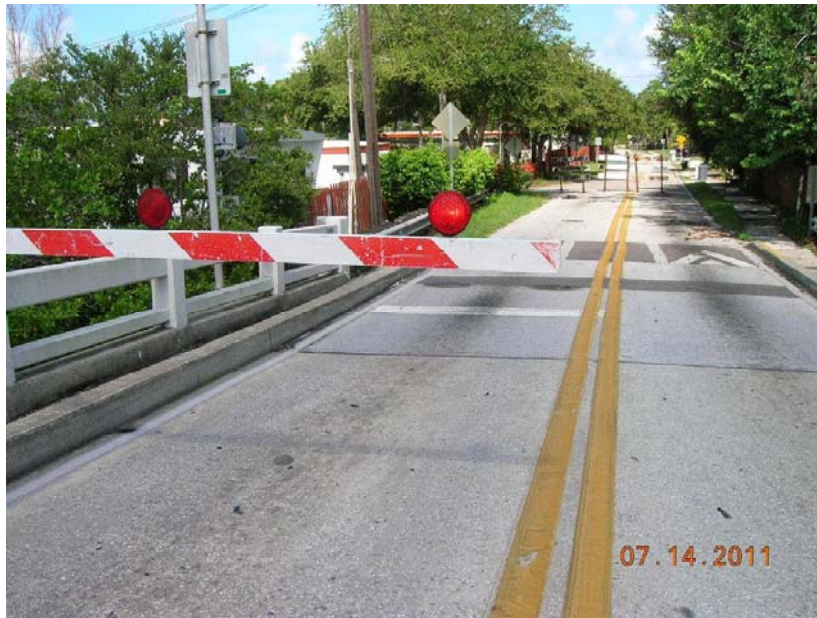
Paint is chipping off the red stripes on both on-coming gates. Refer to Photo 27. REPAIR.

The gate arm light on tip of the Far On-Coming gate is improperly secured. Refer to Photo 27. REPAIR.

PHOTO 27: 591/4 Warning Gates

The gate arm light on Far On-Coming gate is not secured properly. Chipping paint is typical for all gates.

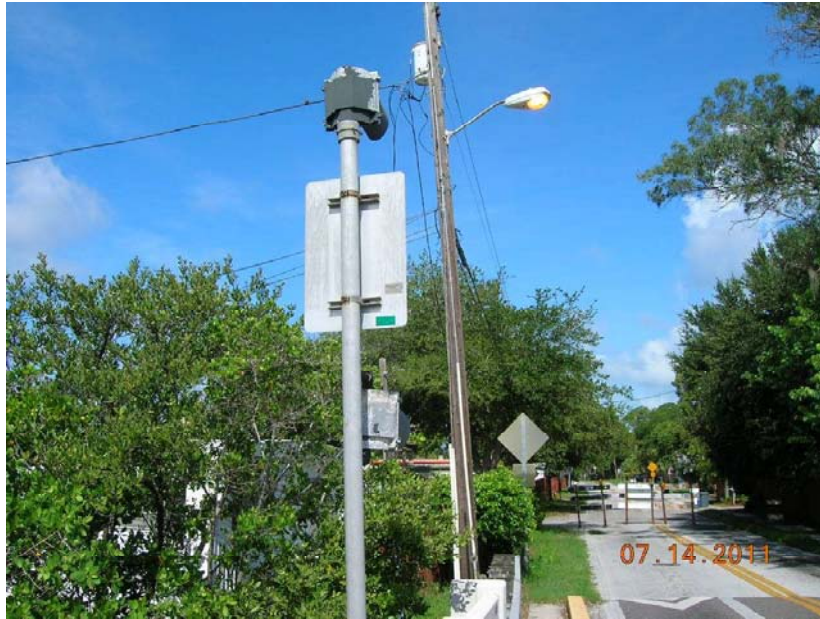
CS2: The paint is peeling off the signal heads of the traffic signals at both ends of the structure – INCREASE. Refer to Photo 30. REPAIR.

PHOTO 30: 592/4 Traffic Signals

Paint is peeling off the signal heads of the traffic signals at both ends of the structure.

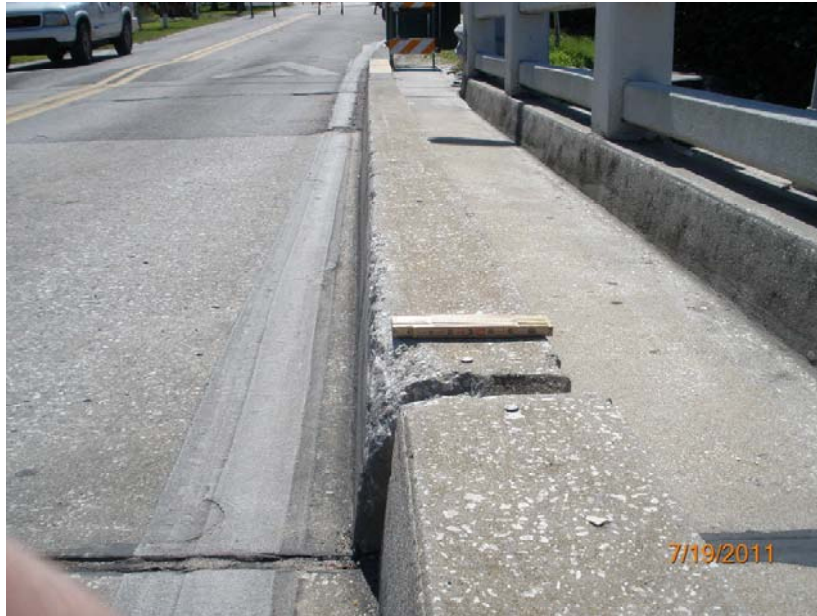
There are lateral misalignments of the approach spans up to 1-1/4 in. Refer to Table 1 in the Addendum for Deck Misalignment Measurements. Refer to Photo 31.

PHOTO 31: 12/4 Bare Concrete Deck

There are lateral misalignments of the approach spans up to 1-1/4 in.

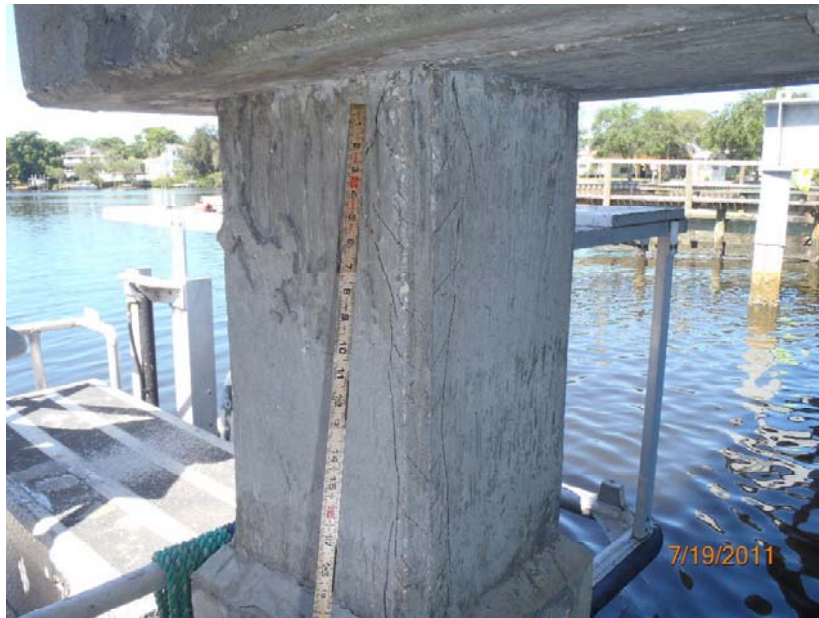
CS3: There is a 20 in. x 6 in. delamination in the NE edge above the jacket of Pile 8-5 - INCREASE. Refer to Photo 41. REPAIR.

PHOTO 41: 204/4 P/S Conc Column

There is a 20 in. x 6 in. delamination in the NE edge above the jacket of Pile 8-5.

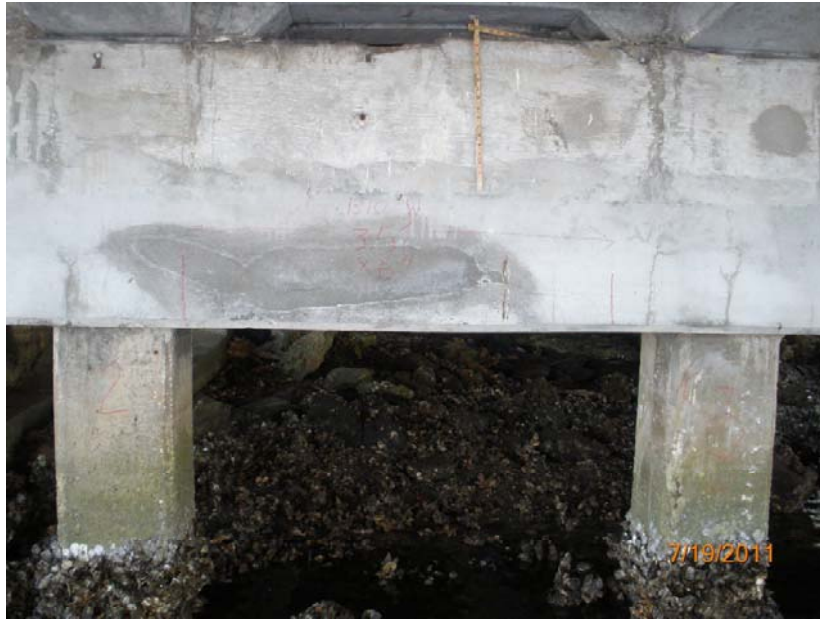
CS3: There are up to 3.5 ft. x 5 ft. delaminations in the bottom west edge of Bent Cap 10 between Piles 10-2 and 10-3 and Piles 10-4 and 10-5. Refer to Photo 45. REPAIR.

PHOTO 45: 234/4 R/Conc Cap

There are up to 3.5 ft. x 5 ft. delaminations in the bottom west edge of Bent Cap 10 between Piles 10-2 and 10-3 and Piles 10-4 and 10-5; delamination between Piles 10-2 and 10-3 shown.

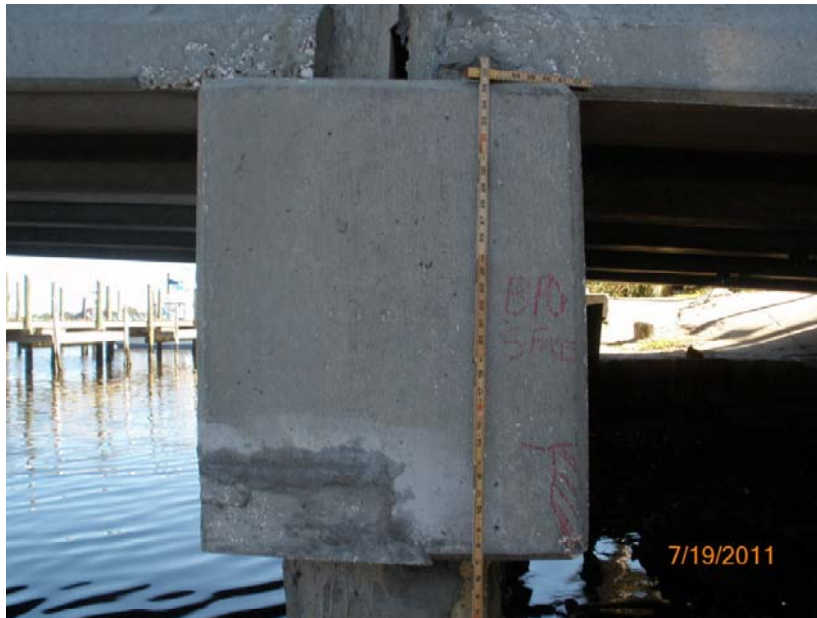
Bent Cap 10 exhibits a 4 in. x 7 in. delamination in the SE edge – NEW. Refer to Photo 46. REPAIR.

PHOTO 46: 234/4 R/Conc Cap

Bent Cap 10 exhibits a 4 in. x 7 in. delamination in the SE edge.

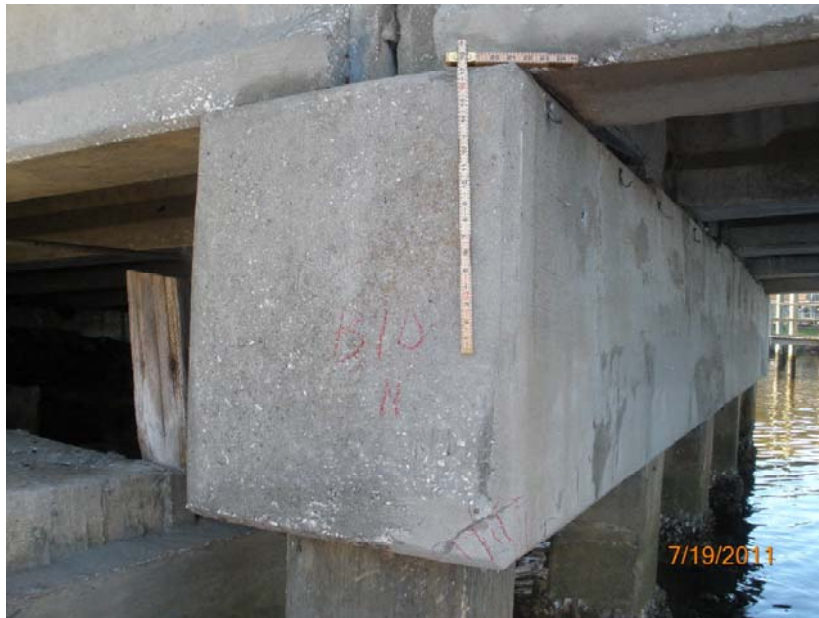
Bent Cap 10 exhibits a 4 in. x 10 in. delamination in the NW edge – NEW. Refer to Photo 47. REPAIR.

PHOTO 47: 234/4 R/Conc Cap

Bent Cap 10 exhibits a 4 in. x 10 in. delamination in the NW edge.

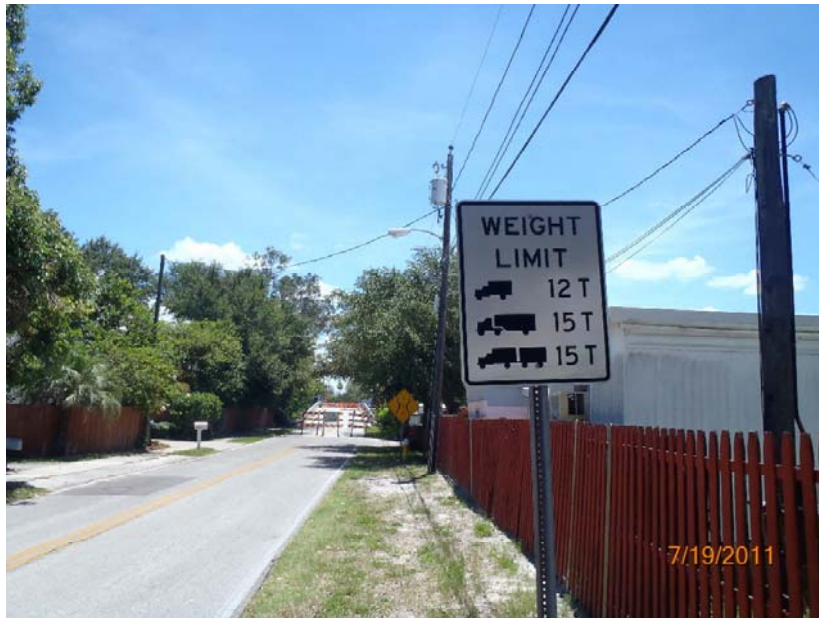
PHOTO 50: West Posting Sign

The bridge is posted. Refer to Photos 50 and 51 for the west and east posting signs respectively.

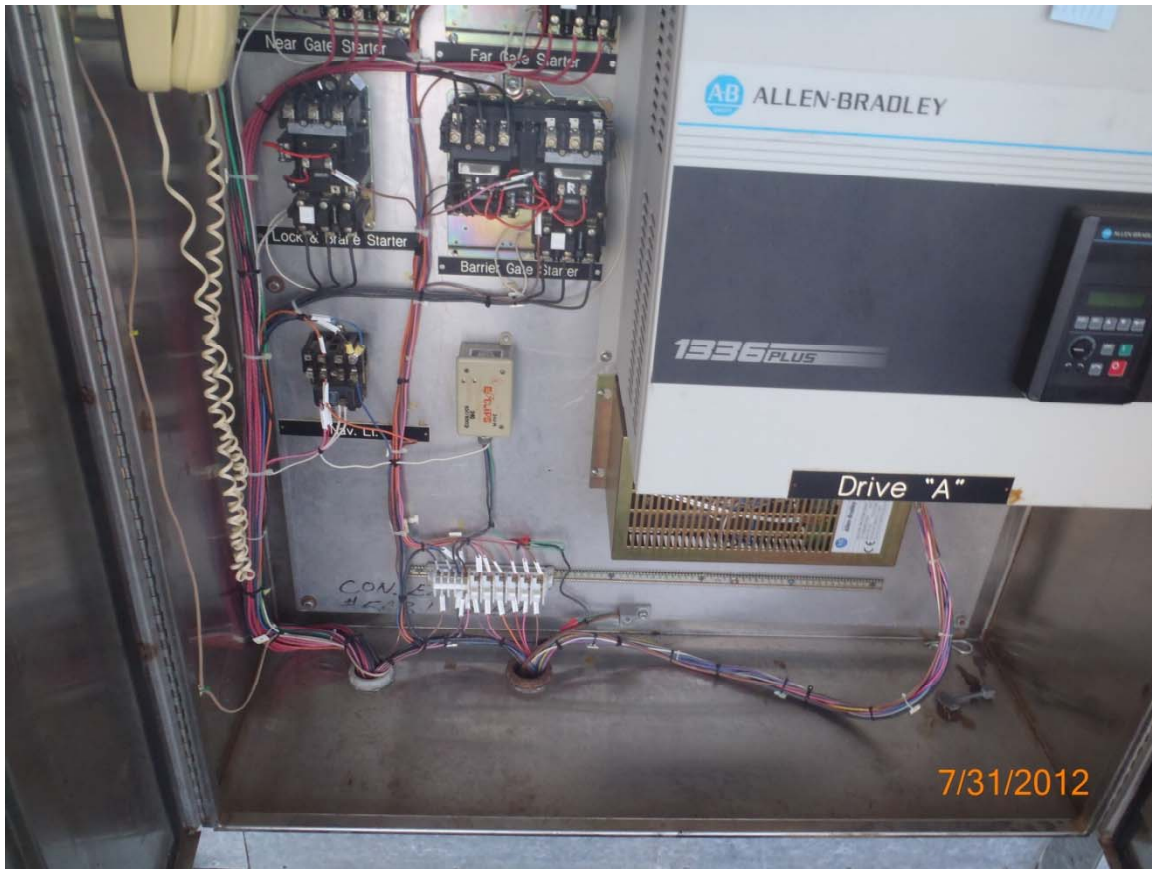
PHOTO 12: 580/4 - Navigational Lights

The UPS backup battery system for the navigational lights has been removed from the bridge. Refer to Photo 12. REPAIR

View of no UPS backup battery system for navigational lights.

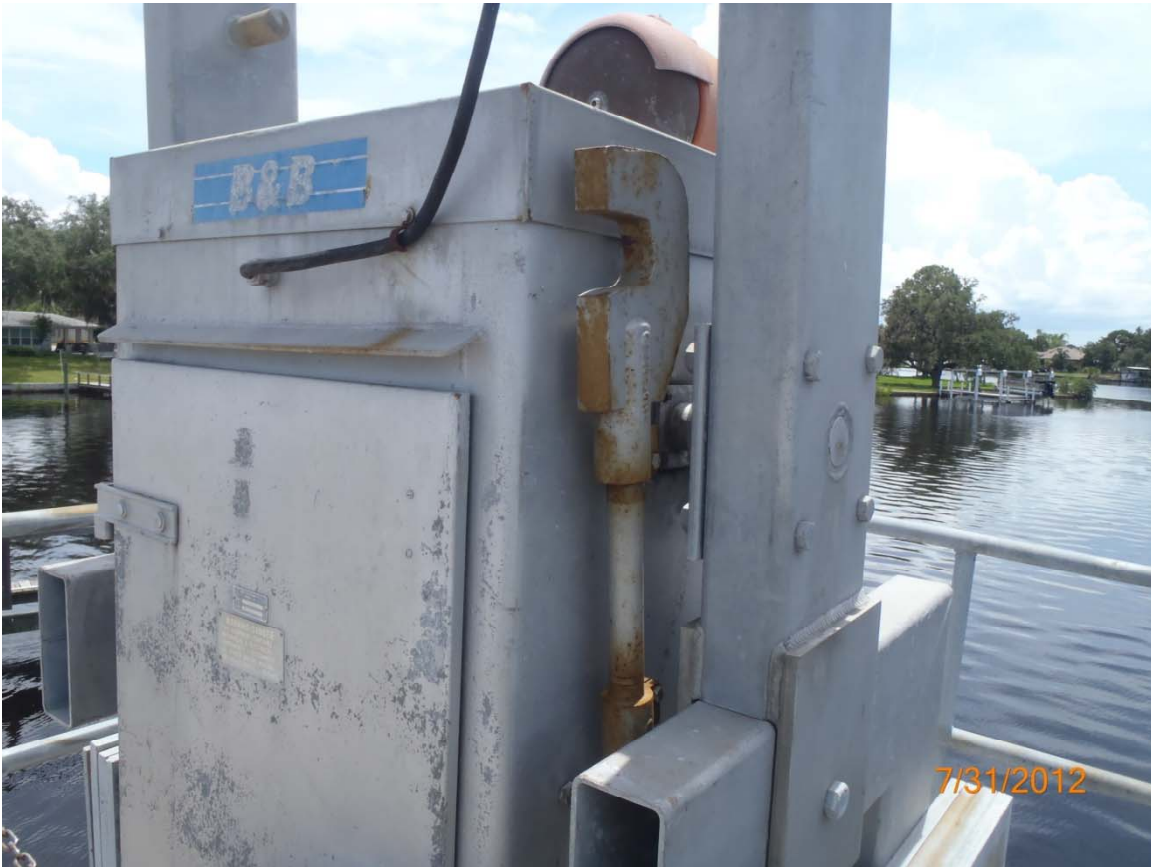
PHOTO 14: 590/4 – Resistance Barriers

CS1: Several components of the resistance barrier exhibit light to moderate surface corrosion - INCREASE. Refer to Photo 14.
REPAIR

Typical view of corrosion in resistance barrier.

CS1: Several components of the resistance barrier exhibit light to moderate surface corrosion - INCREASE. Refer to Photo 14. REPAIR

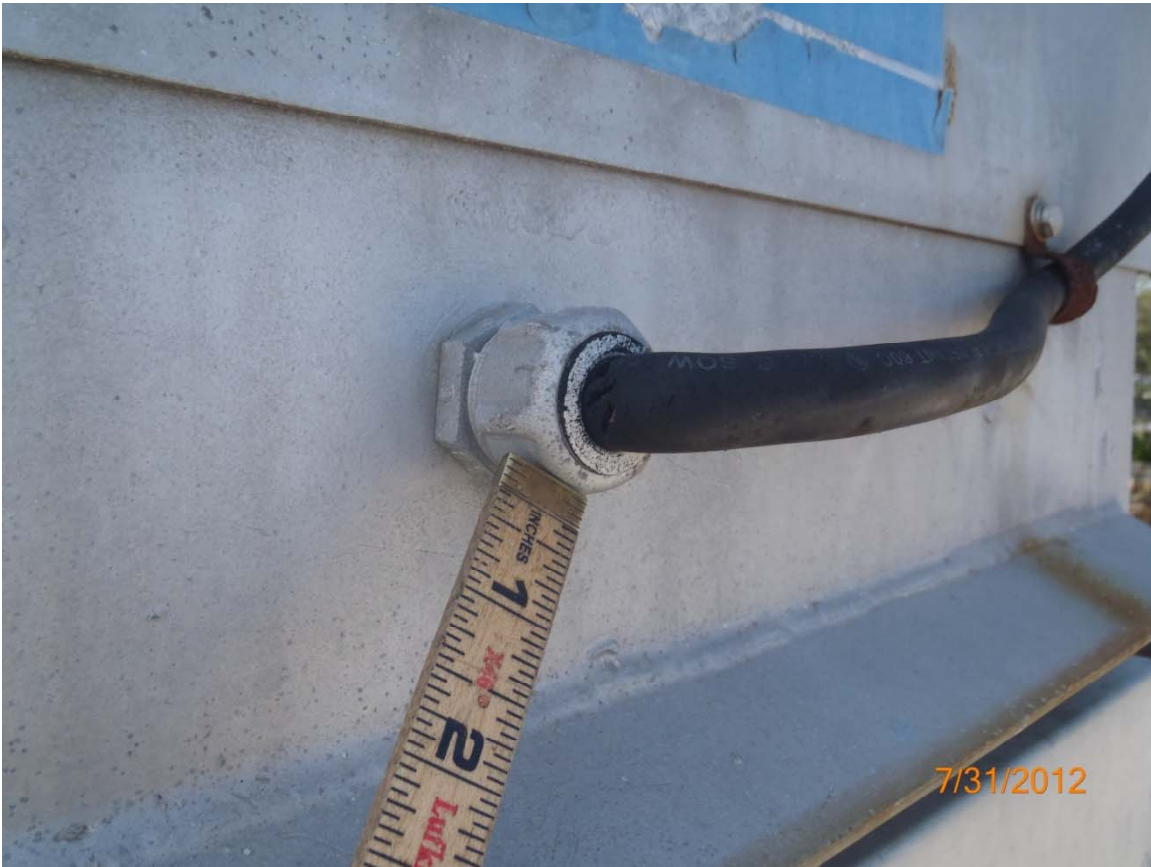
PHOTO 15: 590/4 - Resistance Barriers

The SO cable is cracked at the compression fitting. Refer to Photo 15. REPAIR

Cracked SO cable at resistance barrier.

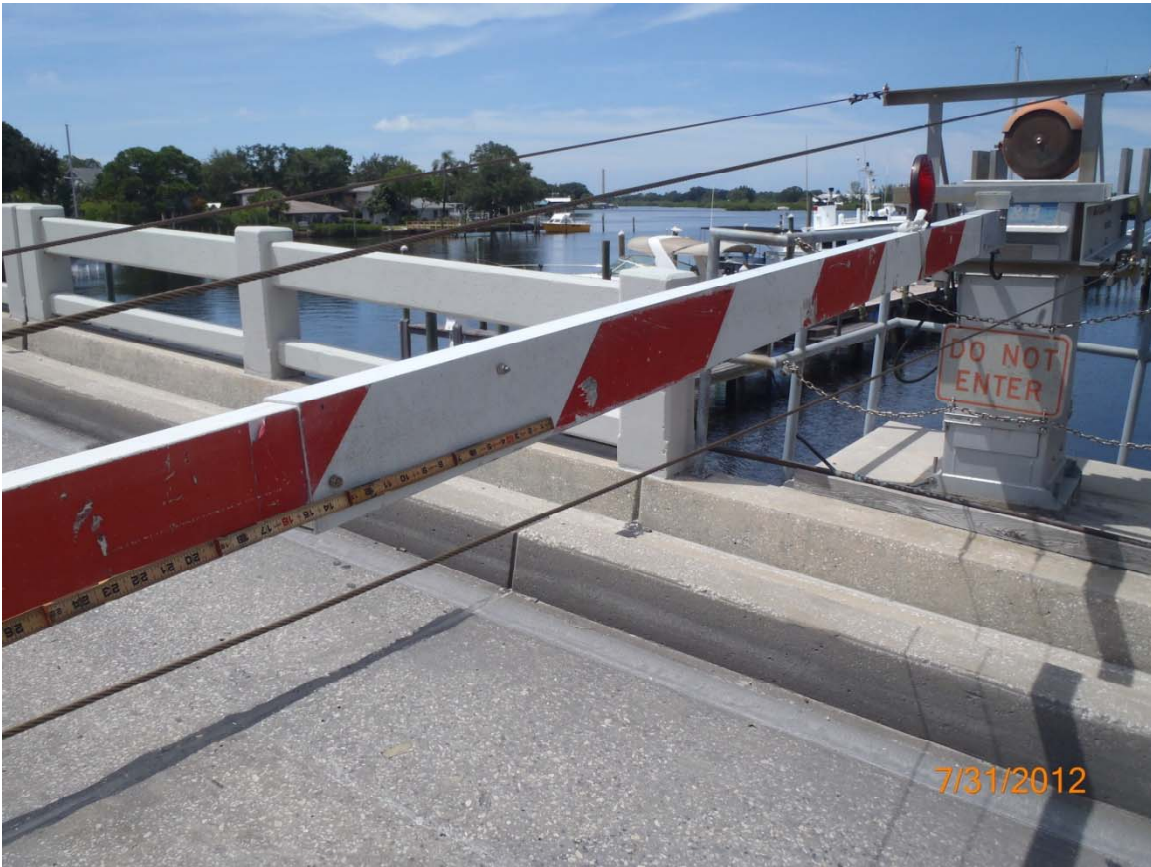
PHOTO 16: 591/4 - Warning Gates

CS2: Both warning gate arms exhibit chipped and faded paint/stripes. Refer to Photo 16. REPAIR

Typical chipped and faded paint/stripes on warning gate arms (near oncoming shown).

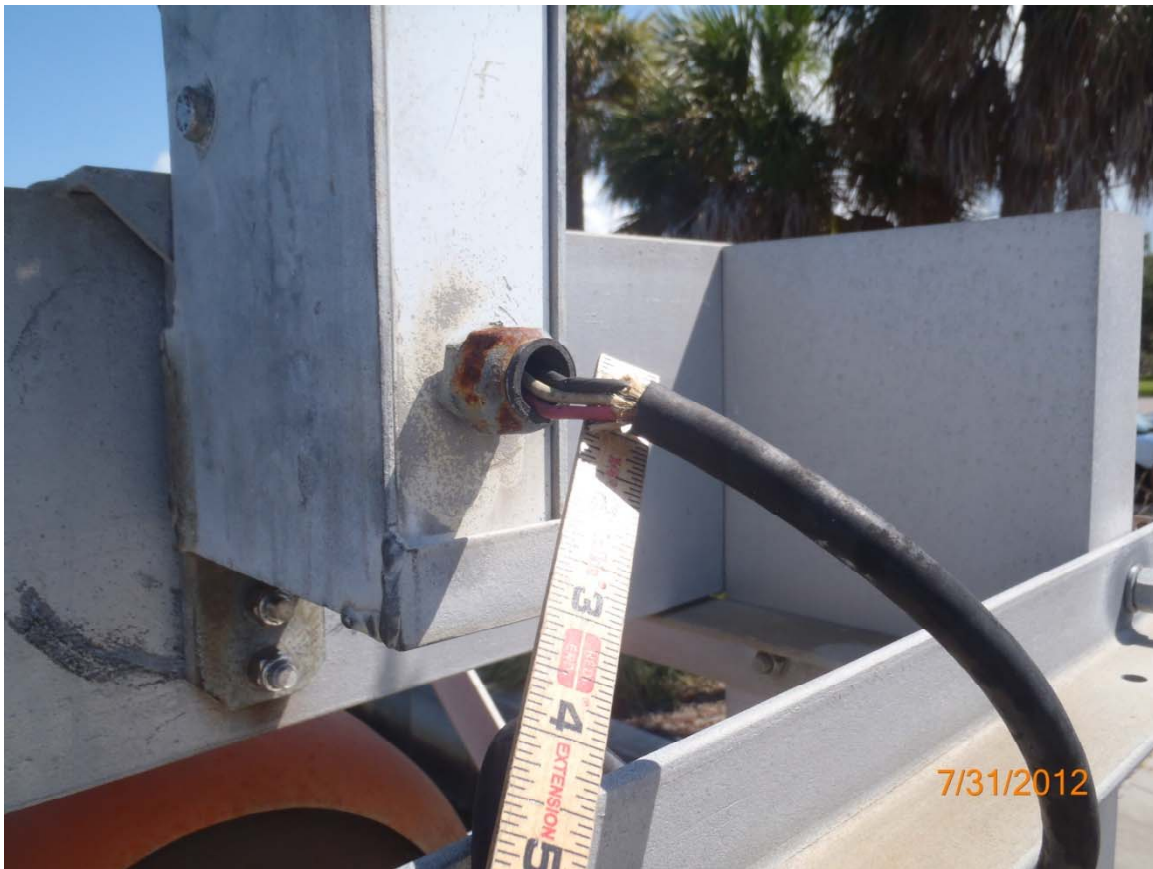
PHOTO 19: 591/4 - Warning Gates

The SO cable for the near oncoming gate has split, exposing the wires - NEW. Refer to Photo 19. REPAIR.

Split SO cable at near oncoming warning gate.
