APPENDIX B
Site Specific Data and Photographs

**SR. 694 (GANDY BLVD) PDE STUDY
FROM U.S. 19 TO EAST OF 4TH STREET
PINELLAS COUNTY, FLORIDA**

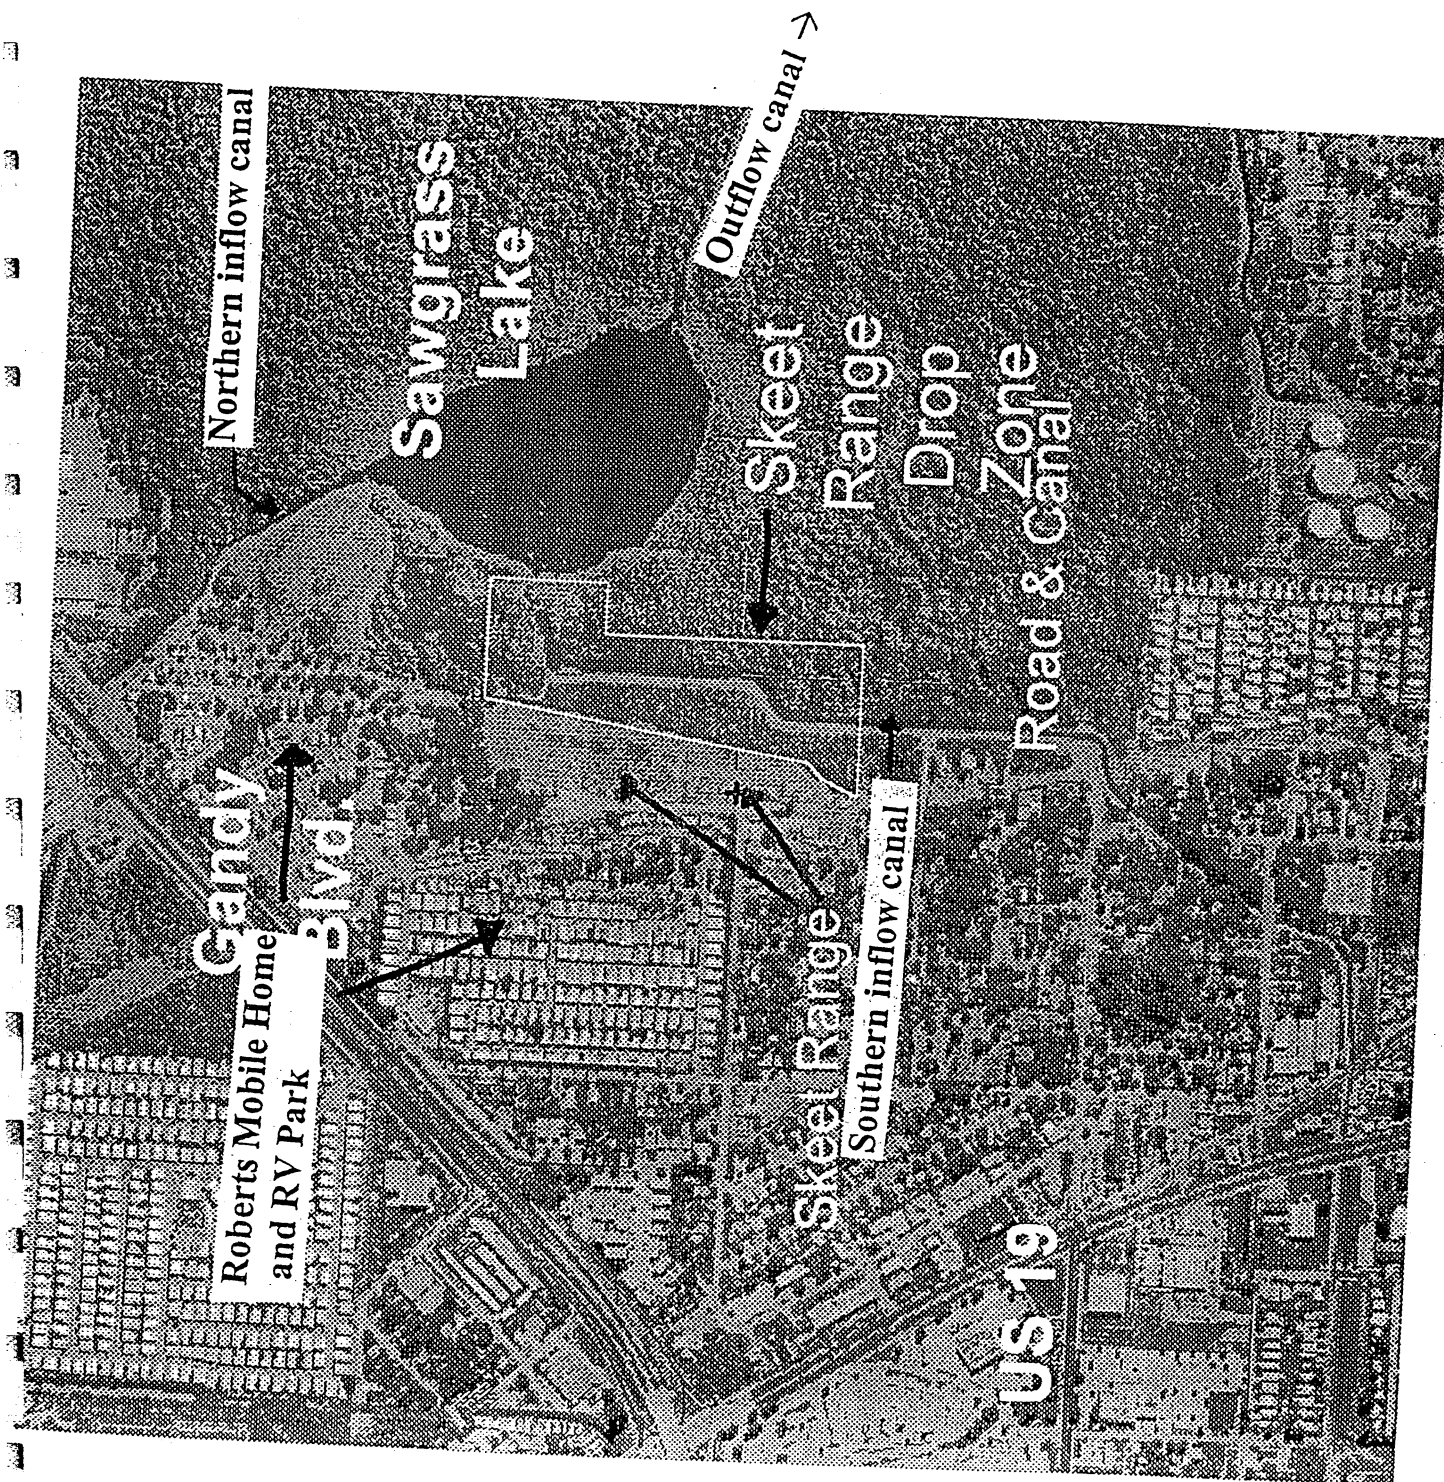
Figure 2

Sawgrass Lake (three locations) and the outflow canal (one location). In addition, during the June sampling event, one surface water sample was collected from the western drainage ditch on the Skyway property and northern inflow canal to Sawgrass Lake. The western drainage ditch is situated between the shooting range and the southern inflow canal. The samples were analyzed for a number of parameters including arsenic and lead. During the April to June time period, elevated levels of lead (6.4 to 27.4 ug/l) were detected in the southern inflow canal. Lead (7 ug/l) was detected in the southern portion of Sawgrass Lake during the June sampling event. The highest level of lead (221 ug/l) was detected in the water sample collected from the western drainage ditch. These levels exceeded the State surface water calculated limit for lead. Lead was not detected in the northern inflow canal sample [29,34] (Figure 2).

The nearest residential area, the Roberts's Mobile Home and RV Resort, is located within 200 feet of the site. The Lake and associated wetlands have been designated as special protection areas by the SWFWMD. In addition, a number of federal and state designated endangered or threatened terrestrial species may inhabit this area of the Park. Please refer to the Surface Water pathway for the species identification. The average persons per household (1990 U.S Census) for Pinellas County is 2.18. Based on the 1990 U.S Census, approximately 202 people live within 1/4 mile of the site. Approximately 166,959 people live within 4 miles of the site. [14,20,23,24,25,26,33,34] (Figures 2,7).
