**ASBESTOS SURVEY REPORT FOR RENOVATION**

***Bridge No. 150049***

***SR 679 – Pinellas Bayway Structure E Bridge  
over Boca Ciega Bay  
St. Petersburg, Pinellas County, Florida***

***February 2009***

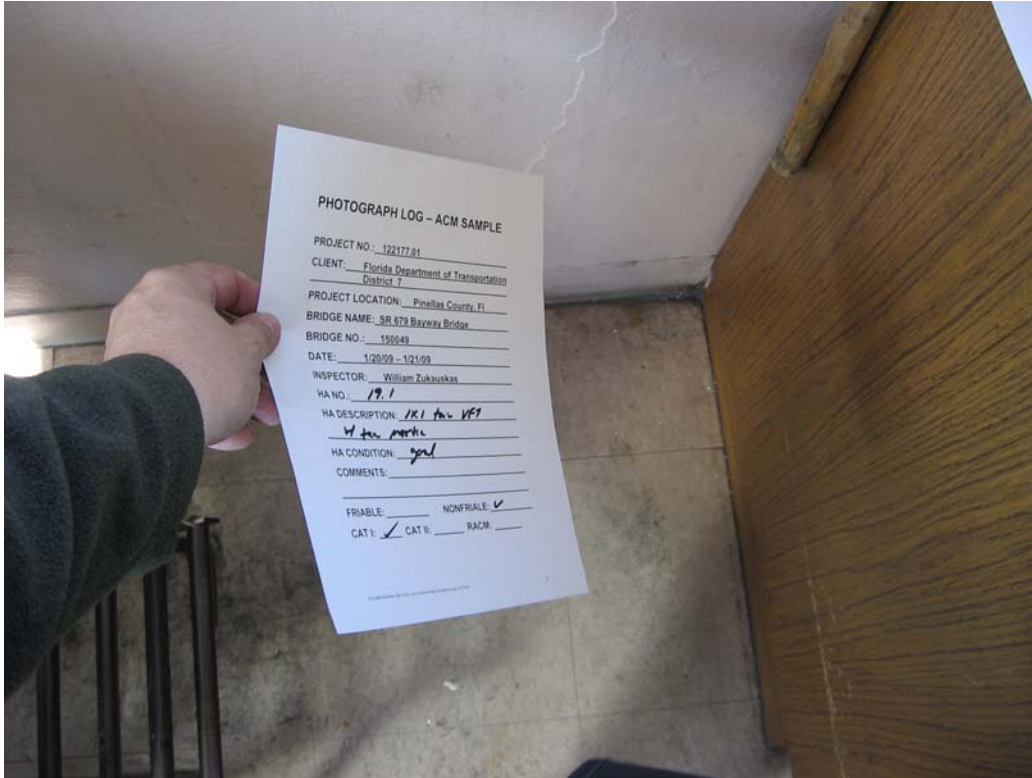
**PHOTO 47 – 01/21/09 – SAMPLE 19.1 – HA 19**  
**1'X 1' TAN VINYL FLOOR TILE WITH TAN MASTIC**  
**TENDER HOUSE AT BRIDGE LEVEL**

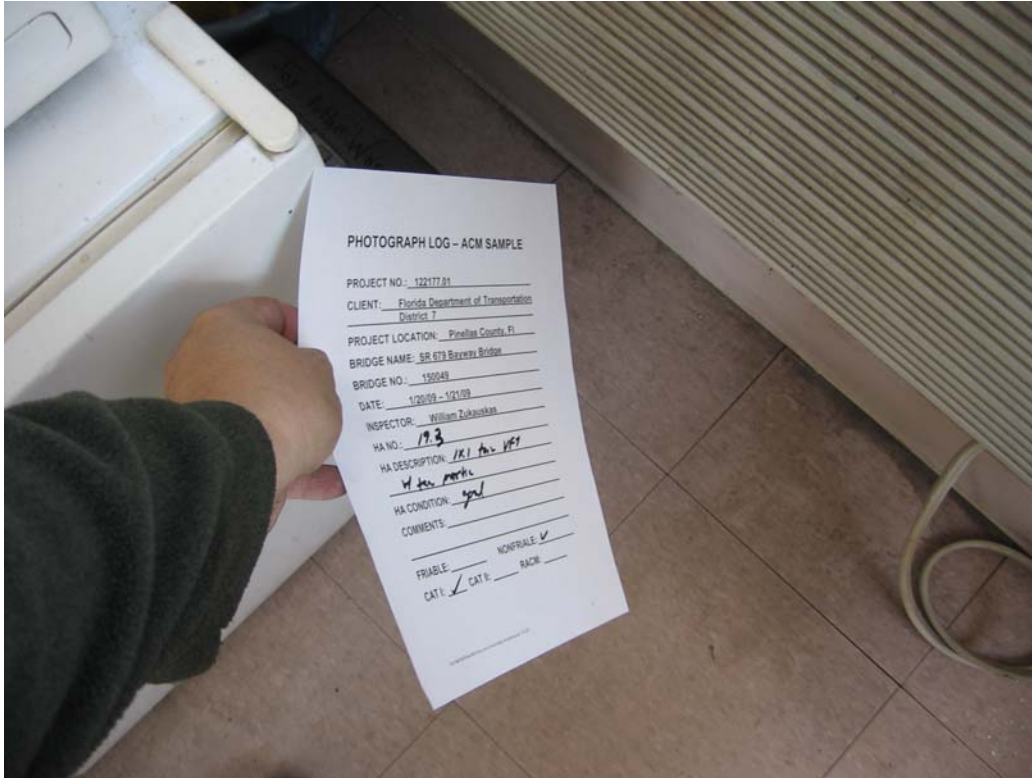
**PHOTO 49 – 01/21/09 – SAMPLE 19.3 – HA 19**  
**1'X 1' TAN VINYL FLOOR TILE WITH TAN MASTIC**  
**TENDER HOUSE AT BRIDGE LEVEL**

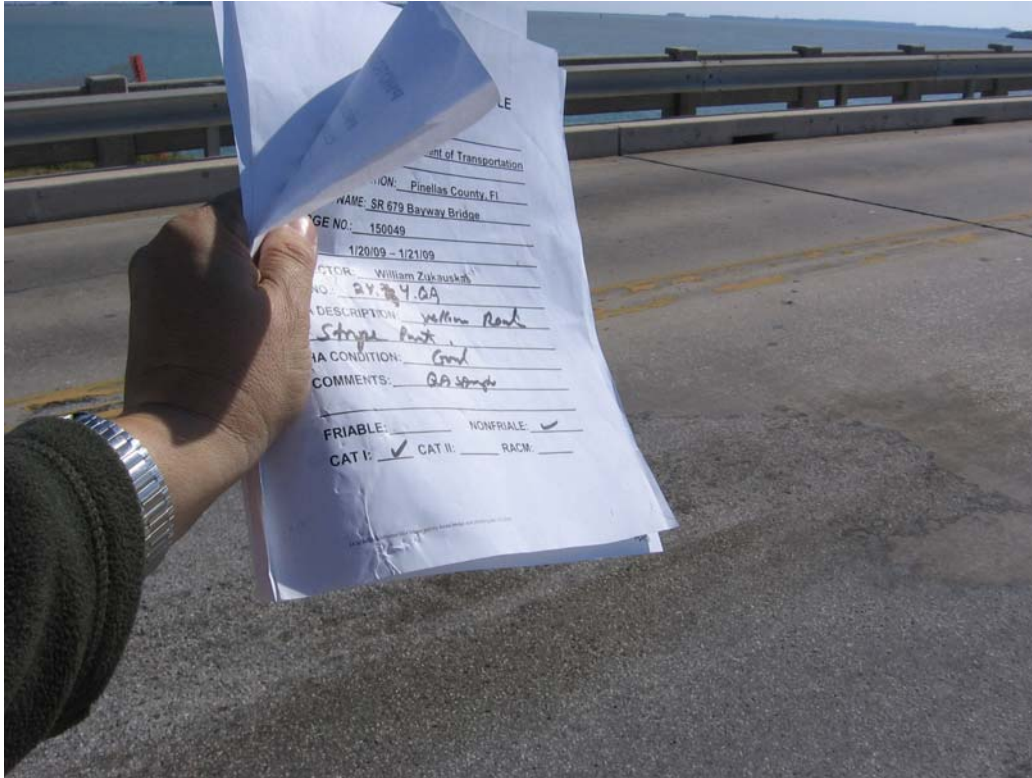
PHOTO 59 – 01/21/09 – SAMPLE 24.4 QA/QC – HA 24  
YELLOW PAINT  
ROAD STRIPES

Quality assurance (QA) sampling was performed in accordance with the State of Florida Asbestos Survey Procedure Manual. Four QA samples (samples No. 6.2, No. 7.2, No. 24.4, and No. 25.4) were collected next to samples No. 6.1, No. 7.1, No. 24.3, and No. 25.3, respectively. None of these samples were found to contain asbestos.

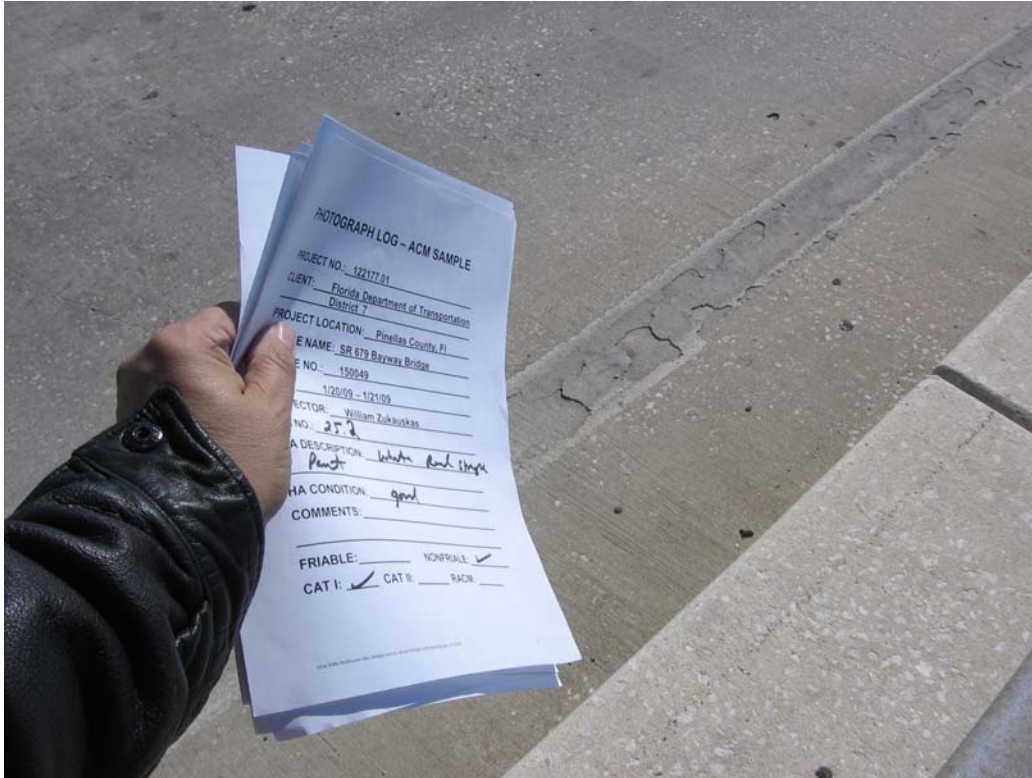
**PHOTO 61 – 01/21/09 – SAMPLE 25.2 – HA 25**  
**WHITE PAINT**  
**ROAD STRIPES**

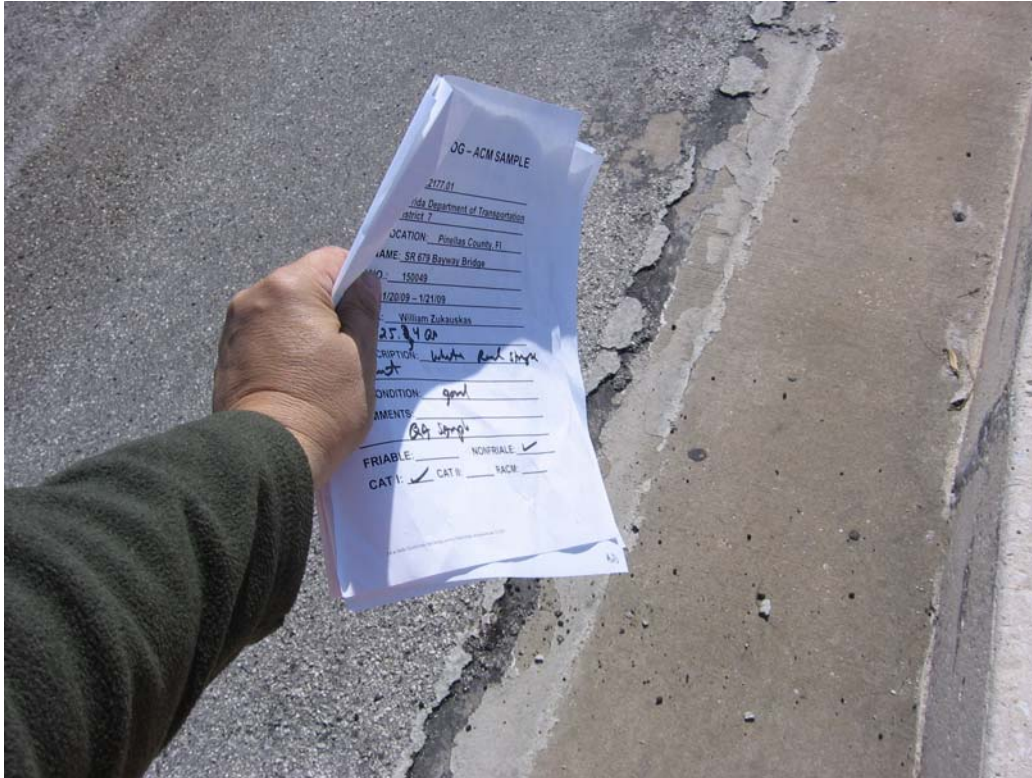
PHOTO 63 - 01/21/09 - SAMPLE 25.4 QA/QC - HA 25  
WHITE PAINT  
ROAD STRIPES

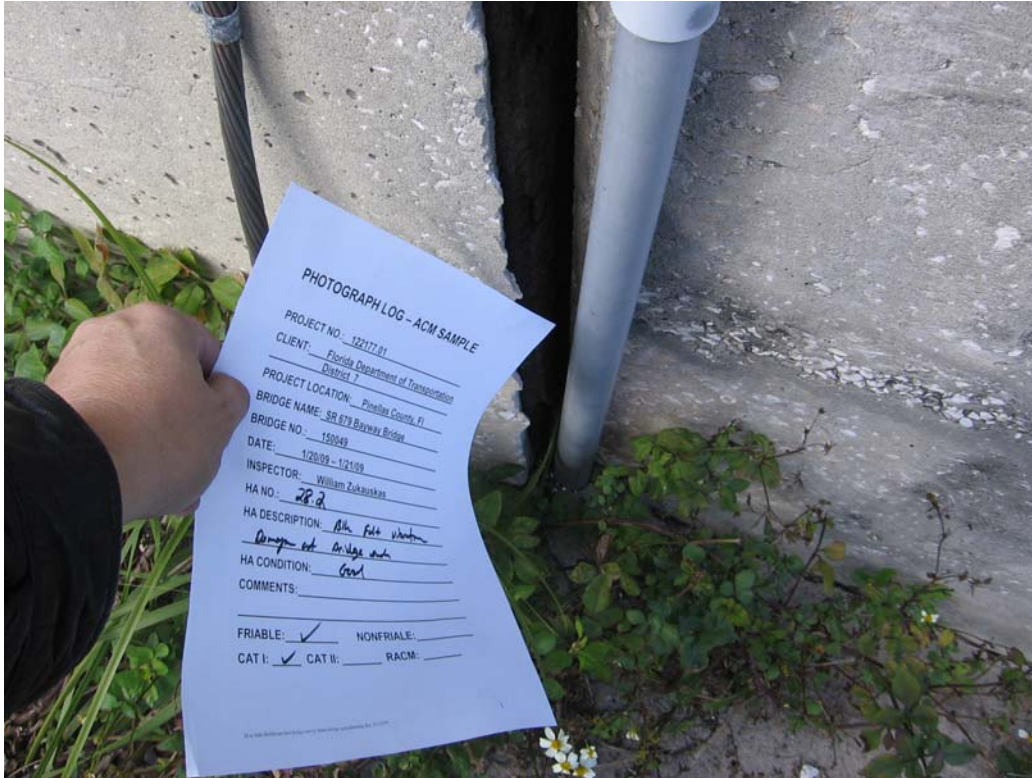
**PHOTO 67 – 01/21/09 – SAMPLE 28.2 – HA 28**  
**BLACK VIBRATION DAMPERS**  
**AT NORTH AND SOUTH BRIDGE ENDS**
