**Gibsonton Drive  
From Fern Hill Drive to US 301  
Project Development & Environment (PD&E) Study**

***Contamination Screening  
Evaluation Report***

Work Program Item Segment No. 450438-1  
ETDM Project No. 14493  
Hillsborough County, Florida

Florida Department of Transportation  
District Seven

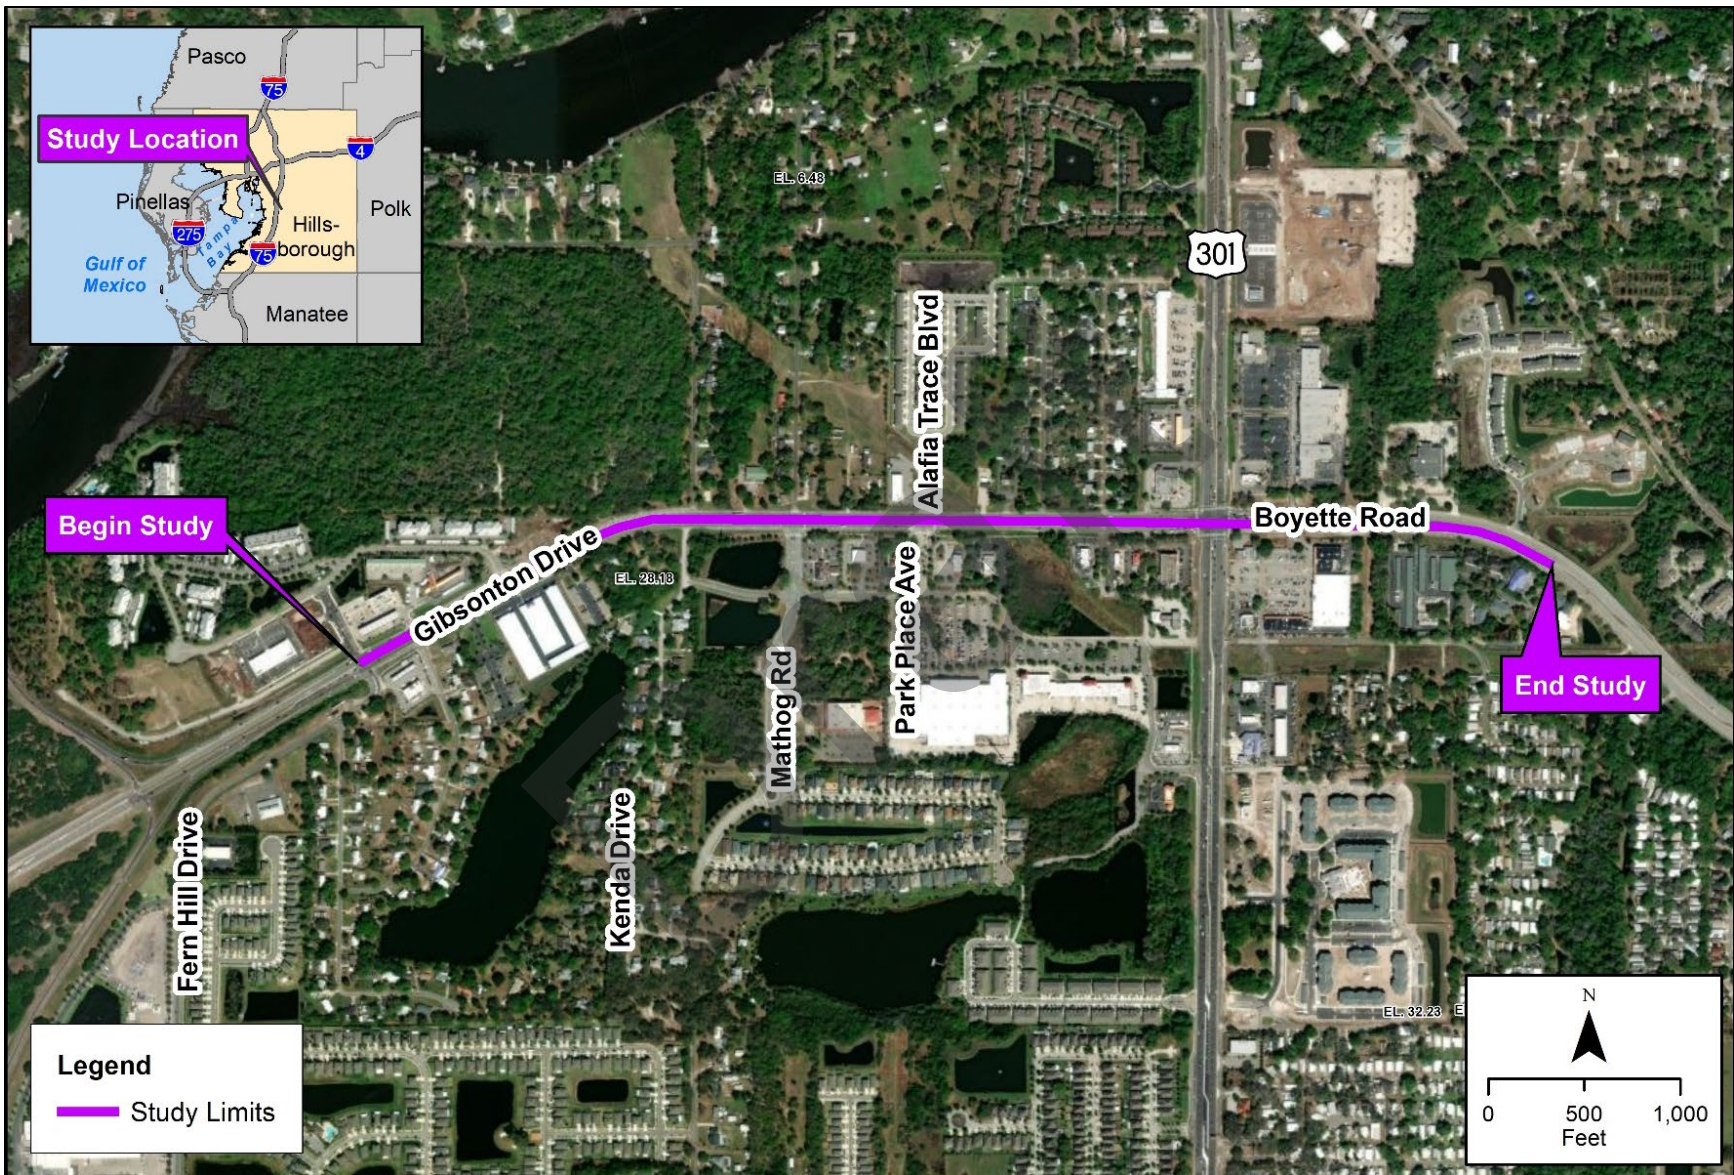
Figure 1-1 Project Location Map

The project consists of widening Gibsonton Drive from Fern Hill Drive to US 301 in Hillsborough County, a distance of approximately 0.95 miles. Improvements will also include a wide sidewalk to accommodate bicycles and pedestrians. The project includes the evaluation of stormwater management facilities (SMF) and floodplain compensation (FPC) sites. The project traverses the unincorporated census designated place of Riverview and provides access to I-75 for the communities of Riverview, Boyette, Fish Hawk and Lithia. Within the project limits, Gibsonton Drive is a four-lane, divided roadway with paved shoulders and 5-foot (ft) sidewalks along both sides of the road. There are some gaps in the sidewalk on the south side (eastbound direction) of the road. Gibsonton Drive is functionally classified by Hillsborough County as an arterial with an existing posted speed limit of 45 miles per hour (mph). A project location map is provided in **Figure 1-1**.

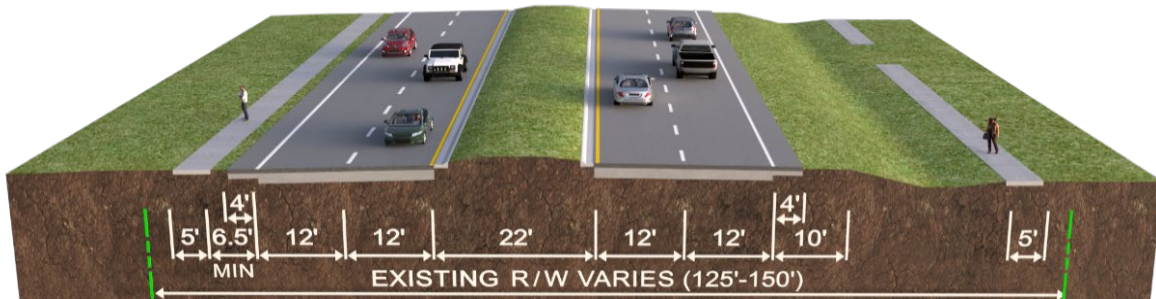
**Figure 1-2 Gibsonton Drive – Existing Typical Section**

Gibsonton Drive is owned and maintained by Hillsborough County. Within the project area, Gibsonton Drive is currently a four-lane divided facility functionally classified as an arterial roadway with a posted speed limit of 45 mph. The roadway has two 12-foot (ft) lanes in each direction, a 22-ft median and turn lanes at many locations along the corridor. The shoulders are approximately 10-ft wide (4-ft paved) on the south side and 6.5-ft minimum width (4-ft paved) on the north side throughout the corridor with no dedicated bicycle lanes. There is a 5-ft sidewalk on both sides of the road with a few gaps in the sidewalk on the south side, west of Kendra Drive. Approximately 230 linear feet of the sidewalk on the south side, east of Kendra Drive, is a wooden boardwalk. The existing right of way (ROW) varies along the corridor between 125 ft and 150 ft wide. The existing typical section is provided as **Figure 1-2**. There is one existing SMF east of US 301, but no SMF between Fern Hill Drive and US 301 and no existing FPC sites within the project corridor.

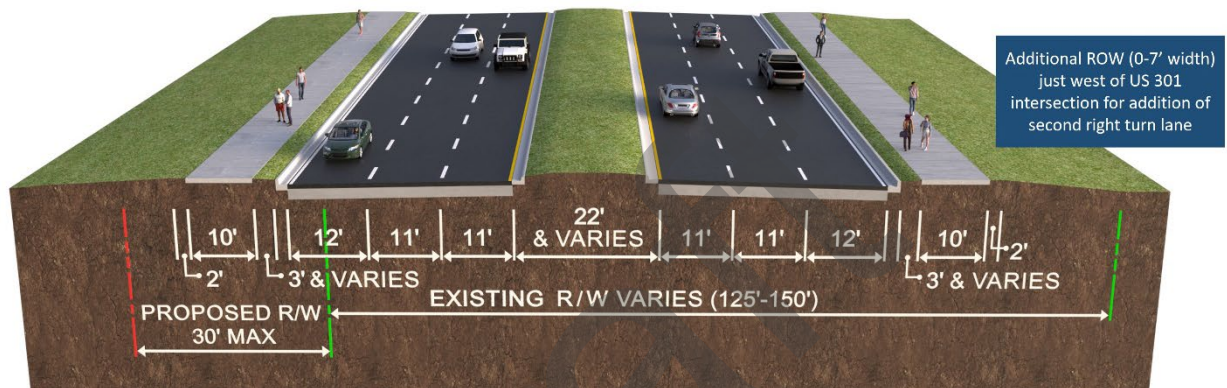
**Figure 1-3 Gibsonton Drive – Proposed Typical Section**

The proposed typical section shows widening Gibsonton Drive to a six-lane divided urban facility with a 22-ft raised median. There will be two 11-ft travel lanes and one 12-ft outside travel lane in each direction with curb and gutter, and 10-ft wide sidewalks. The proposed typical section is provided as **Figure 1-3**. Additional ROW will be required along the north side of Gibsonton Drive (0 to 30 ft in width) to accommodate the widening and along the south side of Gibsonton Drive (0 to 7 ft in width) in advance of the US 301 intersection for intersection improvements. One off-site SMF and one off-site FPC are proposed. Additional ROW will be required for off-site SMF and FPC sites.

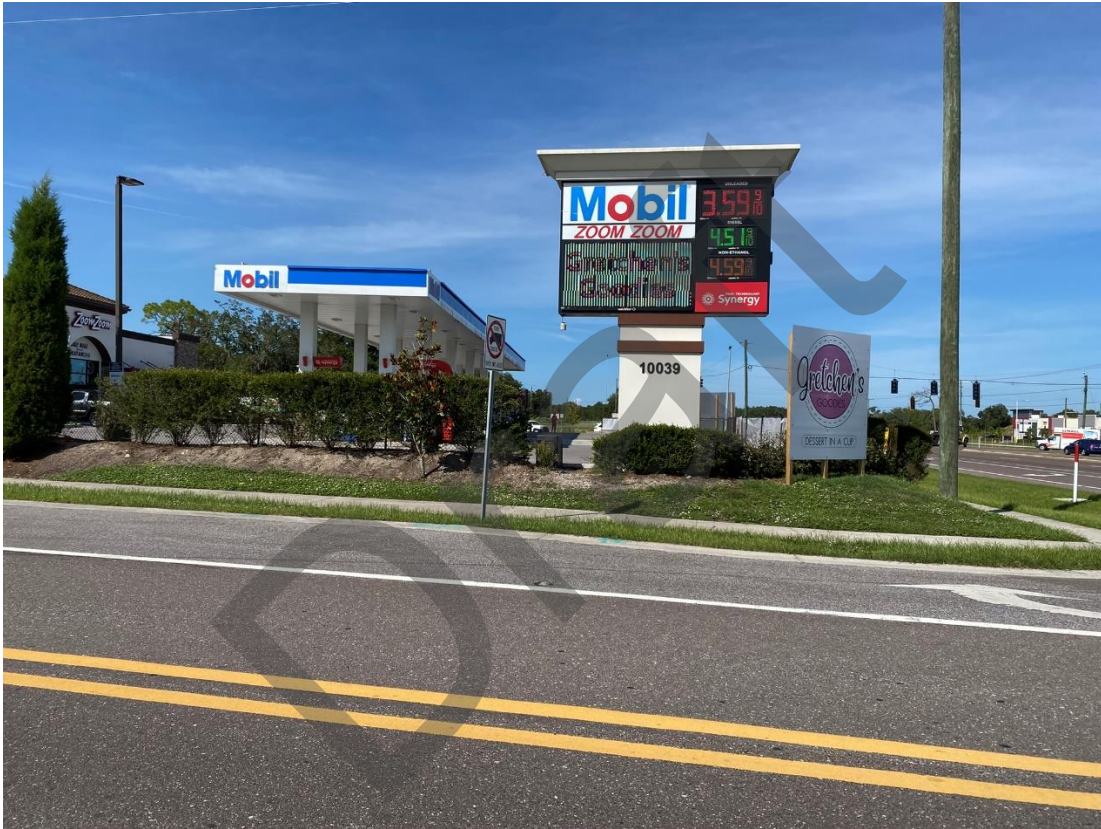
1. Mobil-Riverview #659

The Mobil-Riverview #659 facility is located at 10039 Gibsonton Drive. The facility is registered as an active retail petroleum station. Currently, Mobil-Riverview #659 exists at this location. The facility consists of a large one-story building convenience store with a large petroleum pump facility in front, between the building and Gibsonton Drive. When reviewing the historical aerials, the site appears to be developed in late 2017.

Currently the facility consists of two 12,000-gallon USTs. One tank holds unleaded gas and the other holds vehicular diesel. Both tanks are currently in service. According to the Nexus Information Portal, both tanks were installed on December 1, 2017. The most recent correspondence took place March 1, 2023, for a routine annual compliance inspection dated February 16, 2023. The inspection conducted by the Environmental Protection Commission of Hillsborough County, on behalf of the FDEP, determined the facility to be in compliance. No more recent information was available. Although there is a lack of contamination presence and history, since the facility is an active gasoline station it is rated as **Medium** risk for potential contamination involvement.

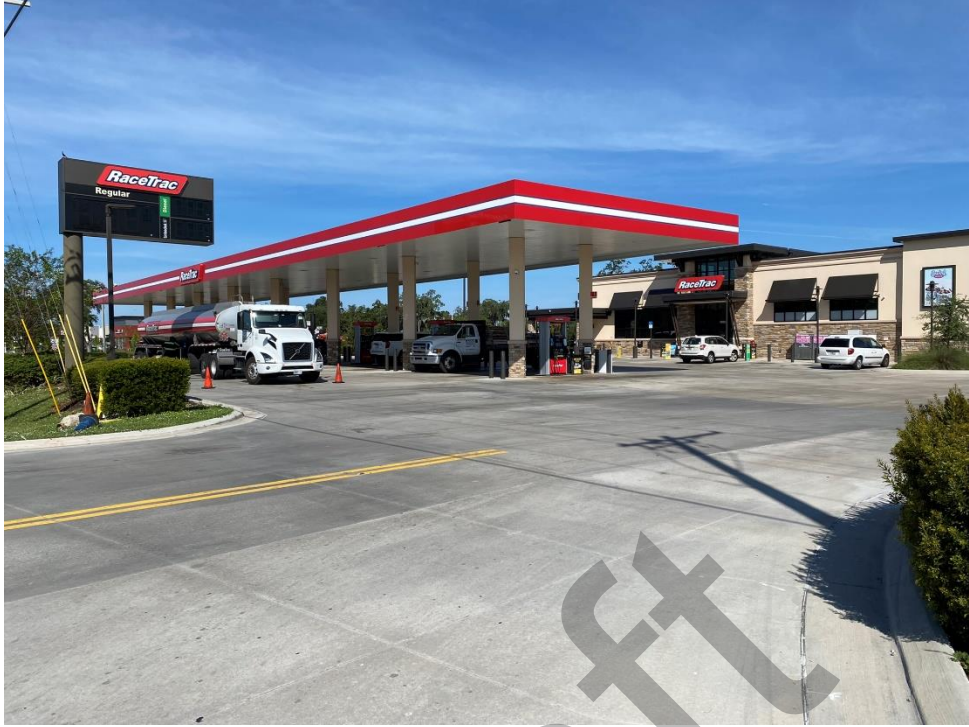
**2. Racetrac Petroleum Inc.**

Historically there was a previous Raceway #999 facility which was redeveloped into the current RaceTrac facility. The site consisted of three USTs, one 15,000-gallon and two 12,000-gallon tanks. These USTs were installed on November 29, 2003. The previous facility had multiple occasions of minor out of compliance violations, including lack of proper internal monitoring checks, and not reporting incidents within 24 hours. The contamination history with the previous site is minimal, consisting of minor diesel leakage resulting in no soil or groundwater impacts. When the previous tanks were removed on April 27, 2018, there were no tank leaks or contamination found.

The new RaceTrac facility installed three 20,000-gallon USTs on May 1, 2018. The RaceTrac facility also has a history of minor out of compliance violations, including excess water near pumps and piping sumps being inaccessible. The most recent correspondence is from July 2023, where the facility was granted approval into the Ethanol/Biodiesel Program after corrosion and microbial growth was noticed by the owner in the 20,000-gallon diesel UST in late October 2021.

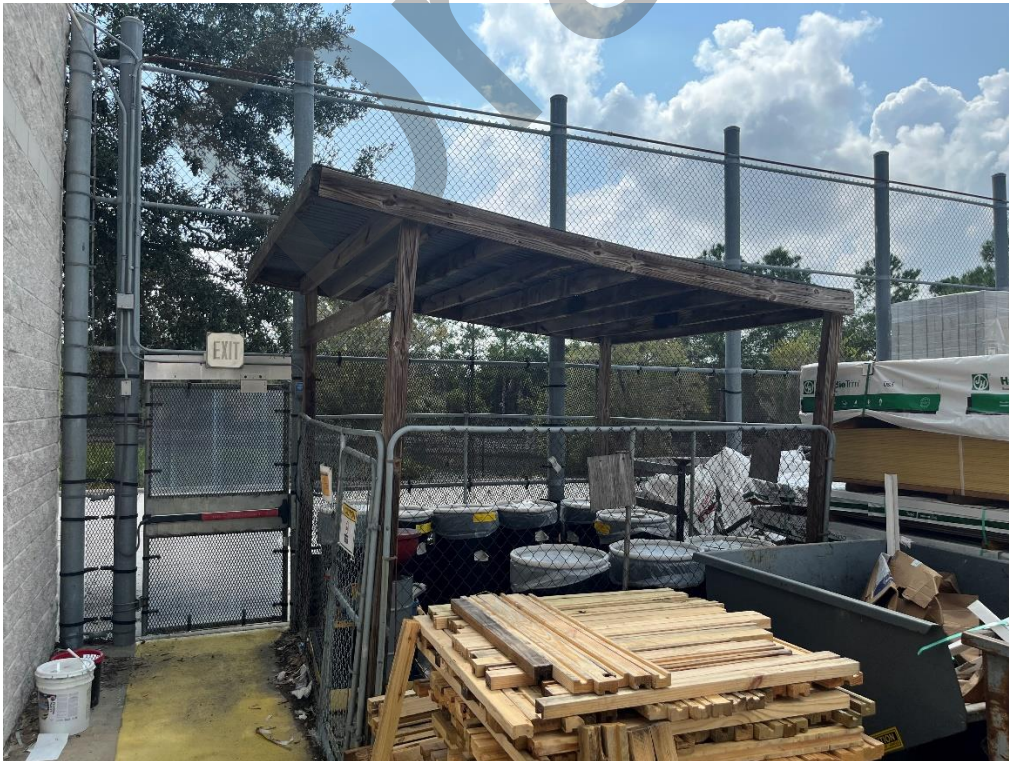
5. Lowes of Riverview #1911

Lowes of Riverview #1911 is located at 10425 Gibsonton Dr. Lowes is a hardware store that includes several retail areas. The property includes a 5 acre parking lot on the northern extent and various loading bays on the southside of the property which includes a shed that houses hazardous waste. The facility was constructed in November 2005.

The facility is registered under the FDEP and EPA as a small quantity hazardous waste generator consisting of spent universal waste lamps and central accumulation area where waste is kept and divided into various containers. Containers are divided into toxic, flammable, corrosive, and oxidizing materials. The latest hazardous waste inspection report performed by the FDEP in June 2020, noted one minor violation; however, it was corrected before the inspection ended. The latest correspondence in February 2021 is between FDEP and the facility, renewing their registration in the hazardous waste program. Although there is a potential for contamination from the hazardous waste at the facility. The site is rated **Low** risk for potential contamination involvement due to the lack of contamination history and nature of the facility.

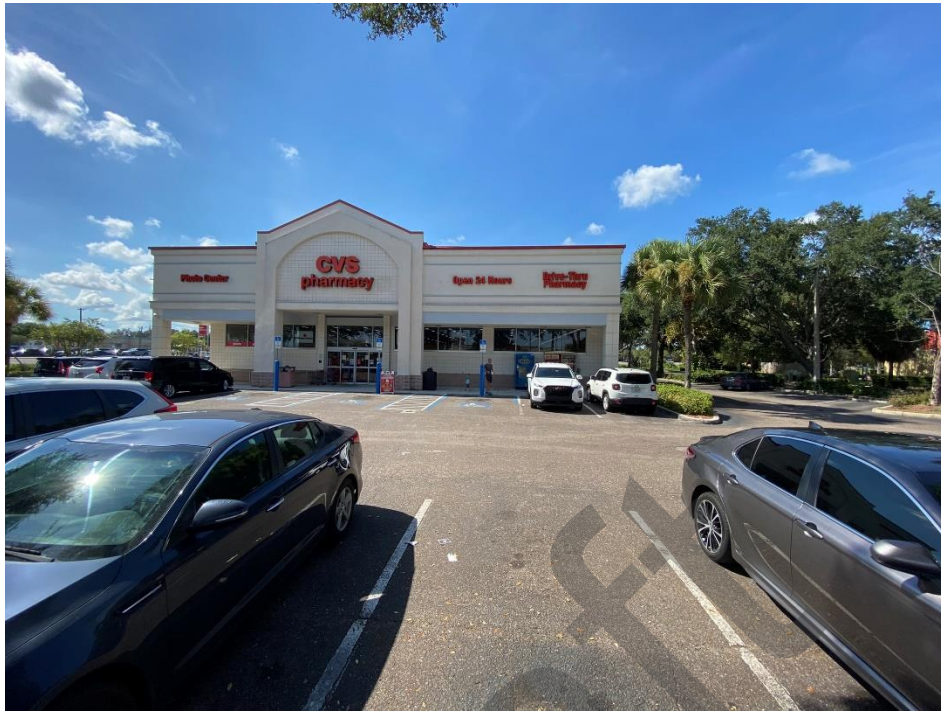
**6. (6A) CVS Pharmacy #3638  
formerly known as (6B) Majik Food Mart #7405**

There is contamination history with this location. In 1992, the site fueling system failed tightness tests suggesting potential contamination. A contamination assessment report was published in 1992 identifying soil and groundwater contamination in the area of the tank pit. The tanks were removed in February 1999 and in May 1999 groundwater treatment and remediation took place. A dual-phase extraction system was operated for one week and 164,000 gallons were extracted. In 2016, more contamination was found in the surrounding soils, and five 40-gallon drums of soils, described as investigative derived wastes (IDW), were collected. Seven groundwater monitoring wells were installed in September 2016 to monitor remediation efforts. The most recent activity at the site is a

This potential contamination site is located on the same property as Potential Contamination Site 6A. Contamination history consists of what is discussed in Site 6A; however, there is no contamination documentation related to the CVS Pharmacy. During the latest annual inspection report from August 2012, minor violations were found in those containers were mislabeled; however, this was corrected before the end of inspection. The latest correspondence, with public agencies, was a FDEP/EPA Identification Number or status/information change in March of 2020.

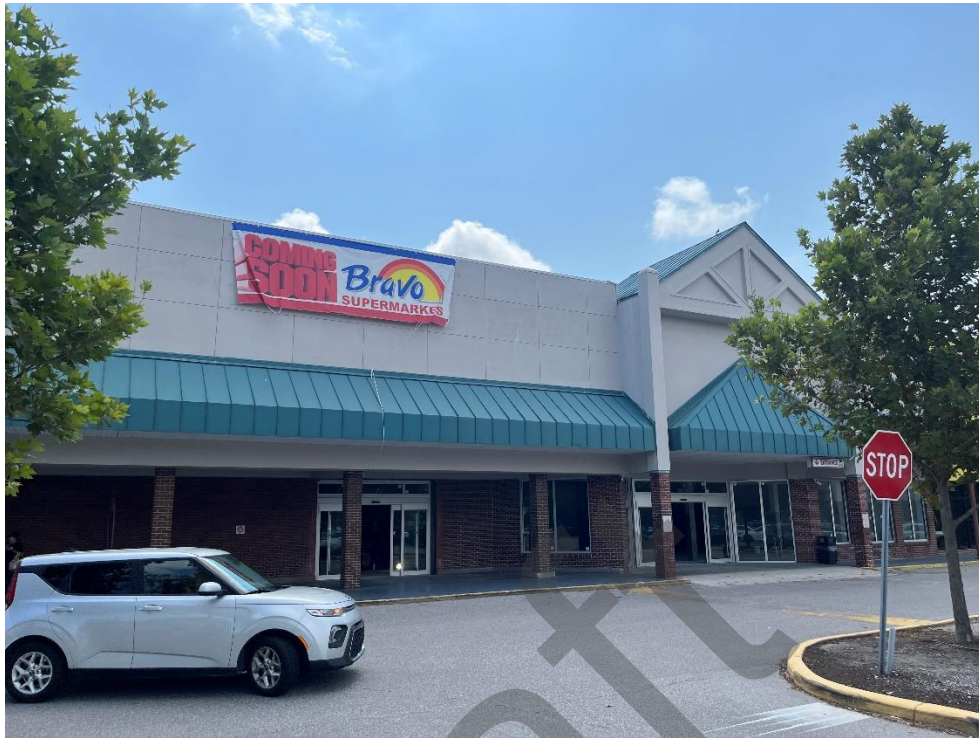
11. Winn-Dixie #678

The site address for Winn-Dixie is 9822 #678 US HWY 301 S. The former grocery store is registered under the EPA and FDEP as a small quantity hazardous waste generating facility.

Not much is known about the inception of the grocery store. In August 2013, the facility was accepted into the FDEP's Hazardous Waste Inspection Program, on behalf of the EPA. The facility disposed of mercury containing waste, and pharmaceuticals. The facility was conditionally exempt from providing separate submissions for universal waste lamps and pharmaceuticals, due to the low volume of waste exported. The facility's official date of closure is unknown, though documentation supplied by FDEP in 2019 clearly states the facility is no longer in use. The latest correspondence on record is a site inspection for the closing of the facility in July 2019.

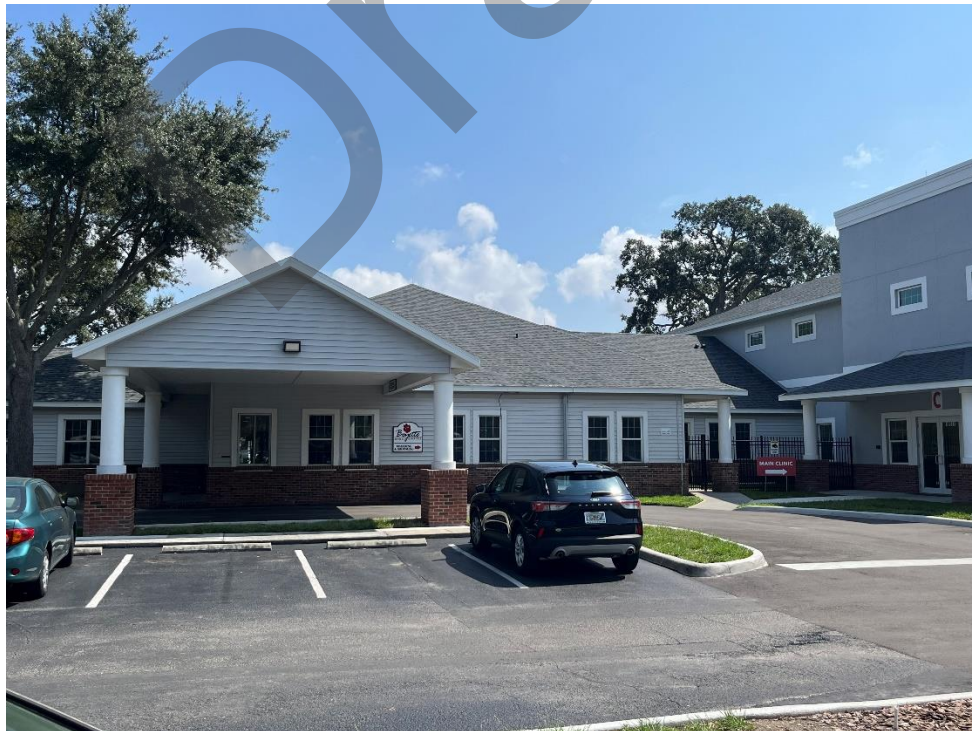
12. Boyette Animal Hospital

The site address for Boyette Animal Hospital is 10931 Boyette Rd. The current veterinary clinic is registered under the EPA and FDEP as a small quantity hazardous waste generating facility.

Opening in 1998, Boyette Animal Hospital operates as a full service hospital for small animals coupled with grooming and boarding services. The main operations of the facility are housed in one approximately 9,000 square foot building with a large outbuilding designated as a pet boarding area. The hazardous waste of concern at the facility includes biomedical and pharmaceutical waste. Biomedical waste is managed by a third party and expired pharmaceuticals are returned to the supplier. Compliance inspections on record were performed FDEP and the Environmental Protection Commission of Hillsborough County (EPC) in January 2002, December 2004, and May 2005. During the

inspection in December 2004, FDEP noted two compliance violations concerning the lack of performing waste determinations when disposing of pharmaceuticals and disposing spent florescent lamps as solid waste. The latest correspondence was a follow-up inspection conducted in May 2005, which revealed that the facility had addressed the issue of performing waste determinations for contaminated pharmaceuticals. The fluorescent bulbs were now being retained for recycling through Chemical Pollution Control.
