Contamination Screening Evaluation Report

**State Road (SR) 50 (US 98/Cortez Boulevard)
Project Development & Environment (PD&E) Study
From the Brooksville Bypass to west of Interstate 75**

Work Program Item Segment No. 430051-1

***Contamination Screening
Evaluation Report***

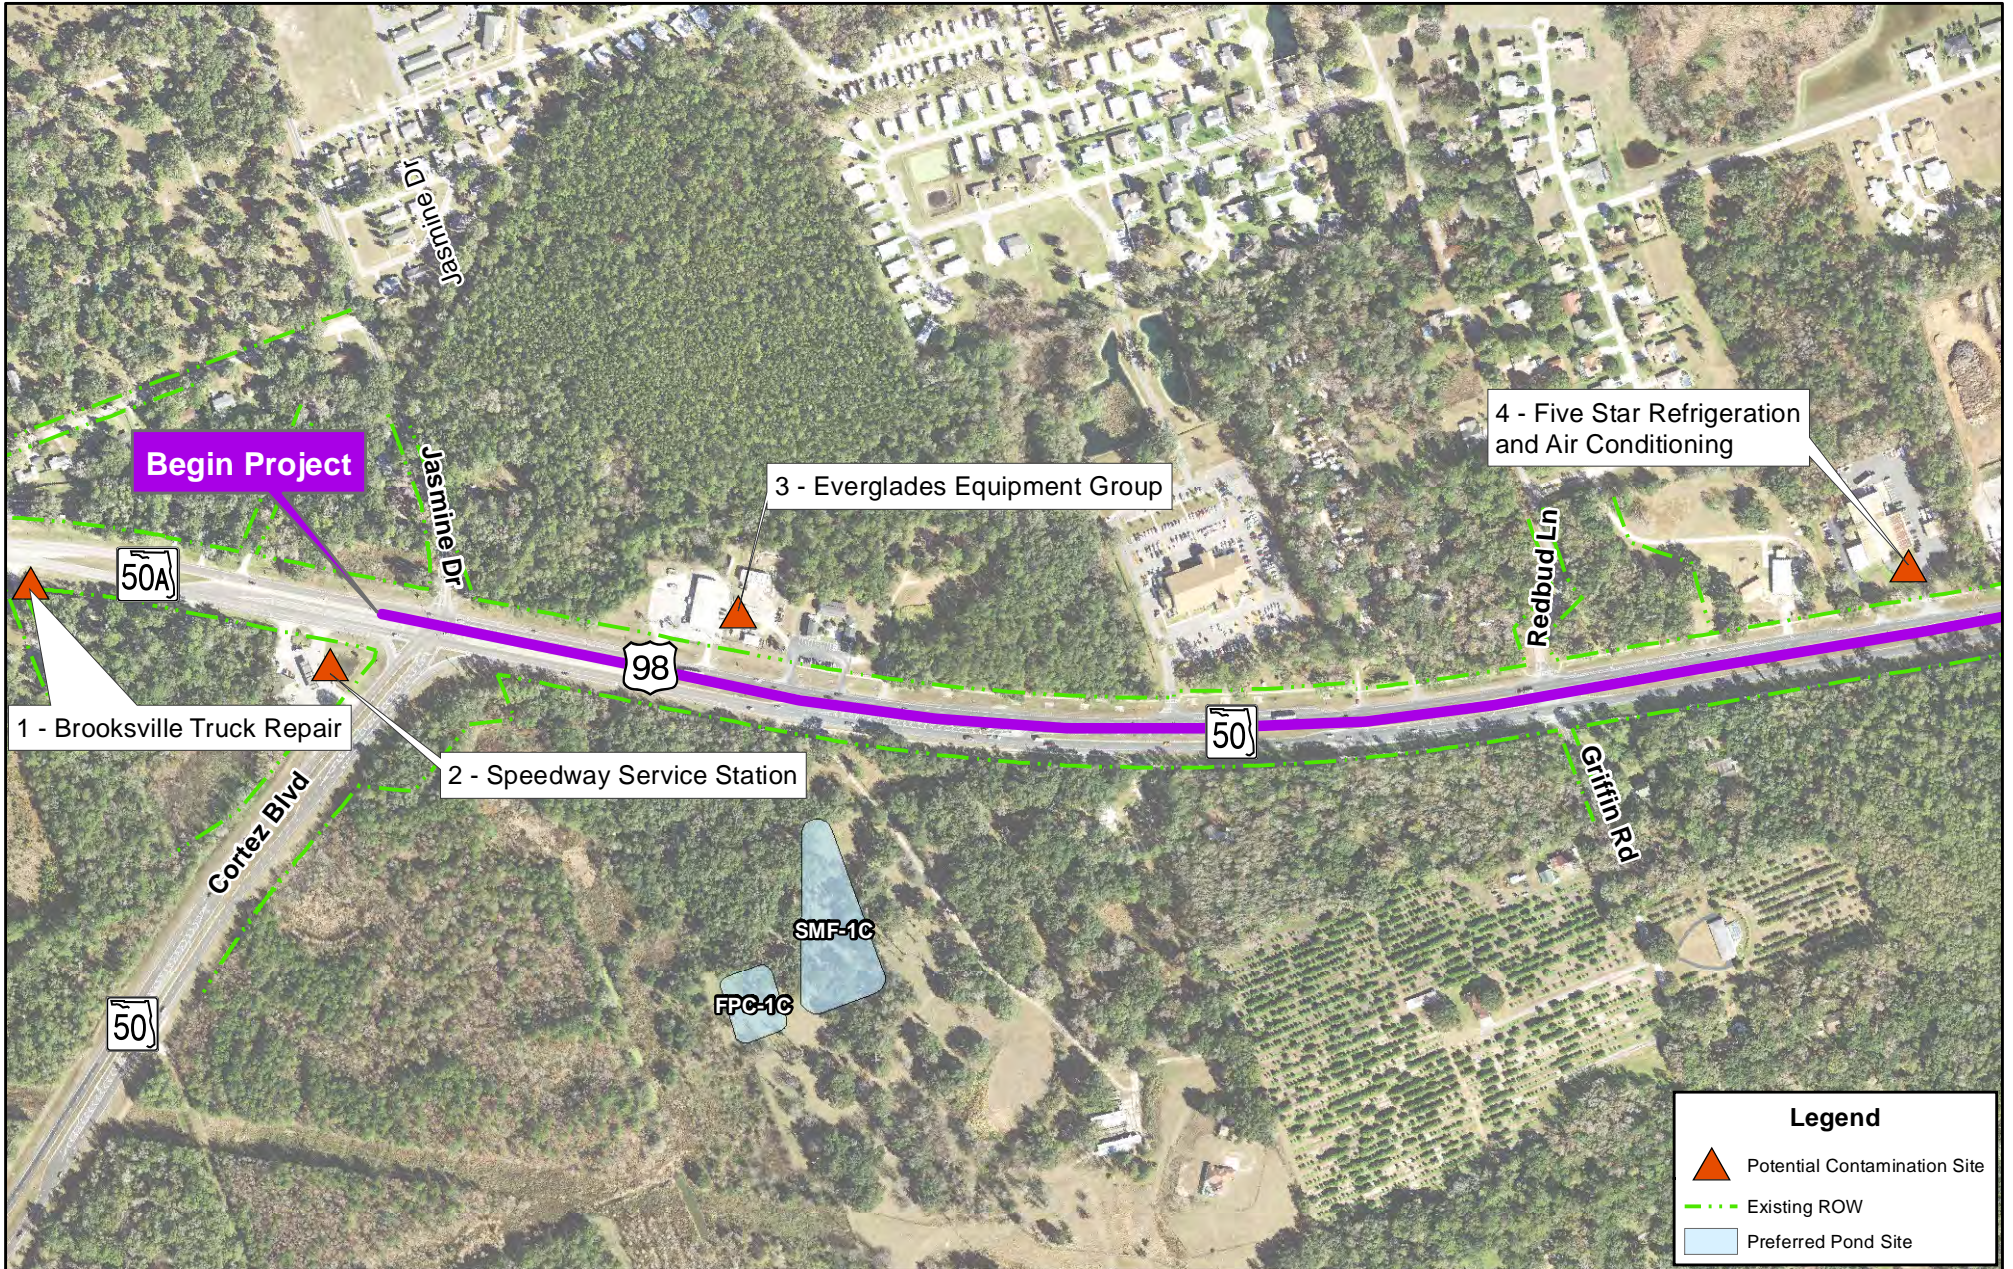
Potential Contamination Site Map

SR 50 (US 98) PD&E Study
 From Brooksville Bypass/SR 50A/E. Jefferson Street to west of Interstate 75
 WPI Segment No. 430051-1: Hernando County

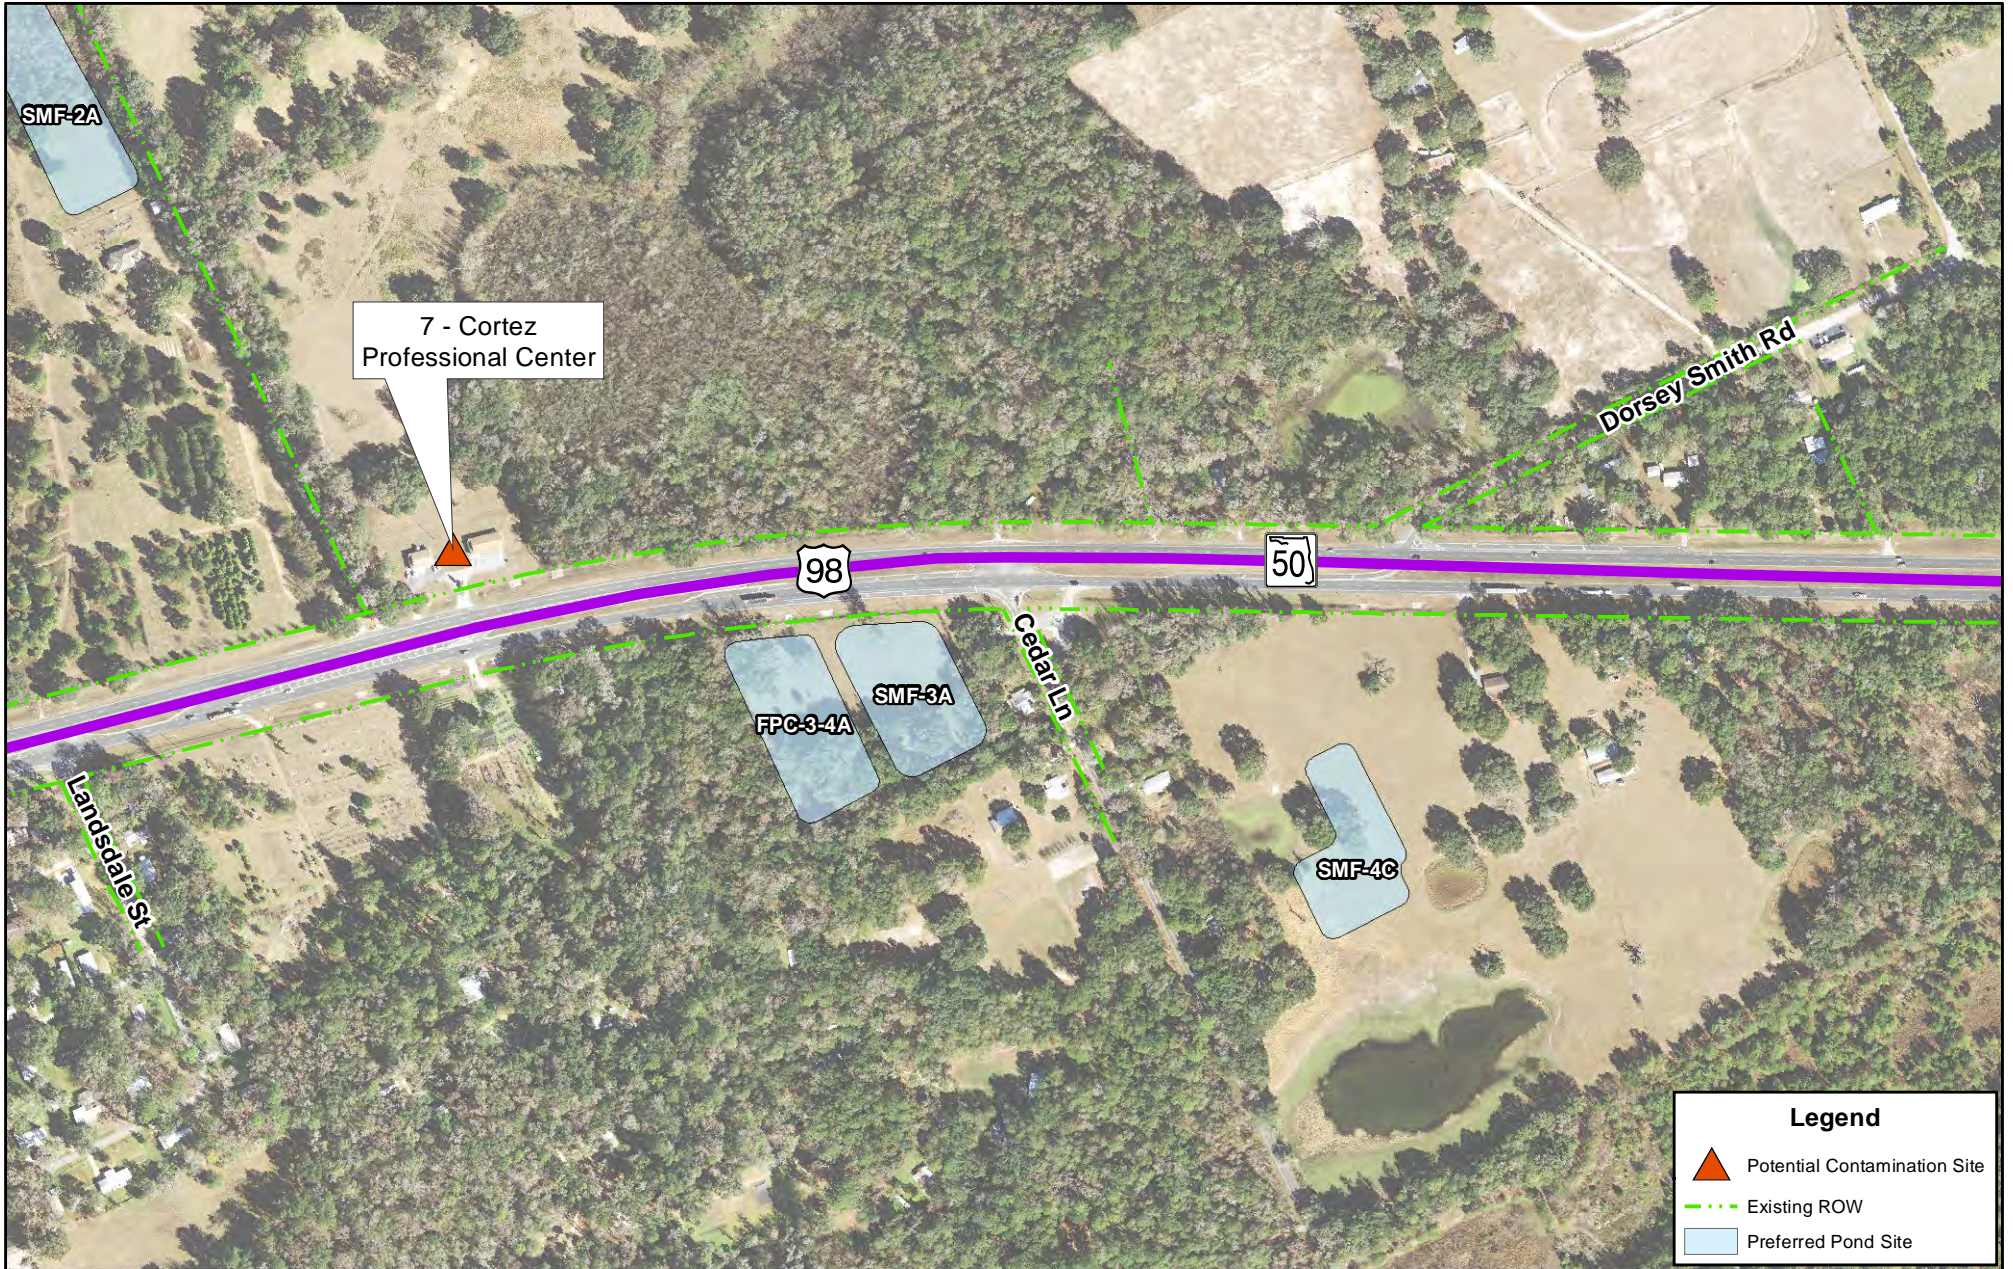
Appendix E
 Sheet 2 of 10

SR 50 (US 98) PD&E Study
From Brooksville Bypass/SR 50A/E. Jefferson Street to west of Interstate 75
 WPI Segment No. 430051-1: Hernando County

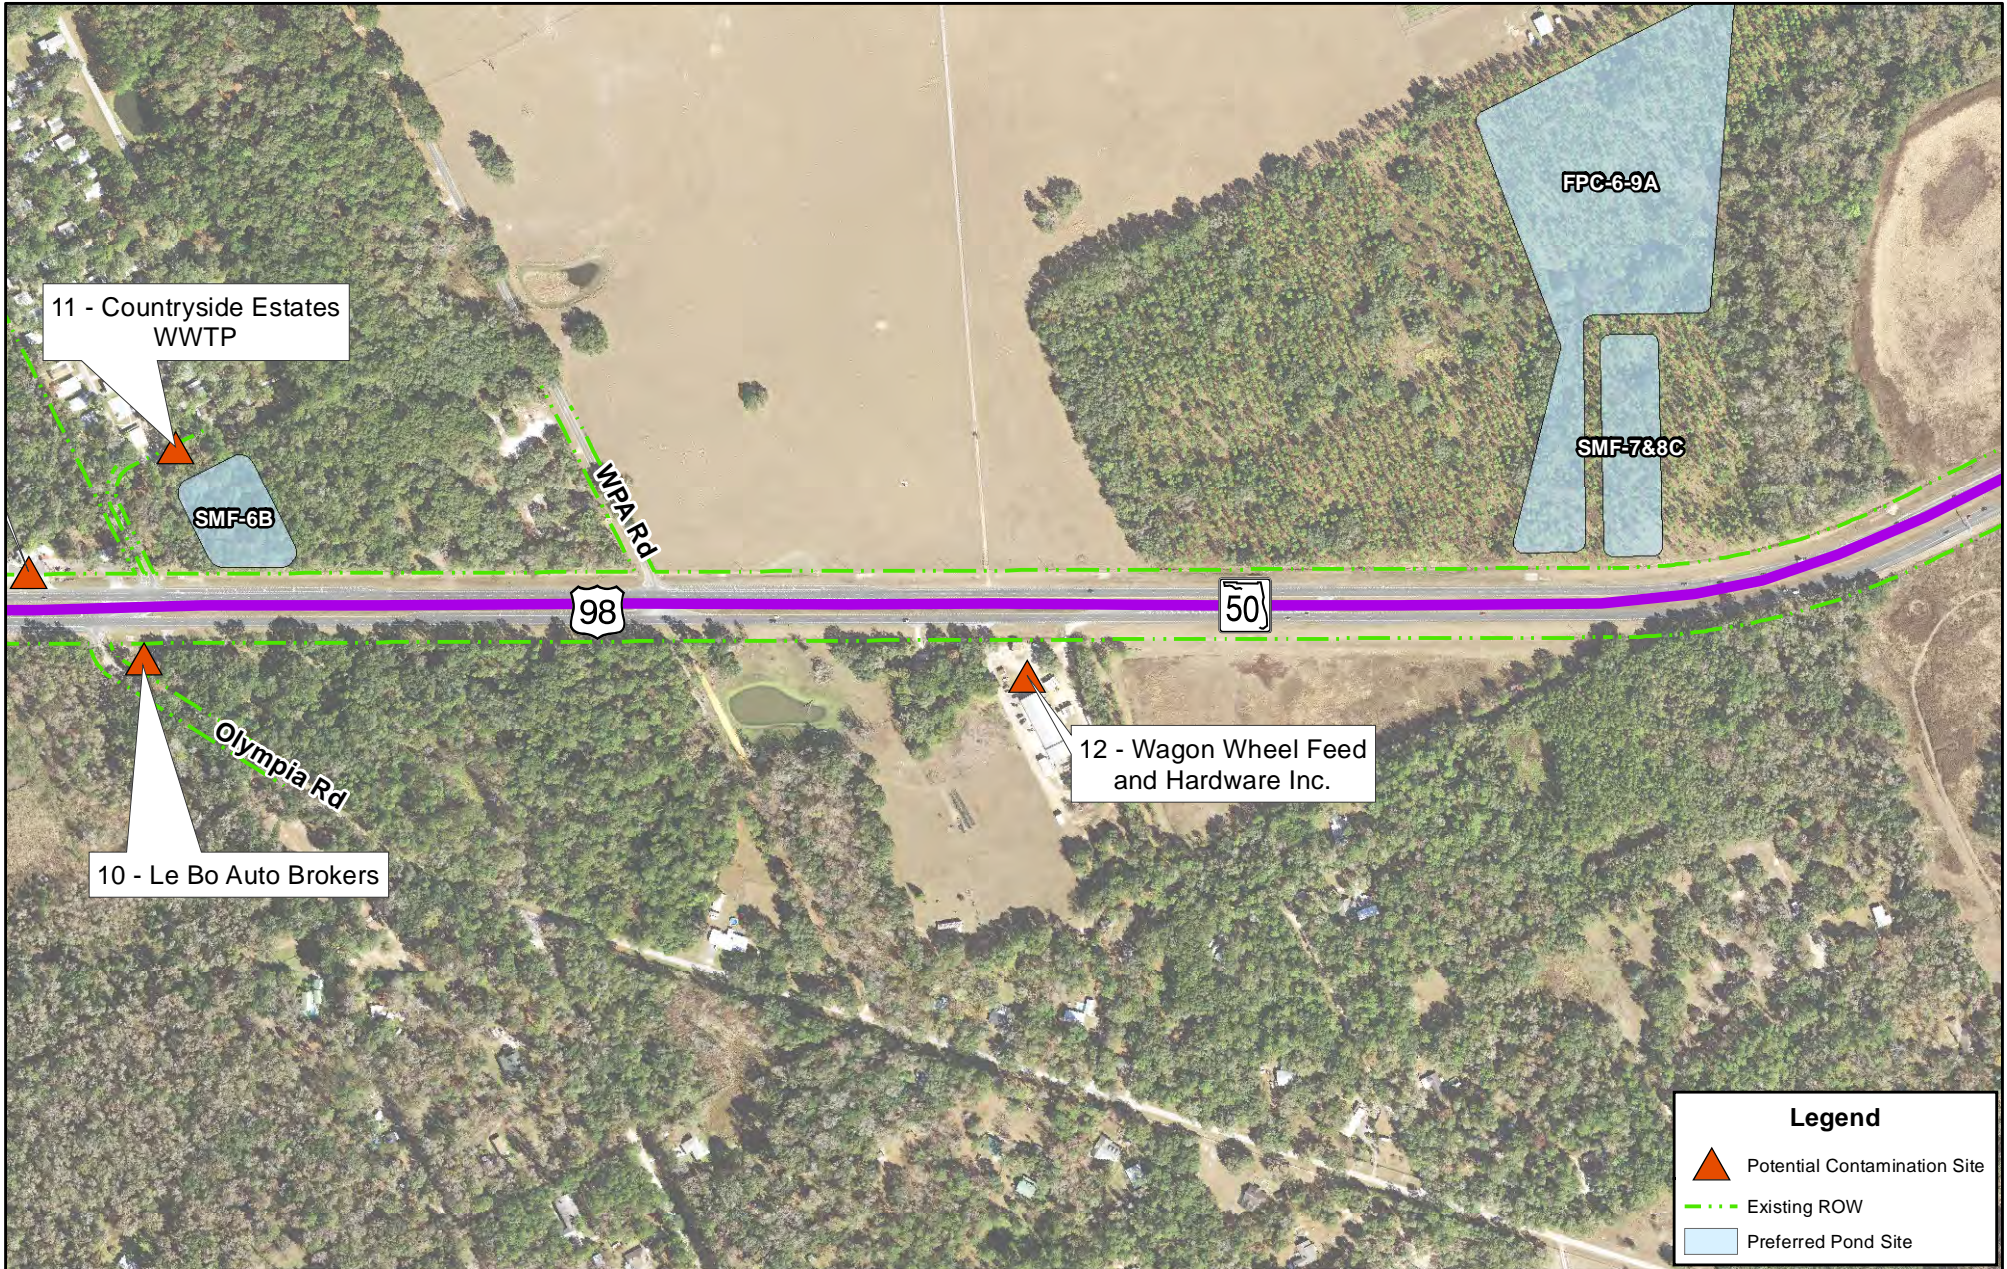
Appendix E
 Sheet 4 of 10

SR 50 (US 98) PD&E Study
 From Brooksville Bypass/SR 50A/E. Jefferson Street to west of Interstate 75
 WPI Segment No. 430051-1: Hernando County

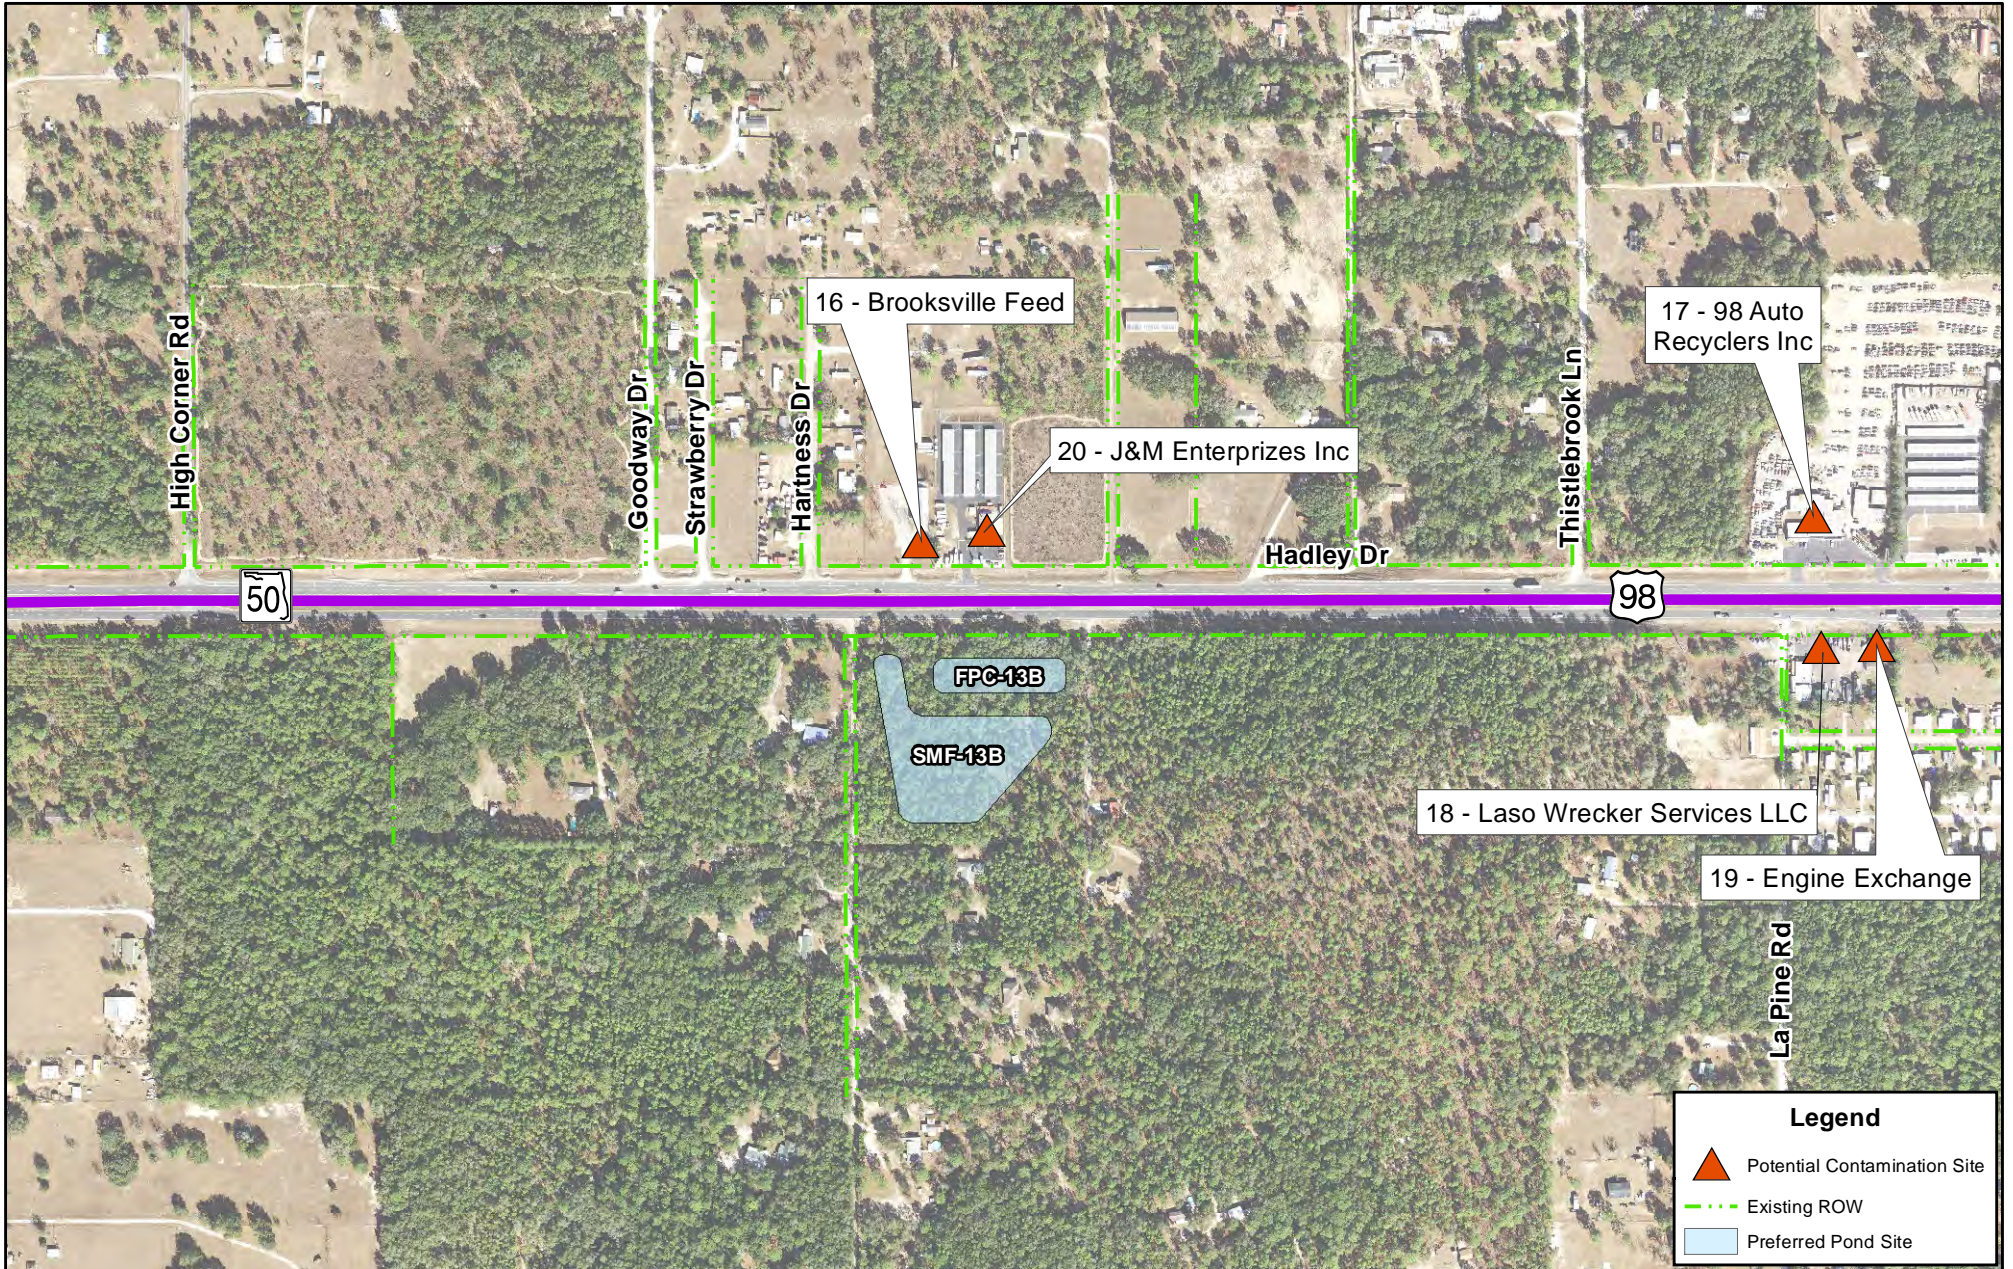
Appendix E
 Sheet 8 of 10

SR 50 (US 98) PD&E Study
From Brooksville Bypass/SR 50A/E. Jefferson Street to west of Interstate 75
 WPI Segment No. 430051-1: Hernando County

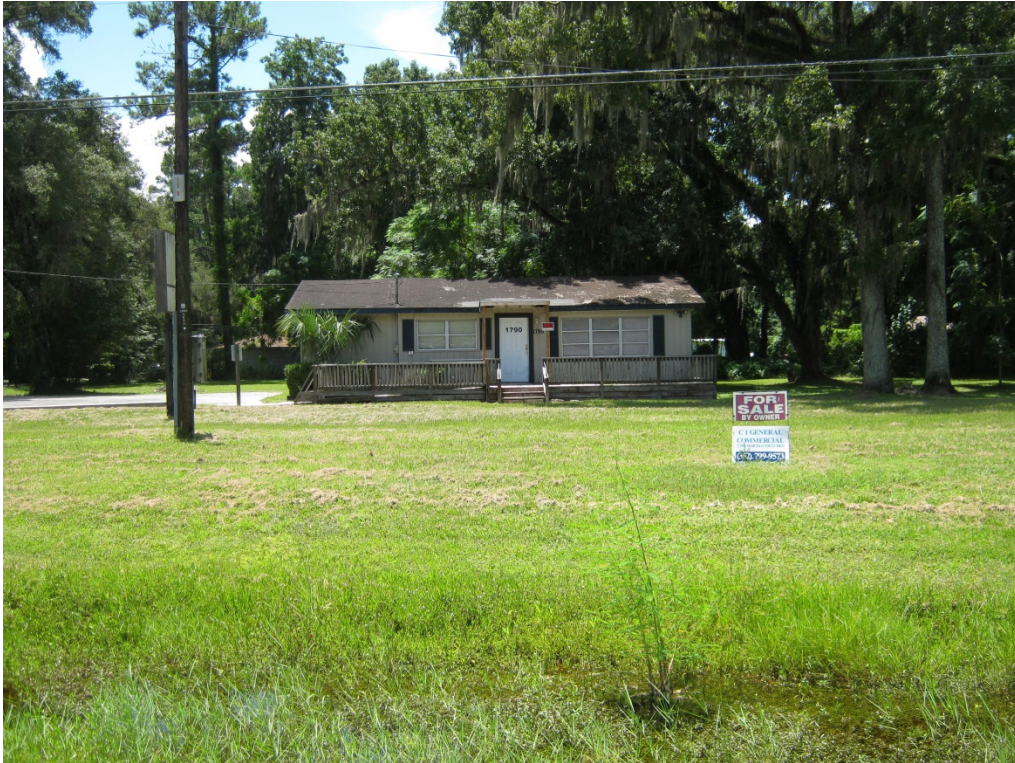
Site 1: Brooksville Truck Repair (closed, now vacant) taken from SR 50 looking south; Photo taken August 12, 2015.

The Brooksville Truck Repair facility is located at 804 Sardis Street. According to the property appraiser, the site is listed as P&F Enterprises Inc. A for-sale sign was also located on site. According to the Hernando County Property Appraiser's website, the building was first constructed in 1960. The building is difficult to see from the aerials until 1995. Prior to this, the parcel appears to be undeveloped, with one business located to the west as early as 1977. However, based on historical aerials on Google Earth, no trucks were seen on the site until 2004.

A review conducted for this site found no files available through DEP's database search, nor were any signs of contamination found during the field review. Potential sources of contamination include leaks and discharges from the equipment stored and repaired on site. The storage of this equipment could contribute contaminants such as gasoline, diesel, motor oil or hydraulic oil. Based on the lack of available information and type of equipment potentially stored on the site, this facility is rated **Low** risk for potential contamination.

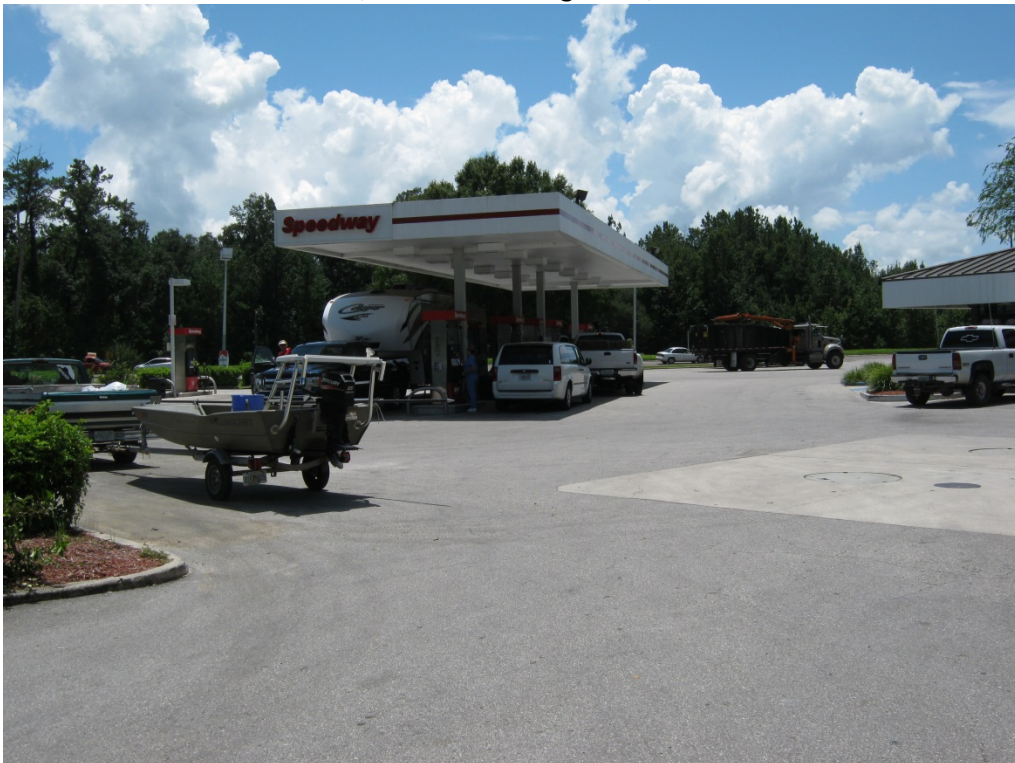
Site 2: Speedway west (F.K.A. Hess #09043) taken from SR 50 looking south; Photo taken August 12, 2015.

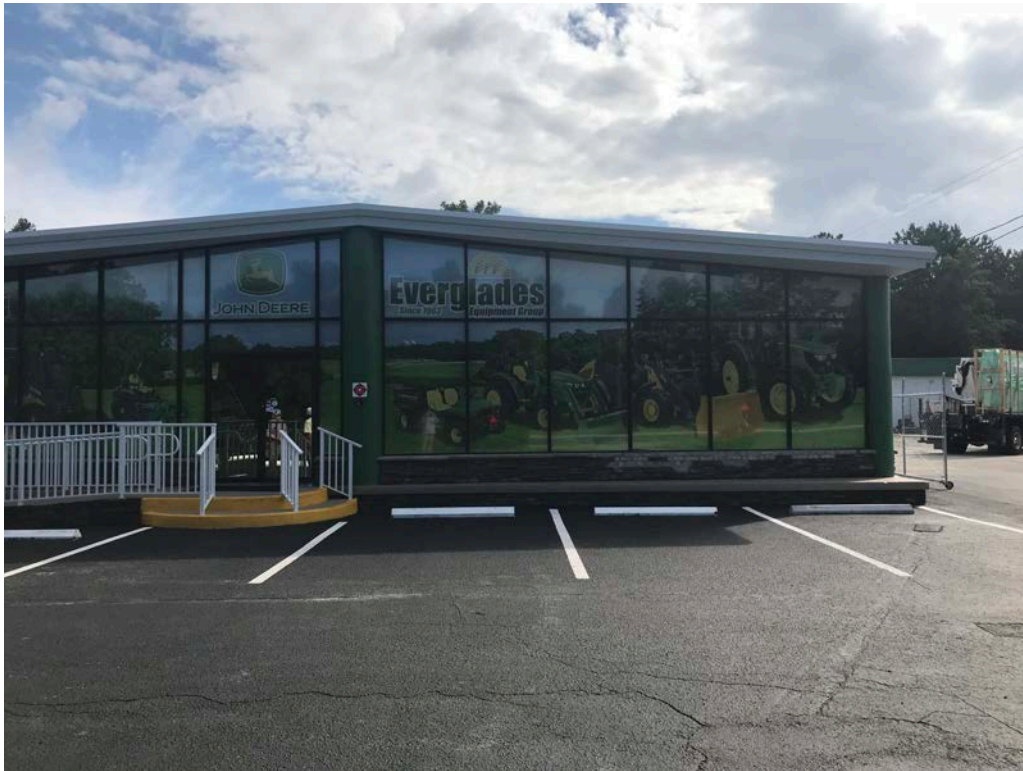
Site 3: Everglades Equipment Group (F.K.A. Liberty Auto Sales/Grubbs Construction/Wildcat Trucking Facility) taken from SR 50 looking north-northeast. Photo taken June 18, 2019.

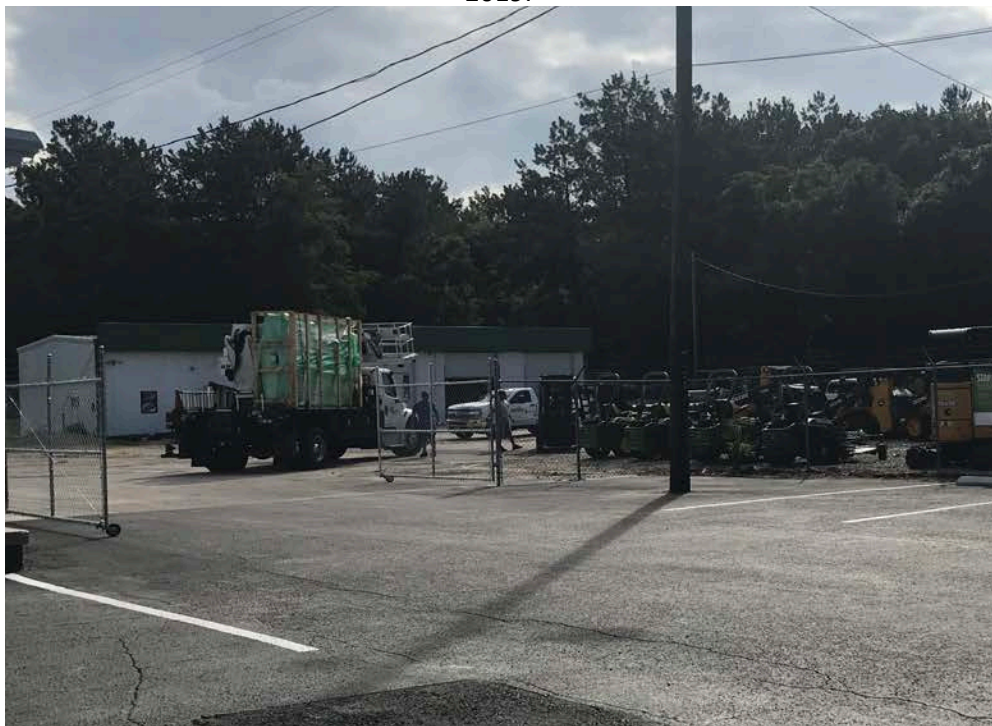
Site 3: Precision Powerstroke (now vacant) taken from SR 50 looking northeast; Photo taken June 18, 2019.

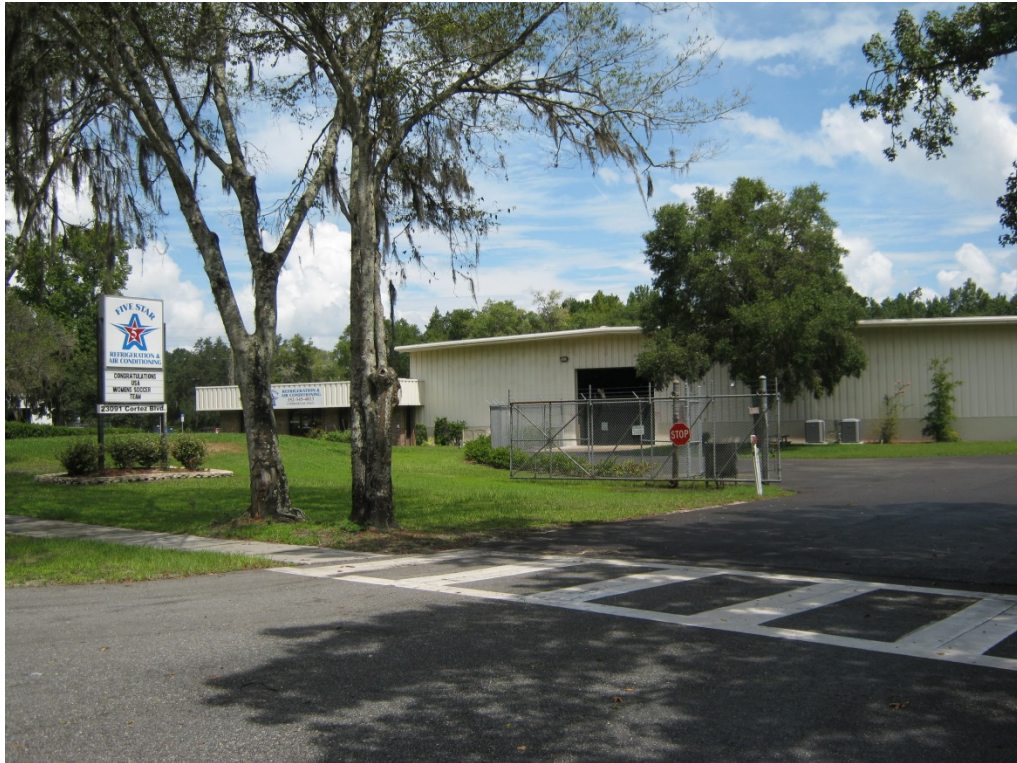
Site 4: Five Star Refrigeration and Air Conditioning (F.K.A. Coca-Cola Bottling Co.) taken from SR 50 looking north; Photo taken August 12, 2015.

The Five Star Refrigeration and Air Conditioning, formerly known as the Coca Cola Bottling Company, is located at 23091 Cortez Boulevard. The site consists of an office building with attached warehouse and detached garage. According to the Hernando County Property Appraiser's website, the warehouse building was constructed in 1981. Prior to this, the site appears to be undeveloped. A small building is present in the 1951 aerials adjacent to the parcel with what could be a residence or farmstead with a large open area that contains the site now containing the warehouse.

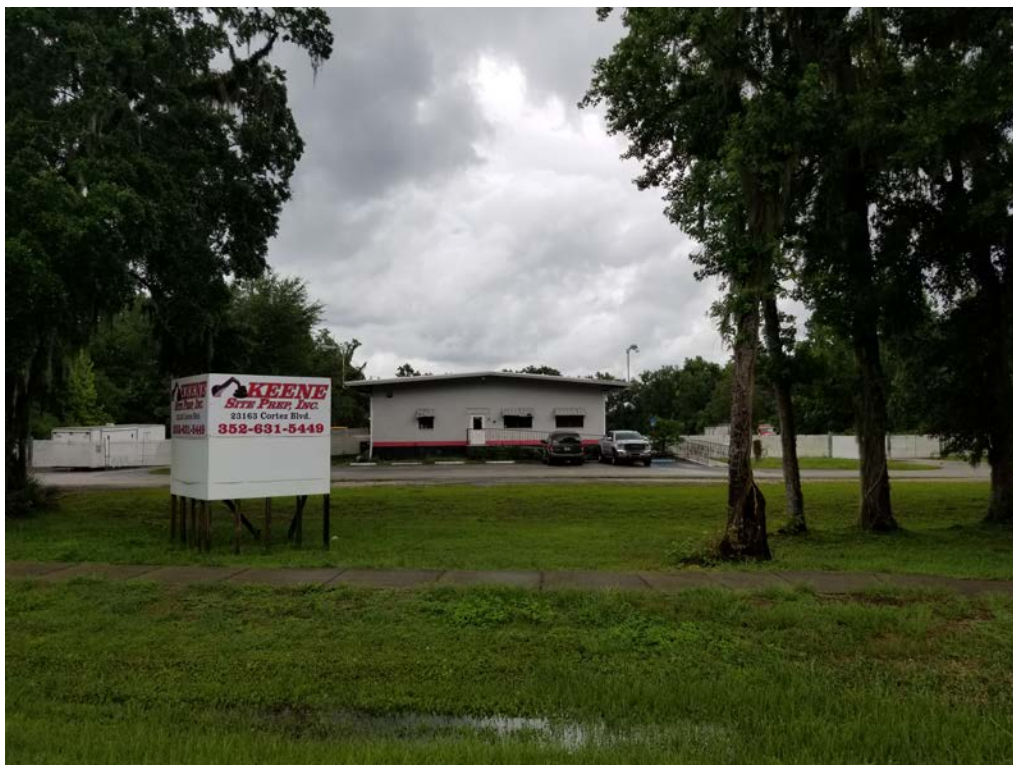
Site 5: Keene Site Prep, Inc. (F.K.A. Consolidated Resource Recovery Yard and Wood Waste Facility) taken from SR 50 looking north; Photo taken June 14, 2019.

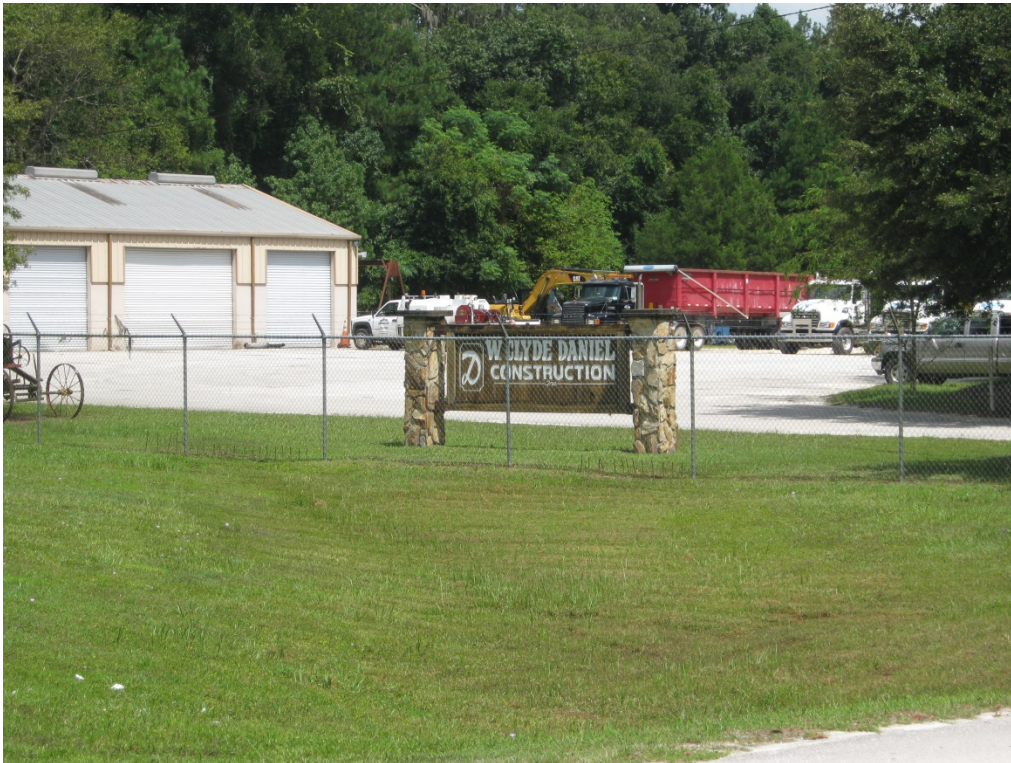
Site 6: W. Clyde Daniels Construction Inc. taken from SR 50 looking north; Photo taken August 12, 2015.

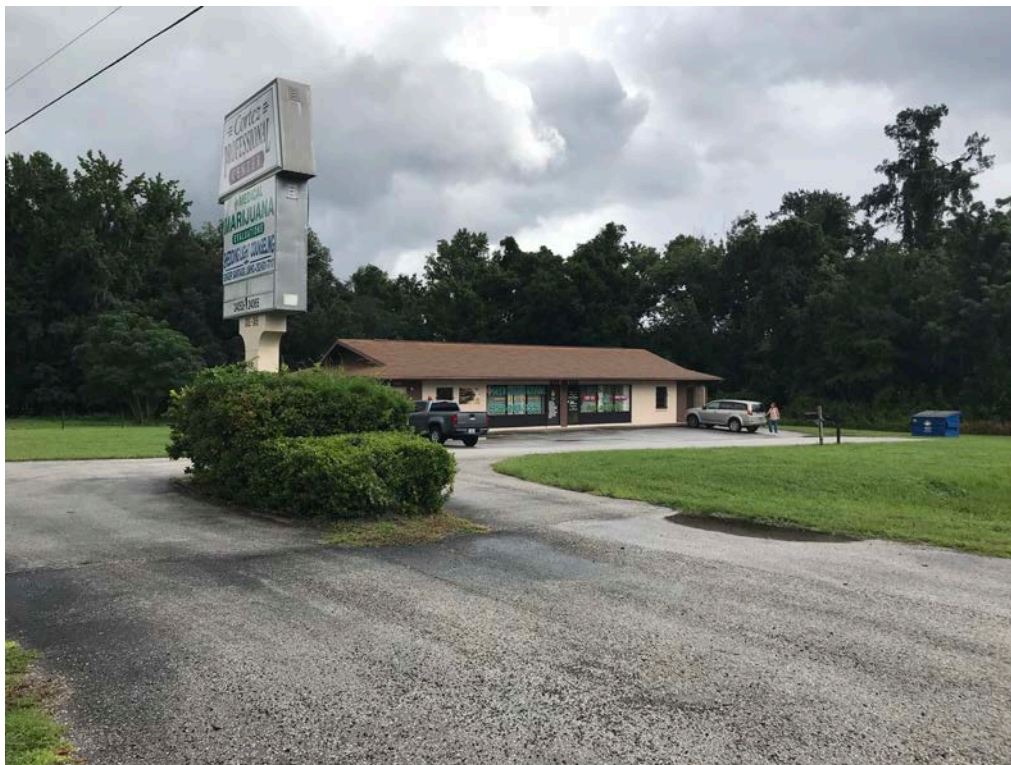
Site 7: Cortez Professional Center (F.K.A. Econo Auto Painting) taken from SR 50 looking northeast;
Photo taken June 14, 2019.

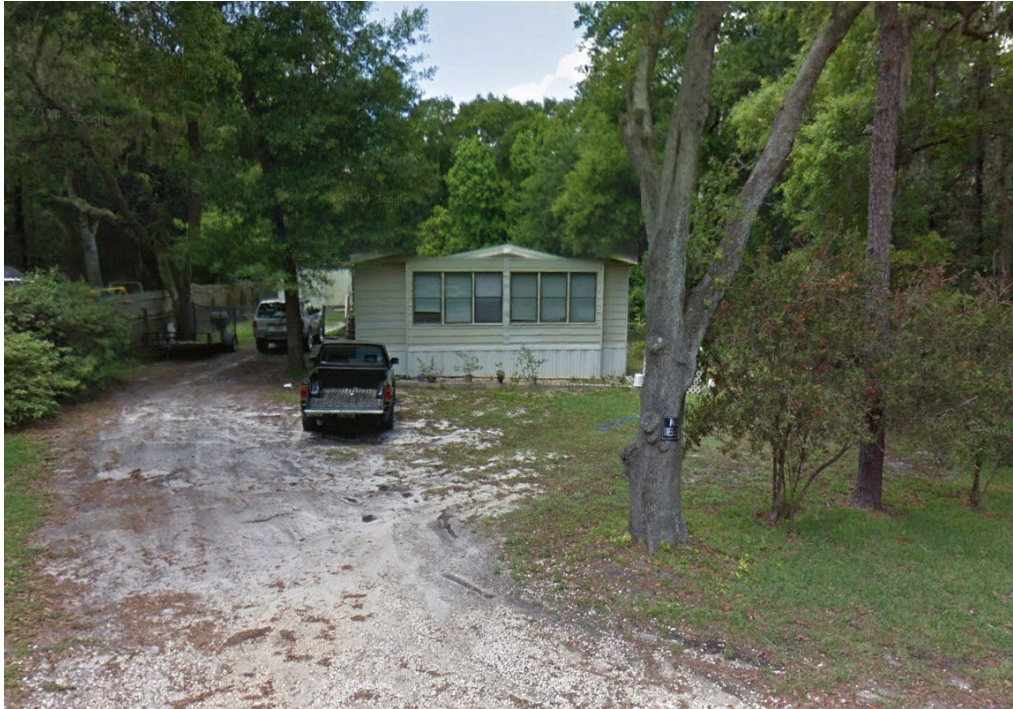
Site 8: R&J Pressure Washing taken from Lang Street looking west; Photo taken August 12, 2015.

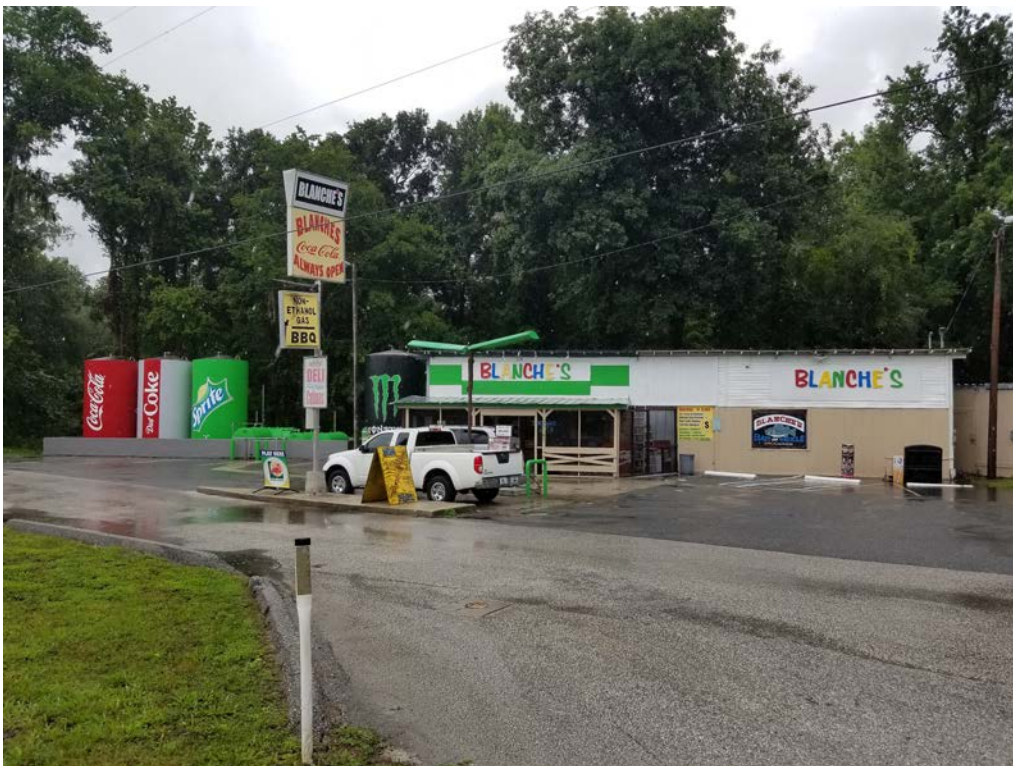
Site 9: Blanche's (F.K.A. Project Oil Company Inc.) taken from SR 50 looking north; Photo taken June 14, 2019.

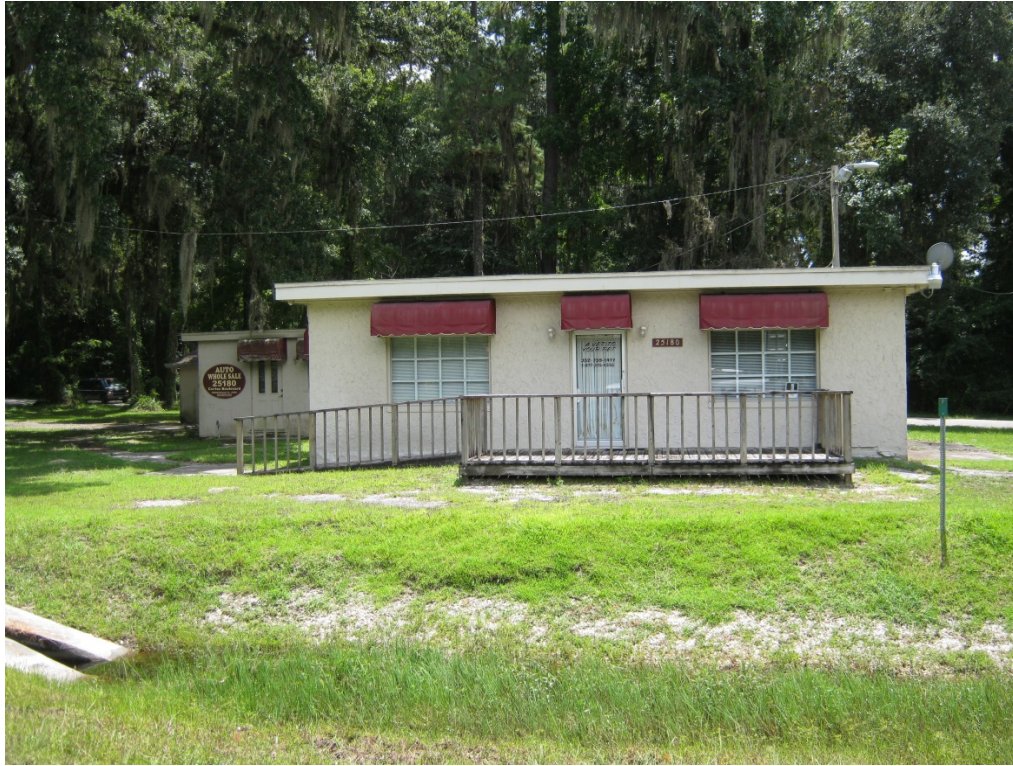
Site 10: Le Bo Auto Brokers (closed) facility taken from SR 50 looking south; Photo taken August 12, 2015.

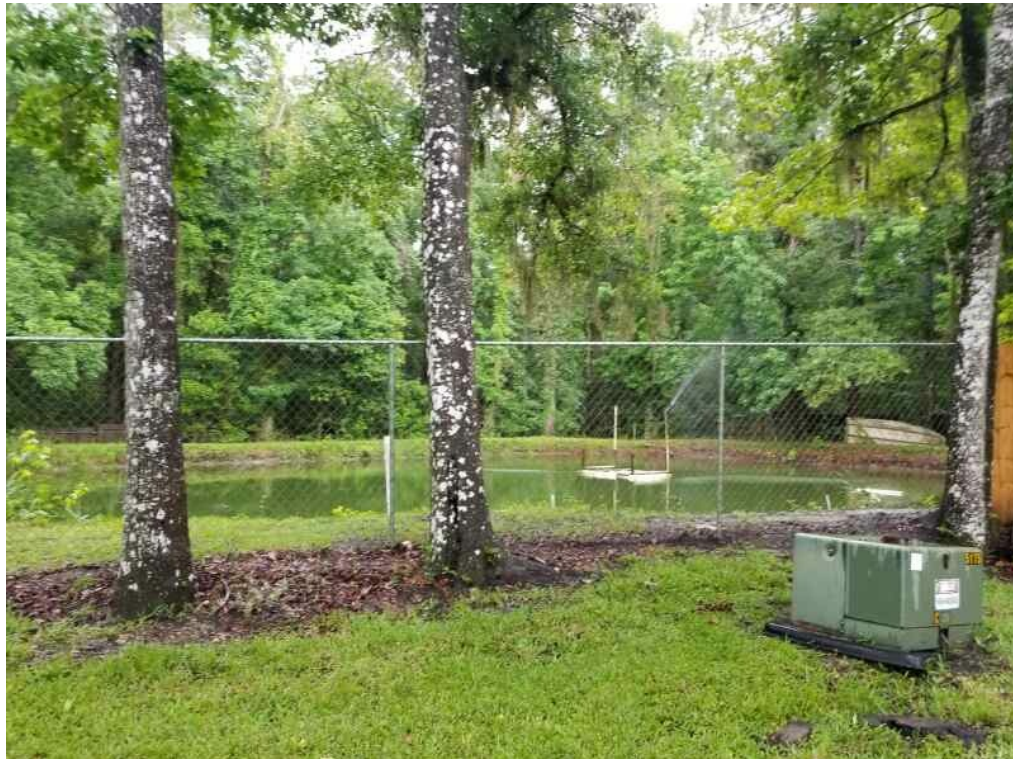
Site 11: Countryside Estates Wastewater Treatment Plant taken from Tall Oaks Lane looking east; Photo taken June 14, 2019

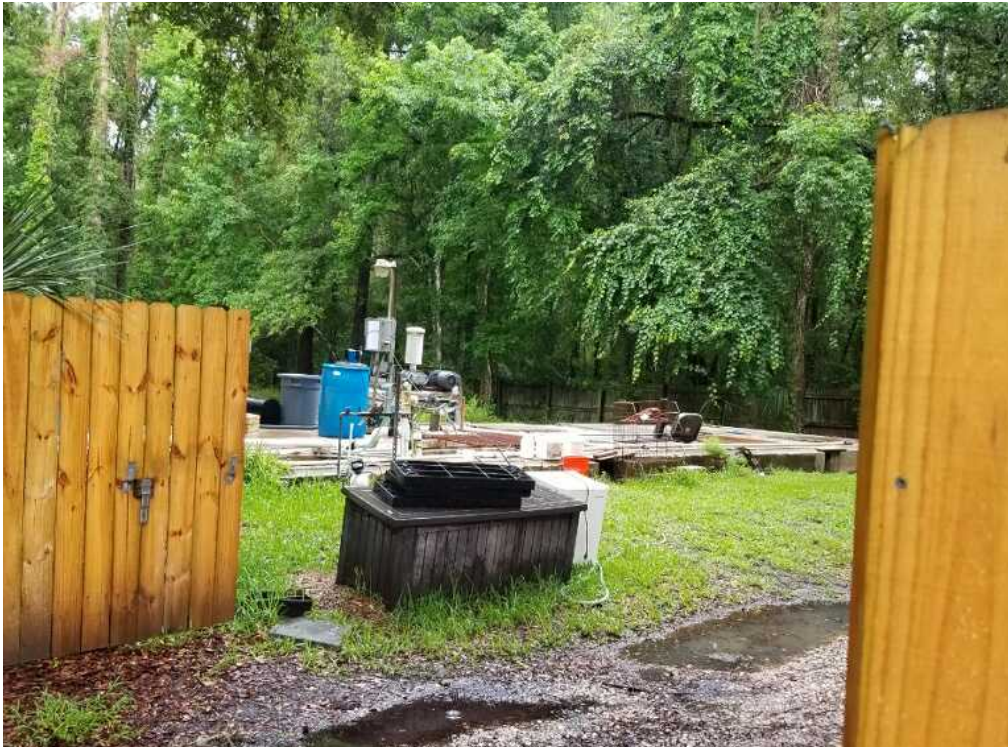
Site 11: Countryside Estates Wastewater Treatment Plant taken from Tall Oaks Lane looking south; Photo Taken June 14, 2019

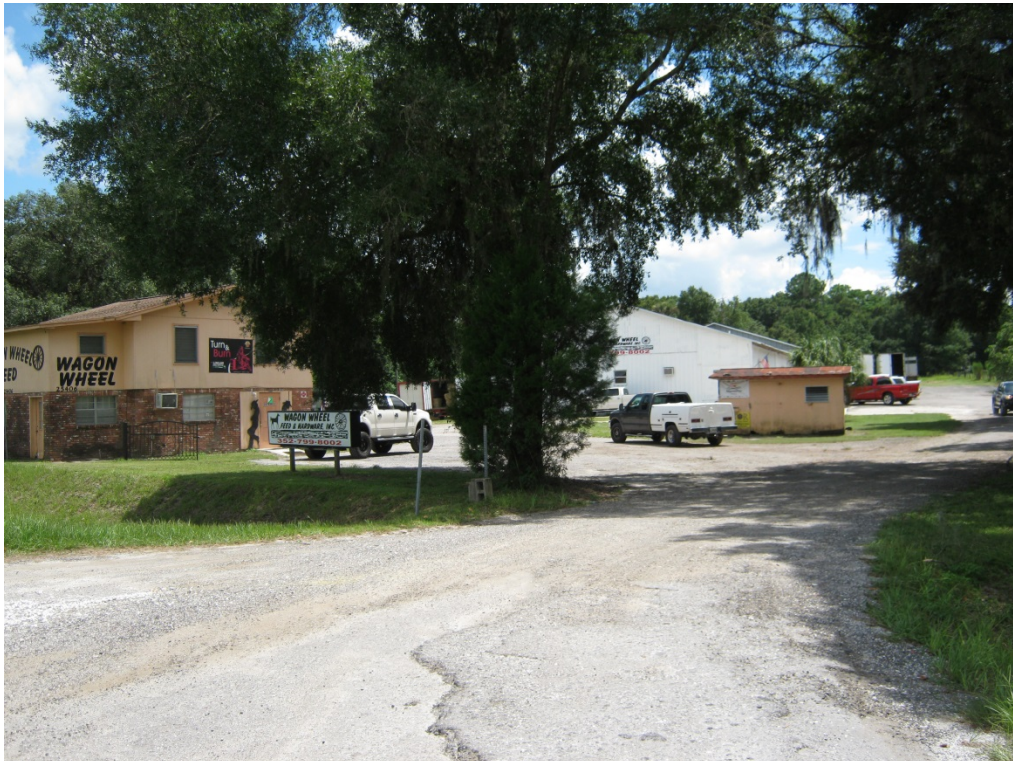
Site 12: Wagon Wheel and Feed Hardware (F.K.A. Packing House) taken from SR 50 looking south; Photo taken August 12, 2015.

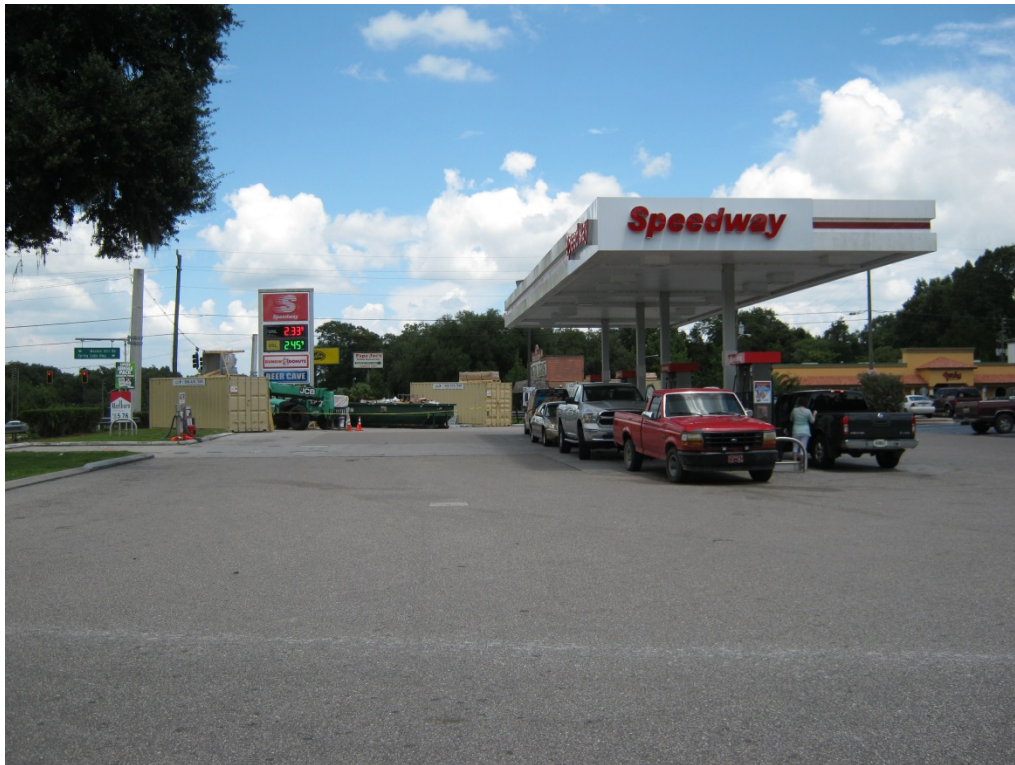
Site 13: Speedway (F.K.A. Hess #09404) taken from SR 50 looking south; Photo taken August 12, 2015.
