Contamination Screening Evaluation Report

**State Road (SR) 50 (US 98/Cortez Boulevard)
Project Development & Environment (PD&E) Study
From the Brooksville Bypass to west of Interstate 75**

Work Program Item Segment No. 430051-1

***Contamination Screening
Evaluation Report***

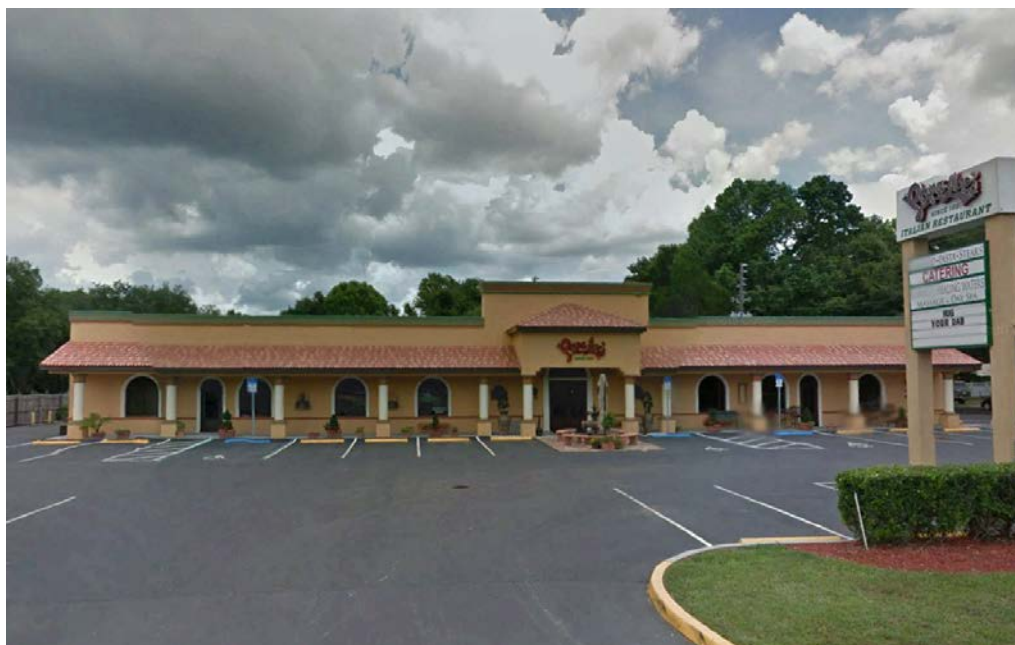
Site 14: Papa Joe's Italian restaurant –Likely location of former Pick Kwik Food Store; taken from Spring Lake Highway looking east; Photo taken August 12, 2015.

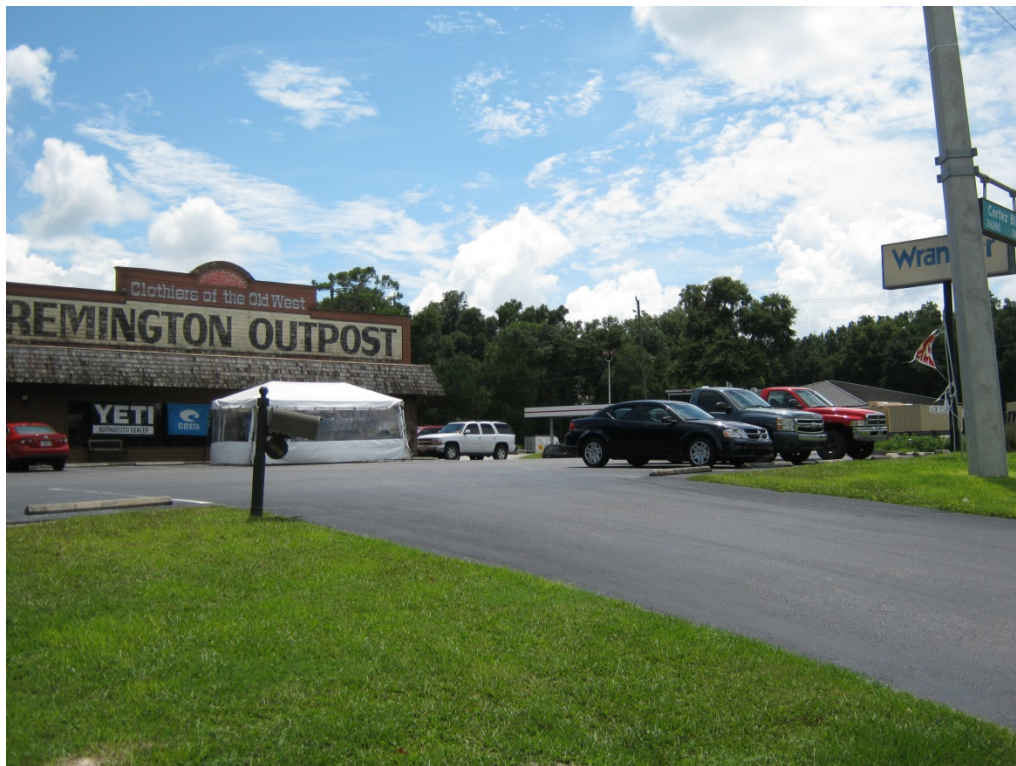
Site 14: Possible location of former Pick Kwik Food Store (now Remington Outpost) taken from SR 50 looking south; Photo taken August 12, 2015.

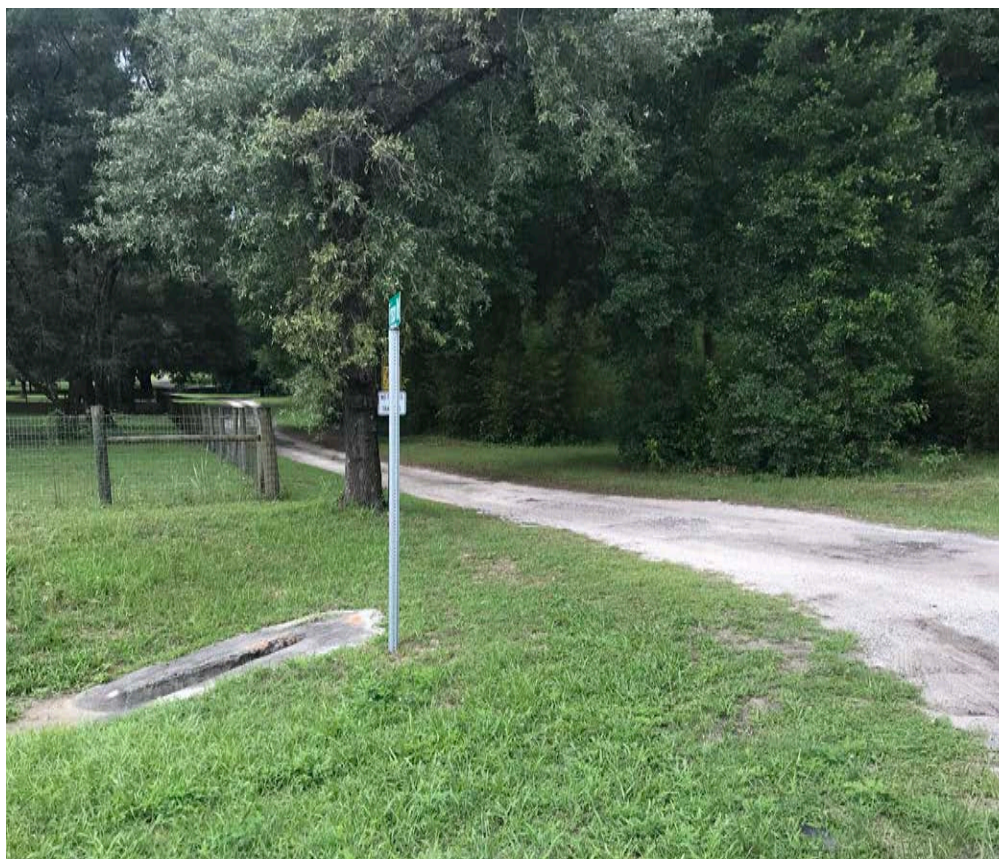
Site 15: Corner of Frisco Road taken from SR50 looking south; Photo taken June 14, 2019

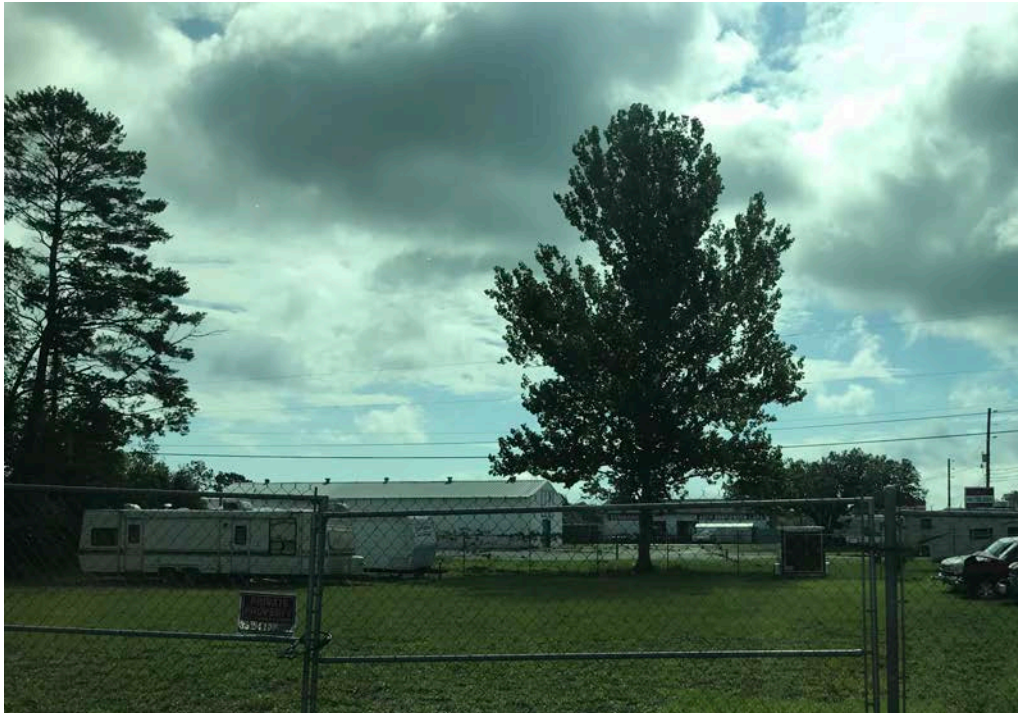
Site 16: Brooksville Feed and Pet Store (now vacant) taken from Hartness Drive looking east;
Photo taken June 18, 2019.

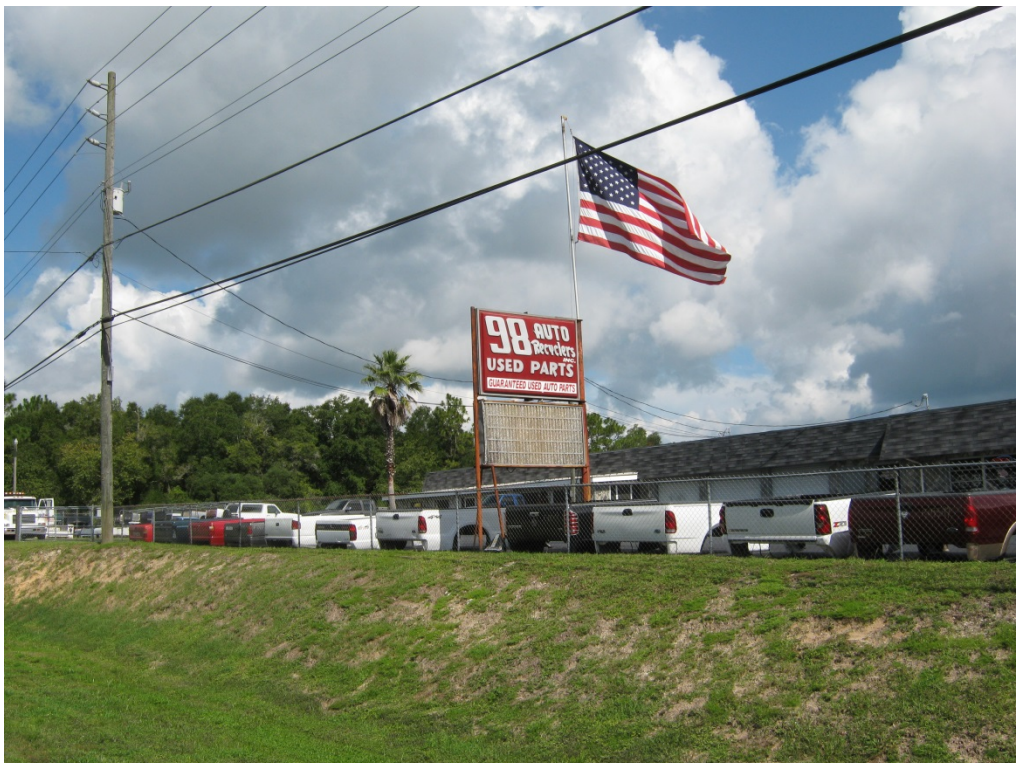
Site 17: 98 Auto Recyclers Inc. (also known as Mitrisin Enterprises Inc.) taken from SR 50 looking
north; Photo taken August 12, 2015.

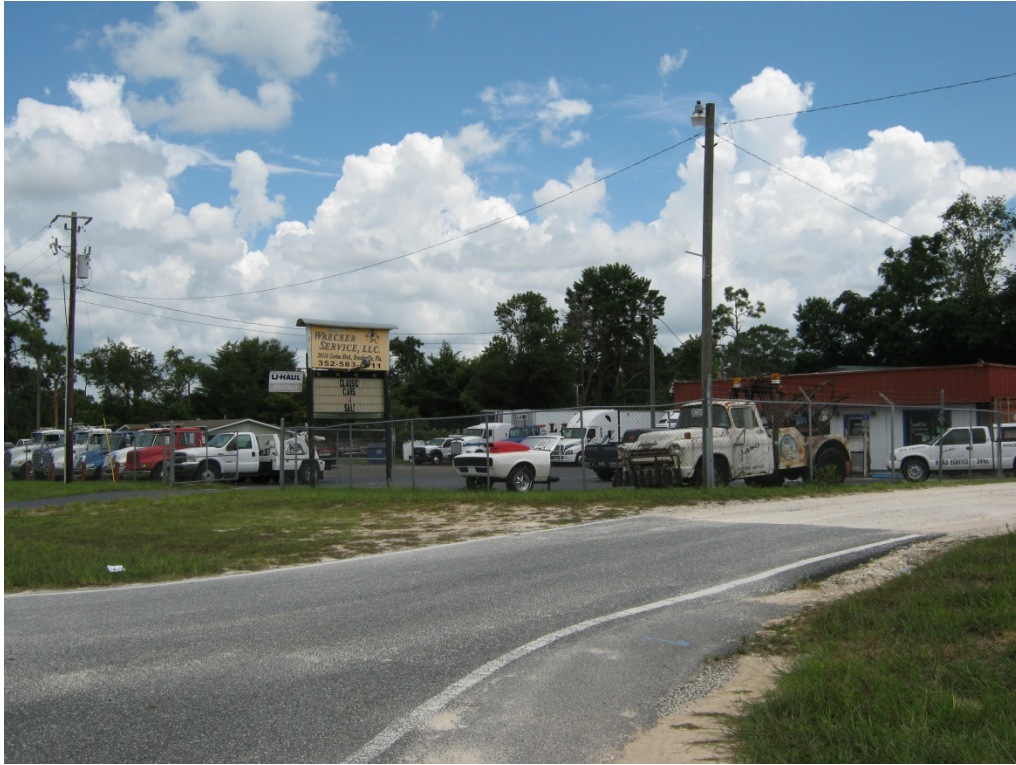
Site 18: Laso Wrecker Service, LLC taken from SR 50 looking south; Photo taken August 12, 2015.

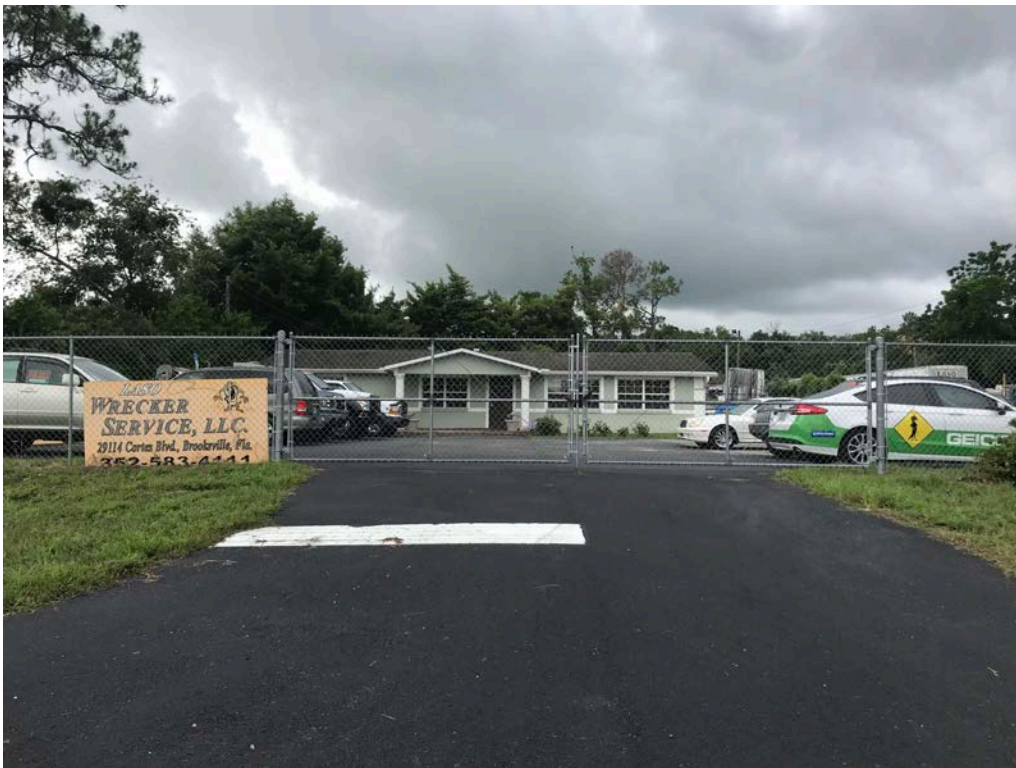
Site 19: Laso Wrecker Service, LLC (F.K.A. Engine Exchange) taken from SR 50 looking south; Photo taken June 14, 2019.

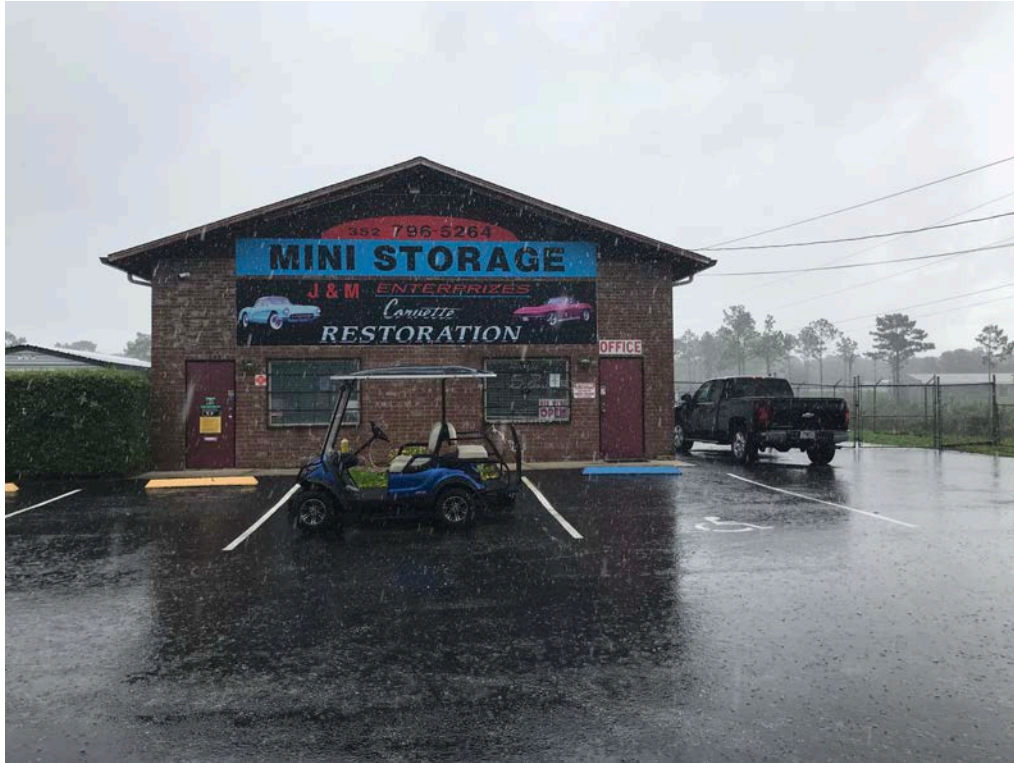
Site 20: J&M Enterprizes Inc. taken from SR 50 looking north; Photo taken June 14, 2019.
