POND SITING REPORT

Gandy Boulevard (US 92/SR 600) Project Development and Environment (PD&E) Study

Limits of Project: 4<sup>th</sup> Street to West Shore Boulevard

Date: February 2023

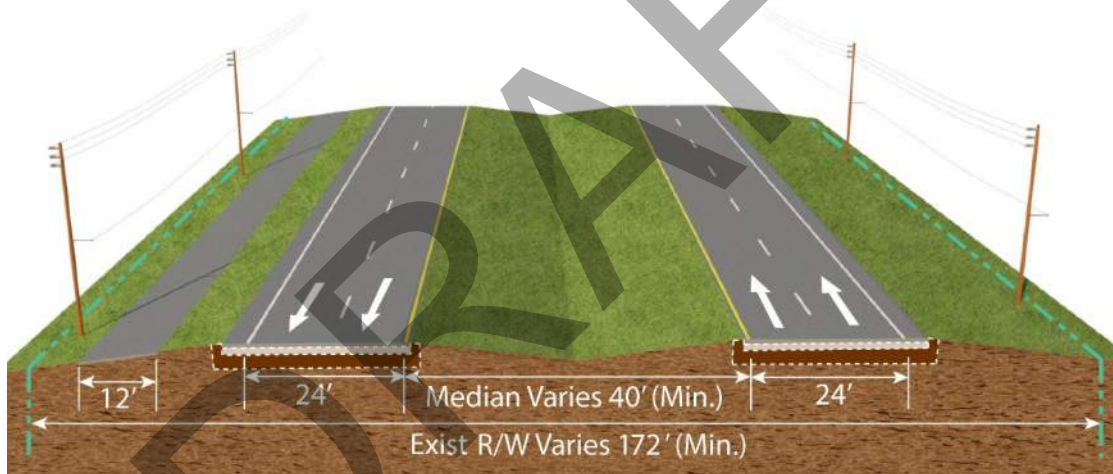
**Figure 1-2: Existing Roadway Typical Section – Segment 1**

Segment 1 (Pinellas Segment) begins at the western project limit at 4th Street and extends 3.5 miles to the west end of the Gandy bridges over Old Tampa Bay in Pinellas County. Within Segment 1, the existing facility consists of a four-lane divided roadway with a varying median width (40 feet minimum), four 12-foot travel lanes, paved outside shoulders (four-foot minimum) designated for bicycle use on the south side, intermittent sidewalk segments, a 12-foot multi-use trail on the north side, and open ditches along the outside. The existing right-of-way (ROW) width varies in Segment 1 with a minimum width of 172 feet as shown in **Figure 1-2**. There are numerous side street and driveway connections to the residential and business land uses between 4th Street and San Fernando Drive.

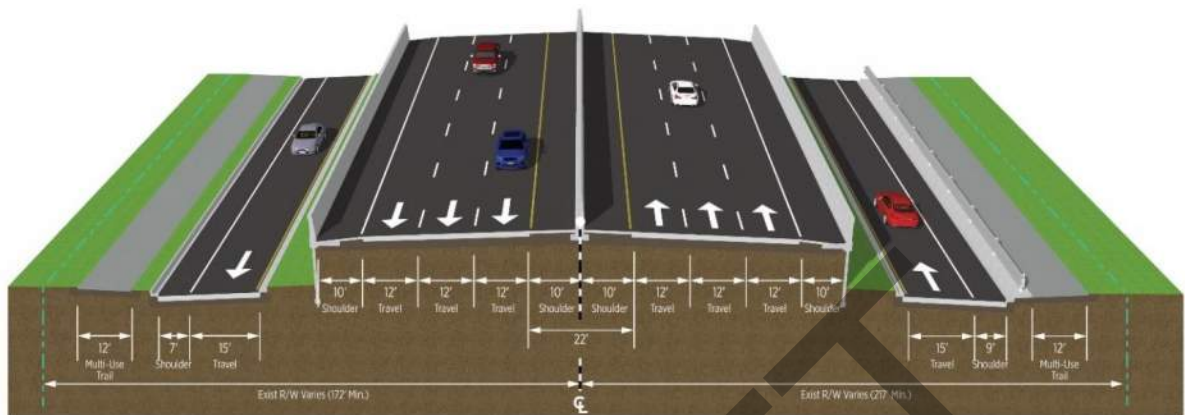
Figure 1-7: Segment 1 – Typical Section 3

Typical Section 3 is proposed from East of San Fernando Drive to the west end of the Gandy bridges. An additional travel lane in either direction is developed from the direct connect access ramps from the local frontage roads creating a six-lane typical section throughout the causeway which continues east over the Gandy bridges. Typical Section 3 consists of an elevated controlled access roadway with three 12-foot travel lanes in each direction, ten-foot paved inside shoulders, and ten-foot paved outside shoulders with barrier wall in each direction. The median transitions from 46 feet to 22 feet with opposing travel lanes separated by median barrier wall. One-lane frontage roads are proposed on the outside of the controlled access roadway in each direction with a 15-foot travel lane, varying outside shoulder widths (seven feet to nine feet paved), curb and gutter, and a 12-foot multi-use trail. One of the frontage roads will provide access to multi-use trail parking. Typical Section 3 is proposed within the existing FDOT ROW as shown in **Figure 1-7**.

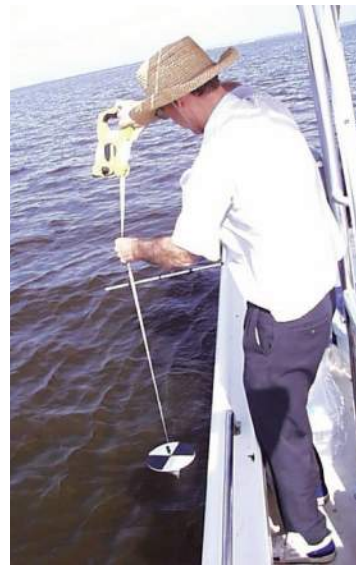
A scientist measures water clarity using a Secchi disk.

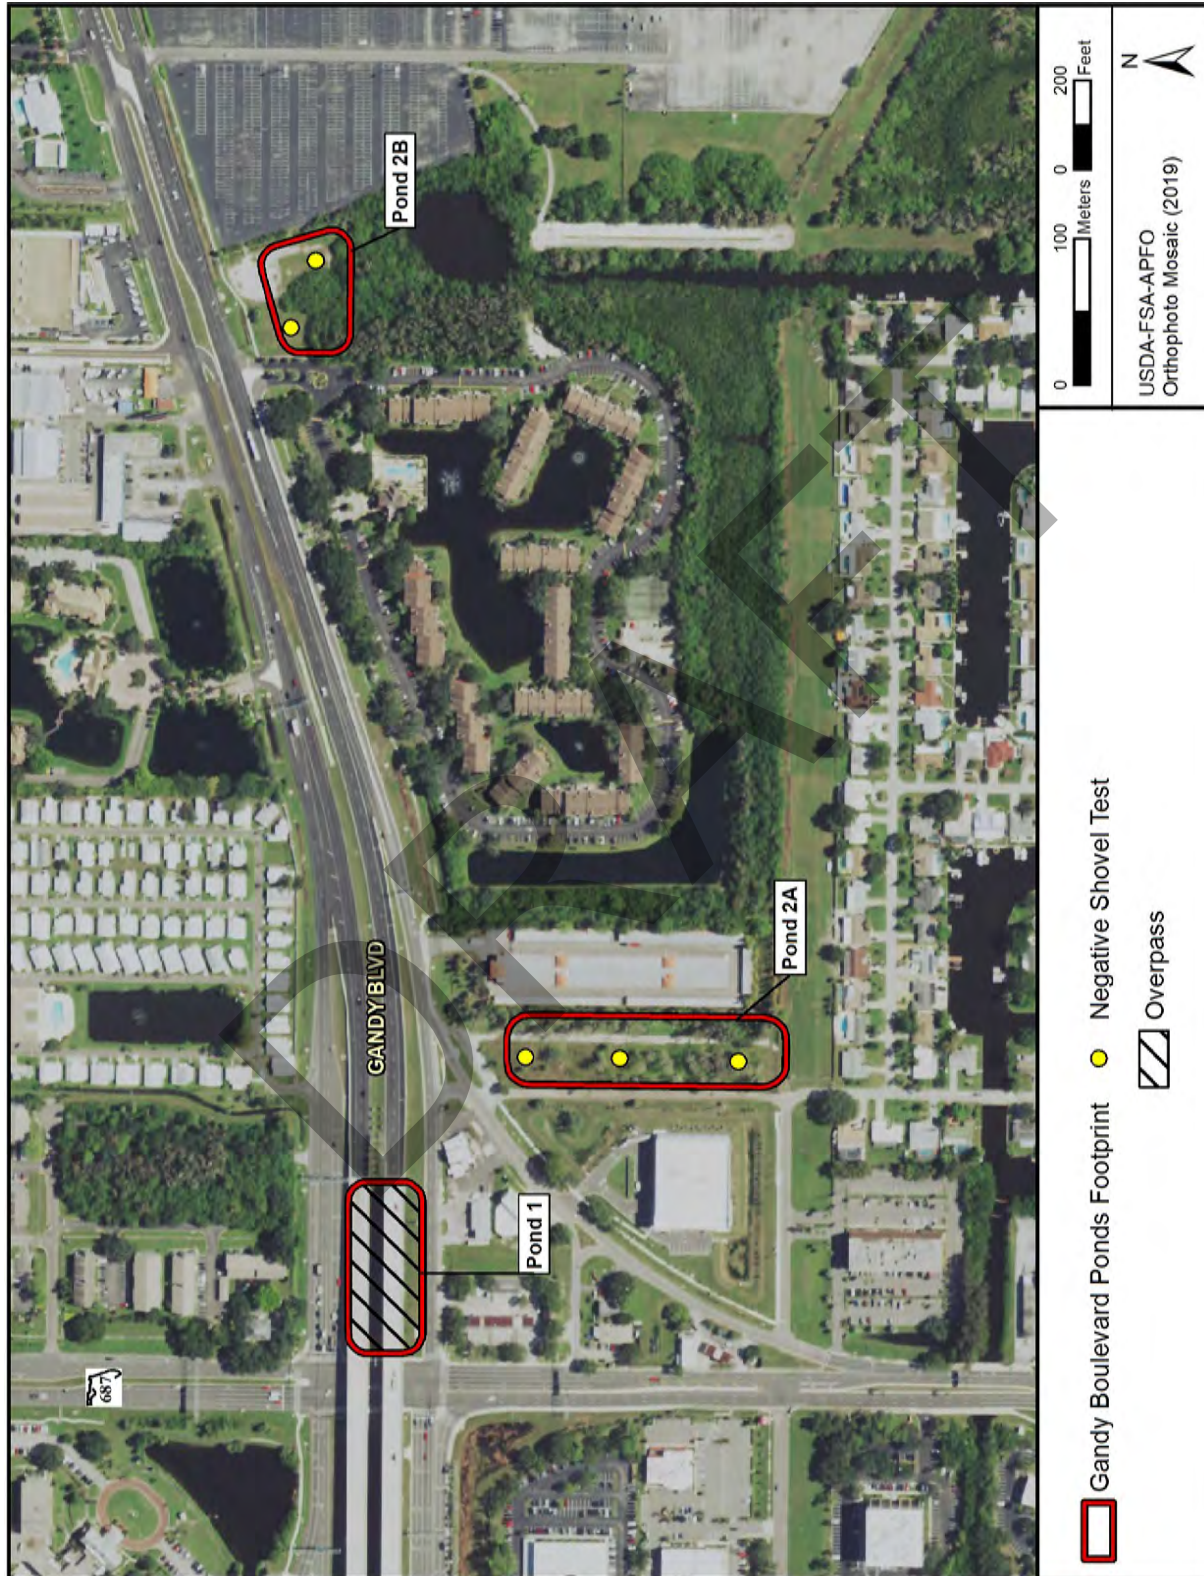
Figure 5. Results of archaeological testing within the APE.

Pond 1 consists of an approximately 0.6-ha (1.4-ac) footprint located in the Gandy Boulevard ROW underneath the overpass at SR 687 just east of the intersection of the two roads (**Figure 6**). No subsurface archaeological testing was conducted at the proposed Pond 1 footprint due to an overlapping existing pond and buried utilities adjacent to the inundated portions of the pond. SEARCH completed pedestrian survey and photo documentation within the pond footprint. These efforts encountered no archaeological sites or occurrences within the proposed Pond 1 footprint. No further archaeological survey is recommended.

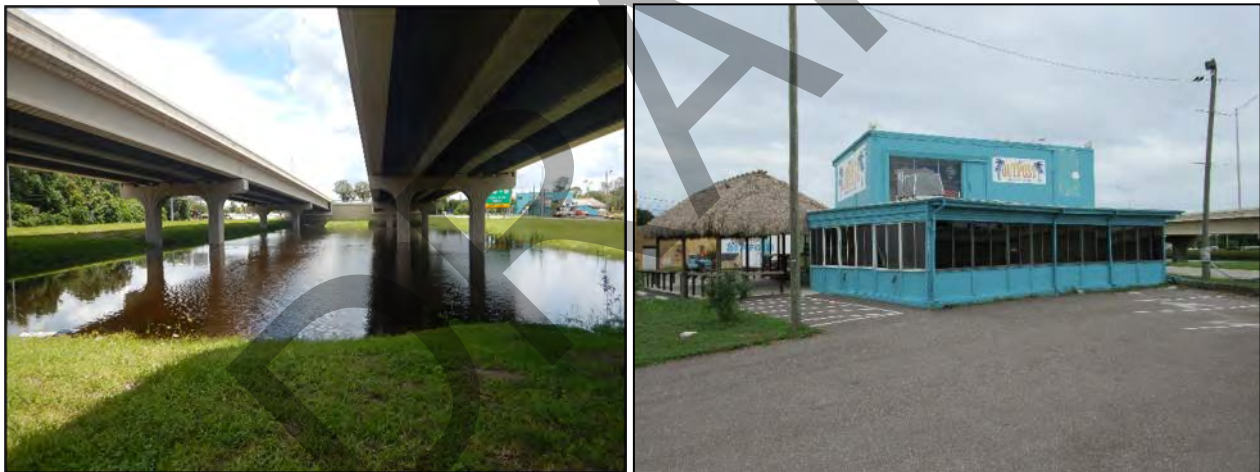
**Figure 6. Pond 1 overview. Left: terrain and vegetation at Pond 1, view east; Right: 8PI12016 (Former Webb's Outpost), view northeast.**

One previously documented historic building, the Former Webb's City Outpost (8PI12016), is located at the southeast corner of the Pond 1 APE (see **Figure 6**). Built ca. 1952, this Masonry Vernacular former retail establishment was evaluated as ineligible for the NRHP by the SHPO in May 2012. SEARCH revisited and documented 8PI12016 during the current Gandy Boulevard mainline roadway CRAS and determined that the building remained ineligible for the NRHP. Based on the results of the roadway and ponds CRAS, no further work is recommended for Pond 1.

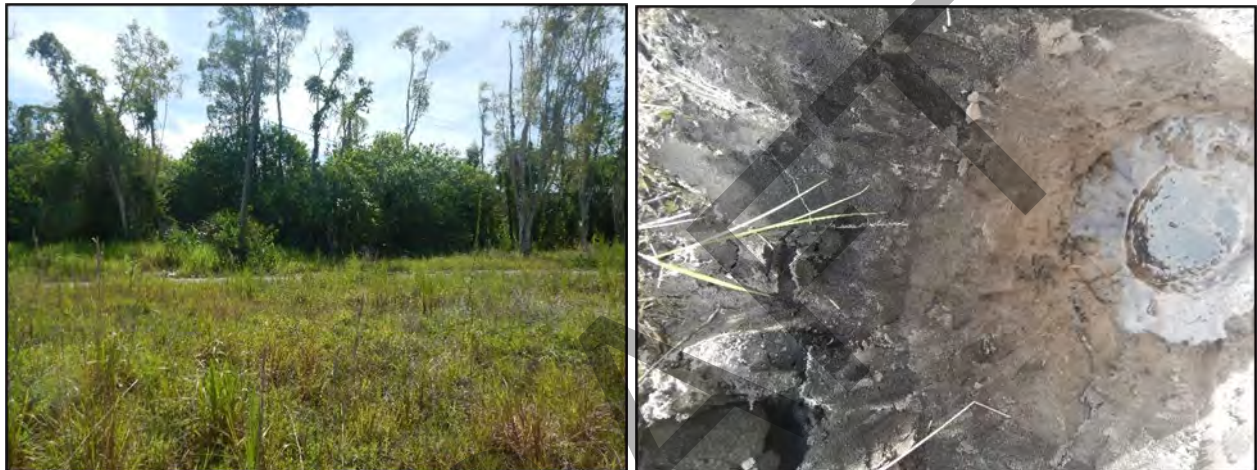
**Figure 7. Pond 2A overview. Left: Terrain and vegetation at Pond 2A, view east; Right: Typical shovel test profile observed at Pond 2A.**

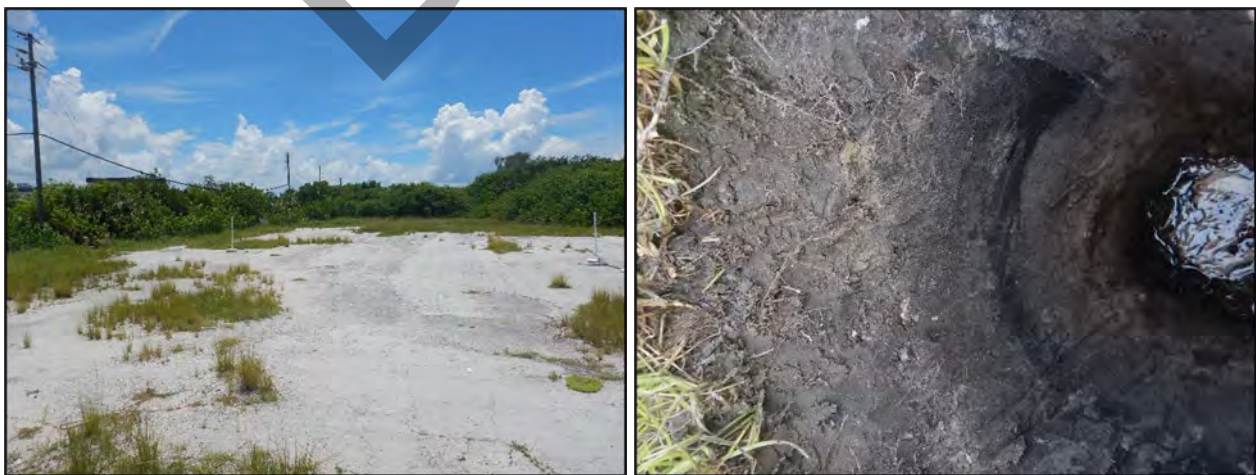
**Figure 8. Pond 2B overview. Left: Terrain and vegetation at Pond 2B and within the Derby Lane Historic District boundaries, view east; Right: Typical shovel test profile observed in Pond 2B.**

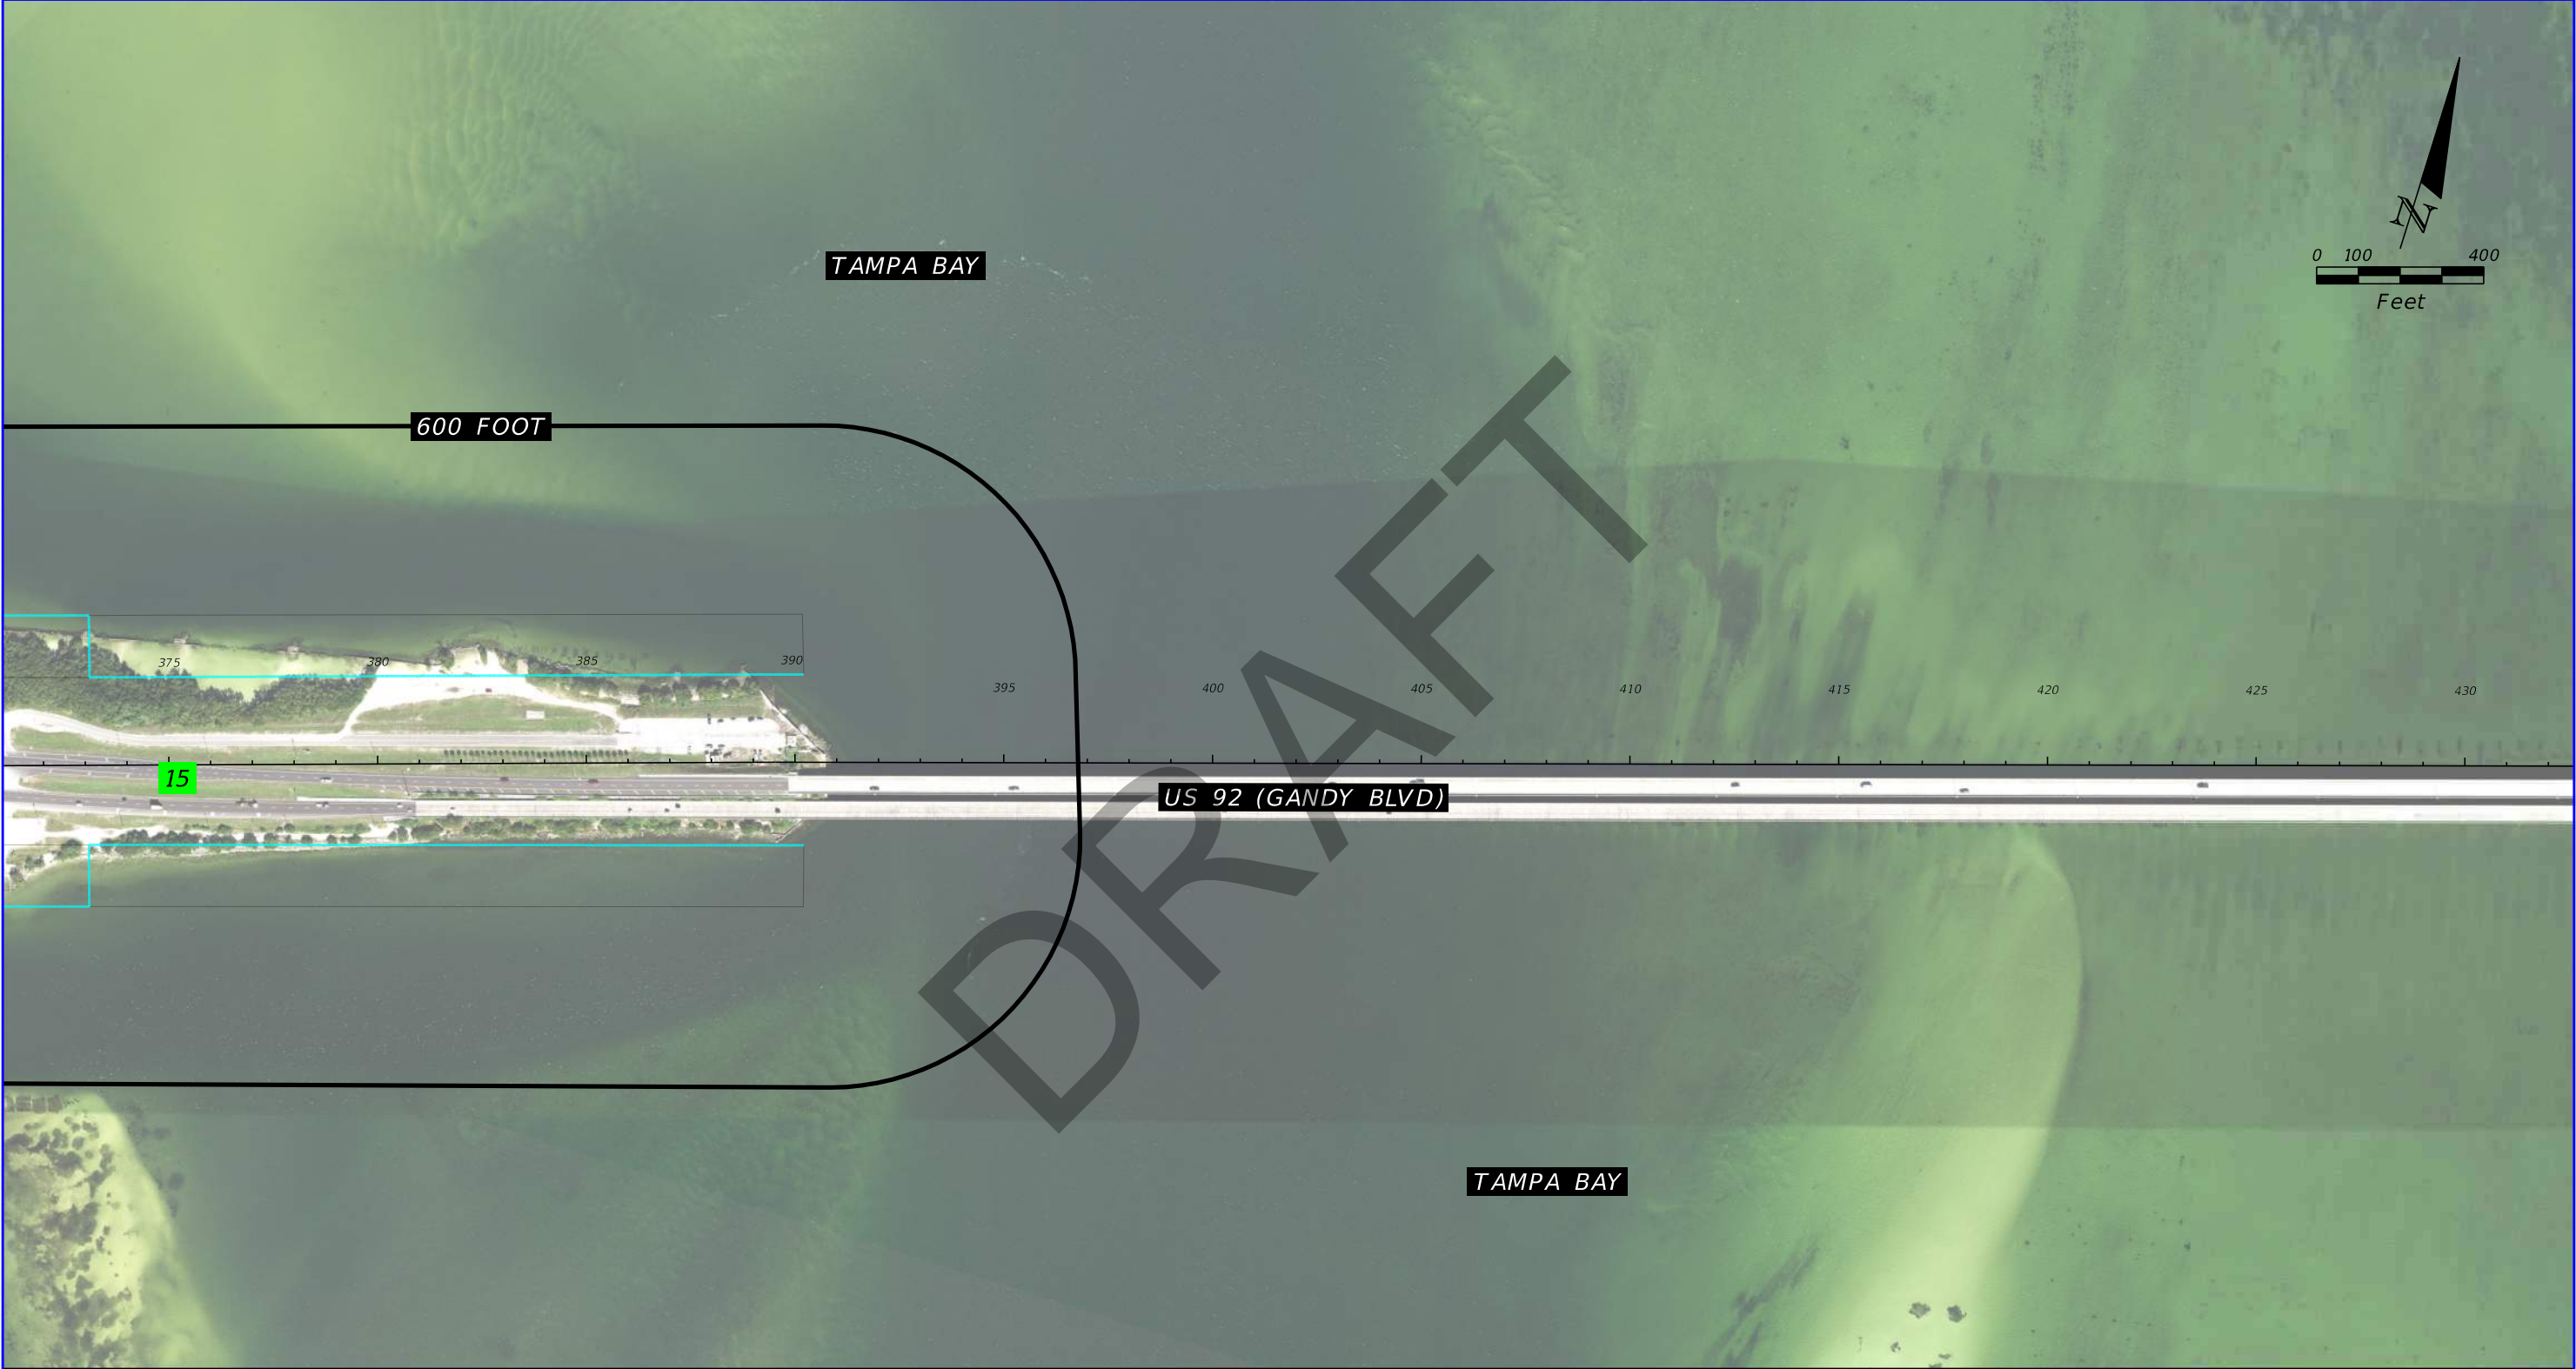
RED = HIGH/MEDIUM RISK SITES

POTENTIAL CONTAMINATION SITES

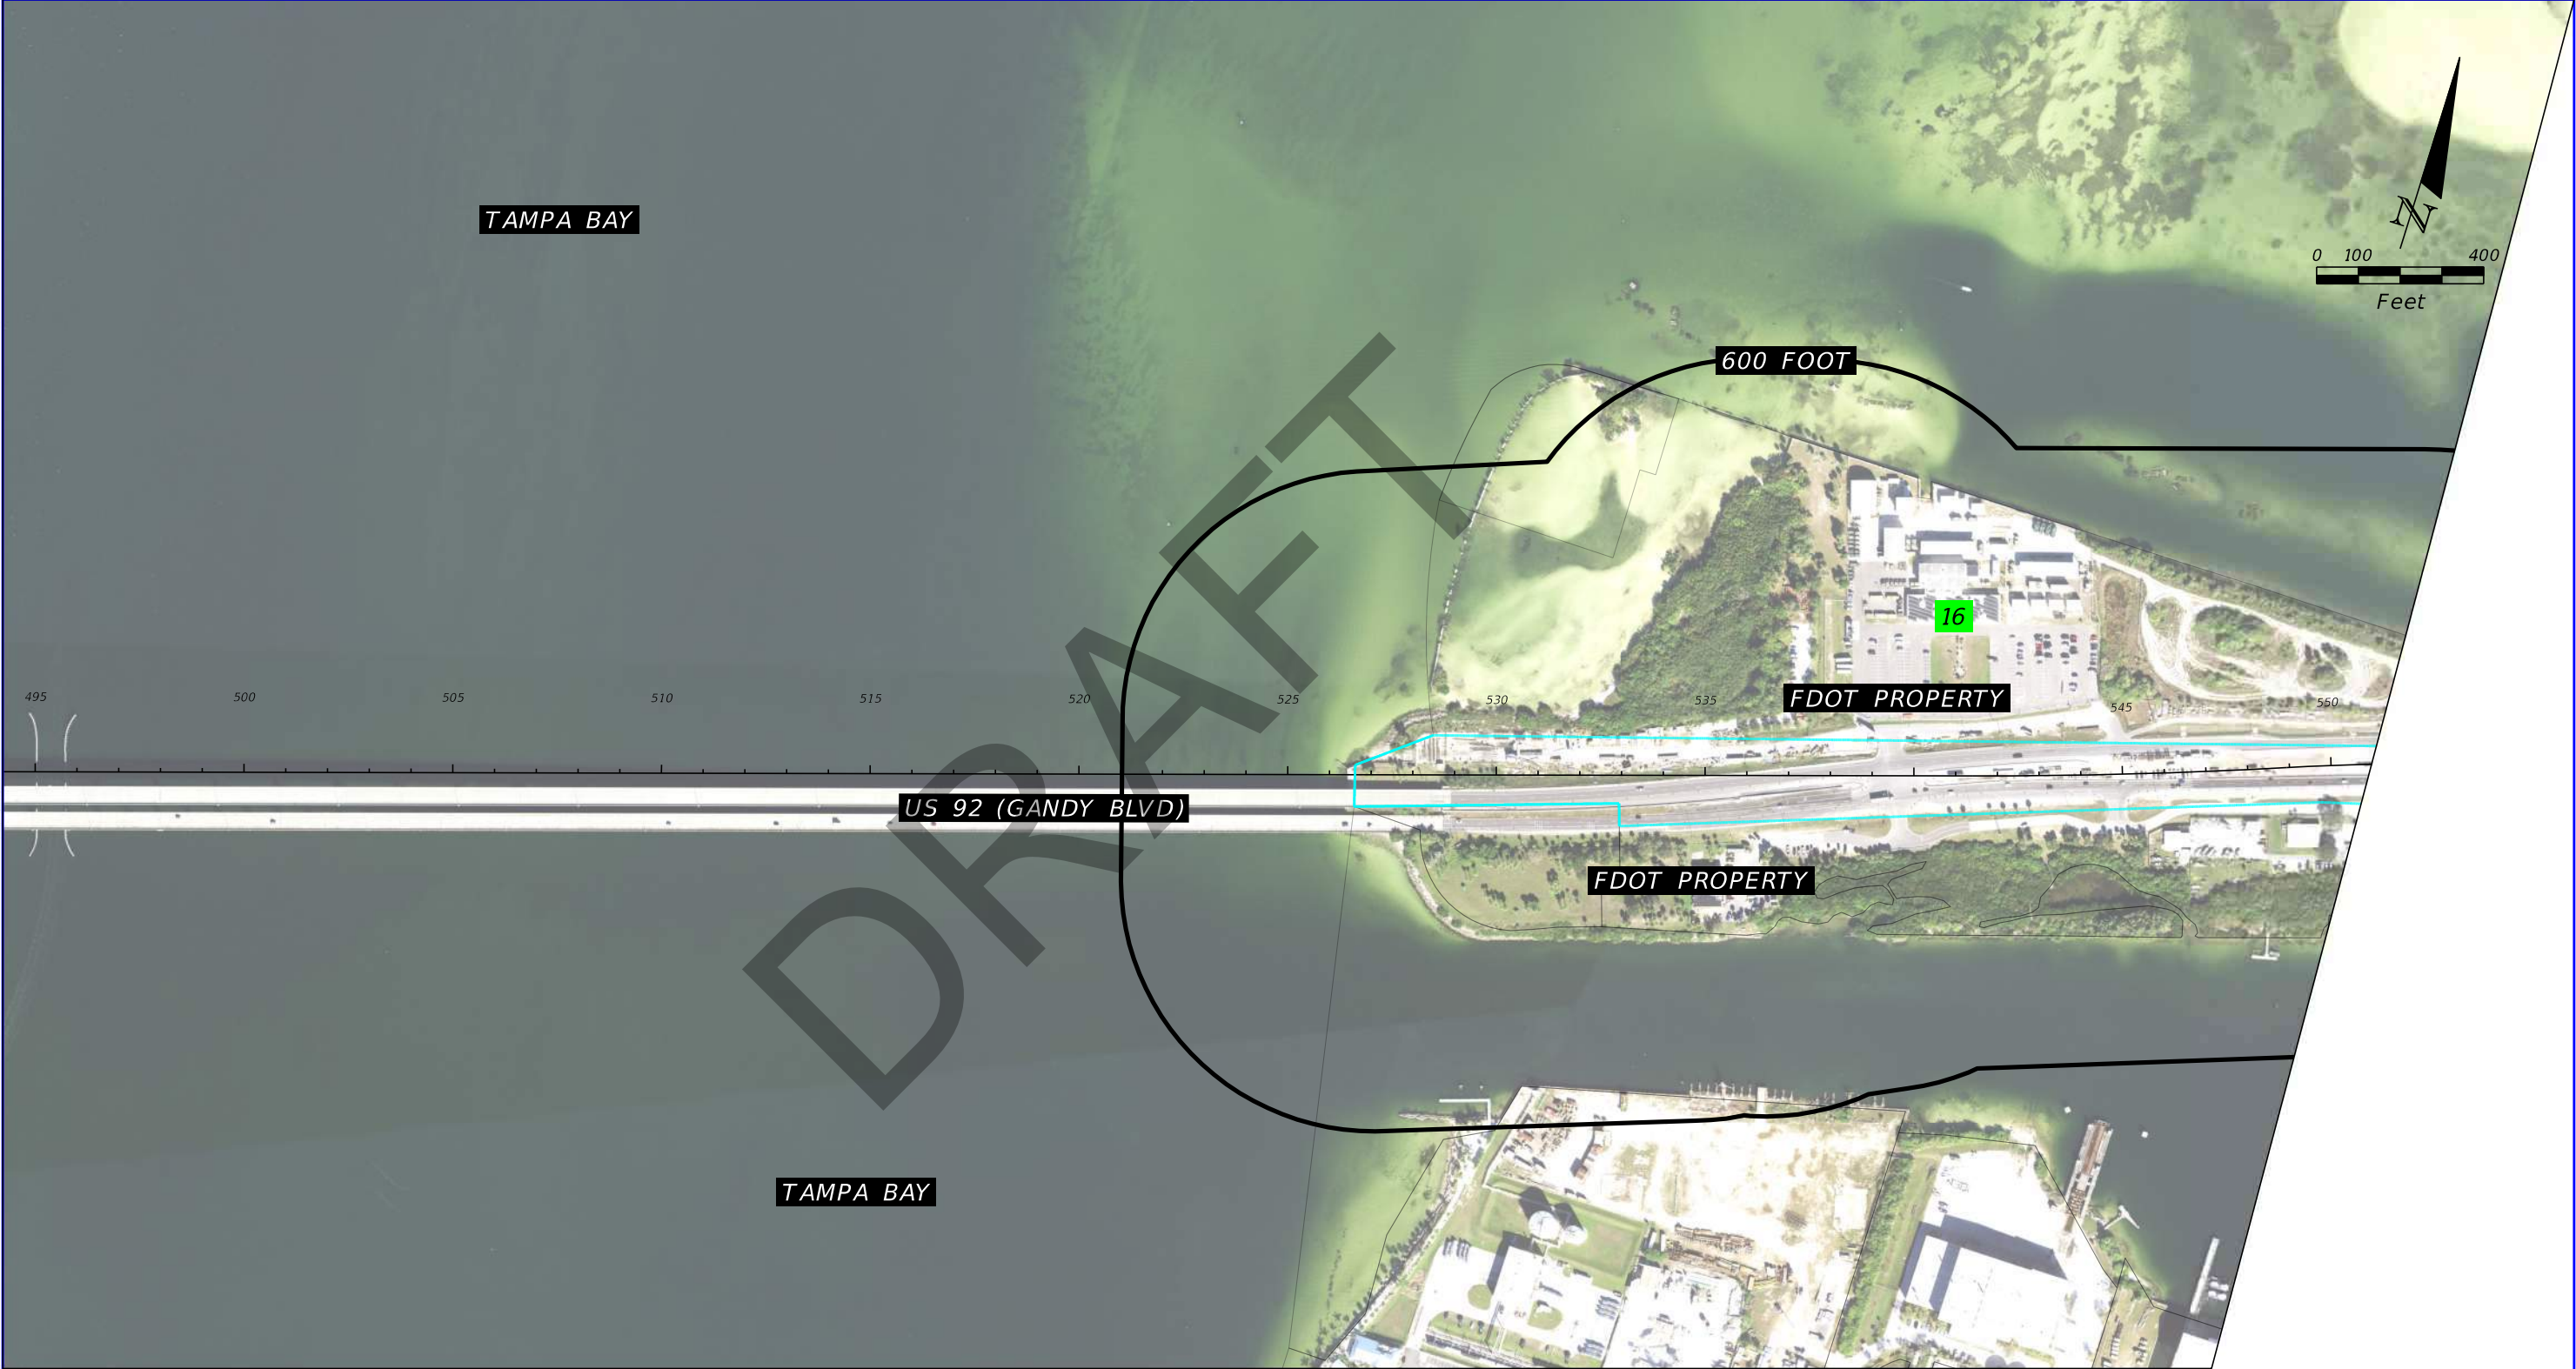
POTENTIAL CONTAMINATION SITES
